Appendix II

SBEACH Model Erosion Profile Plots

Walton County

15-year and 25-year Storm Events

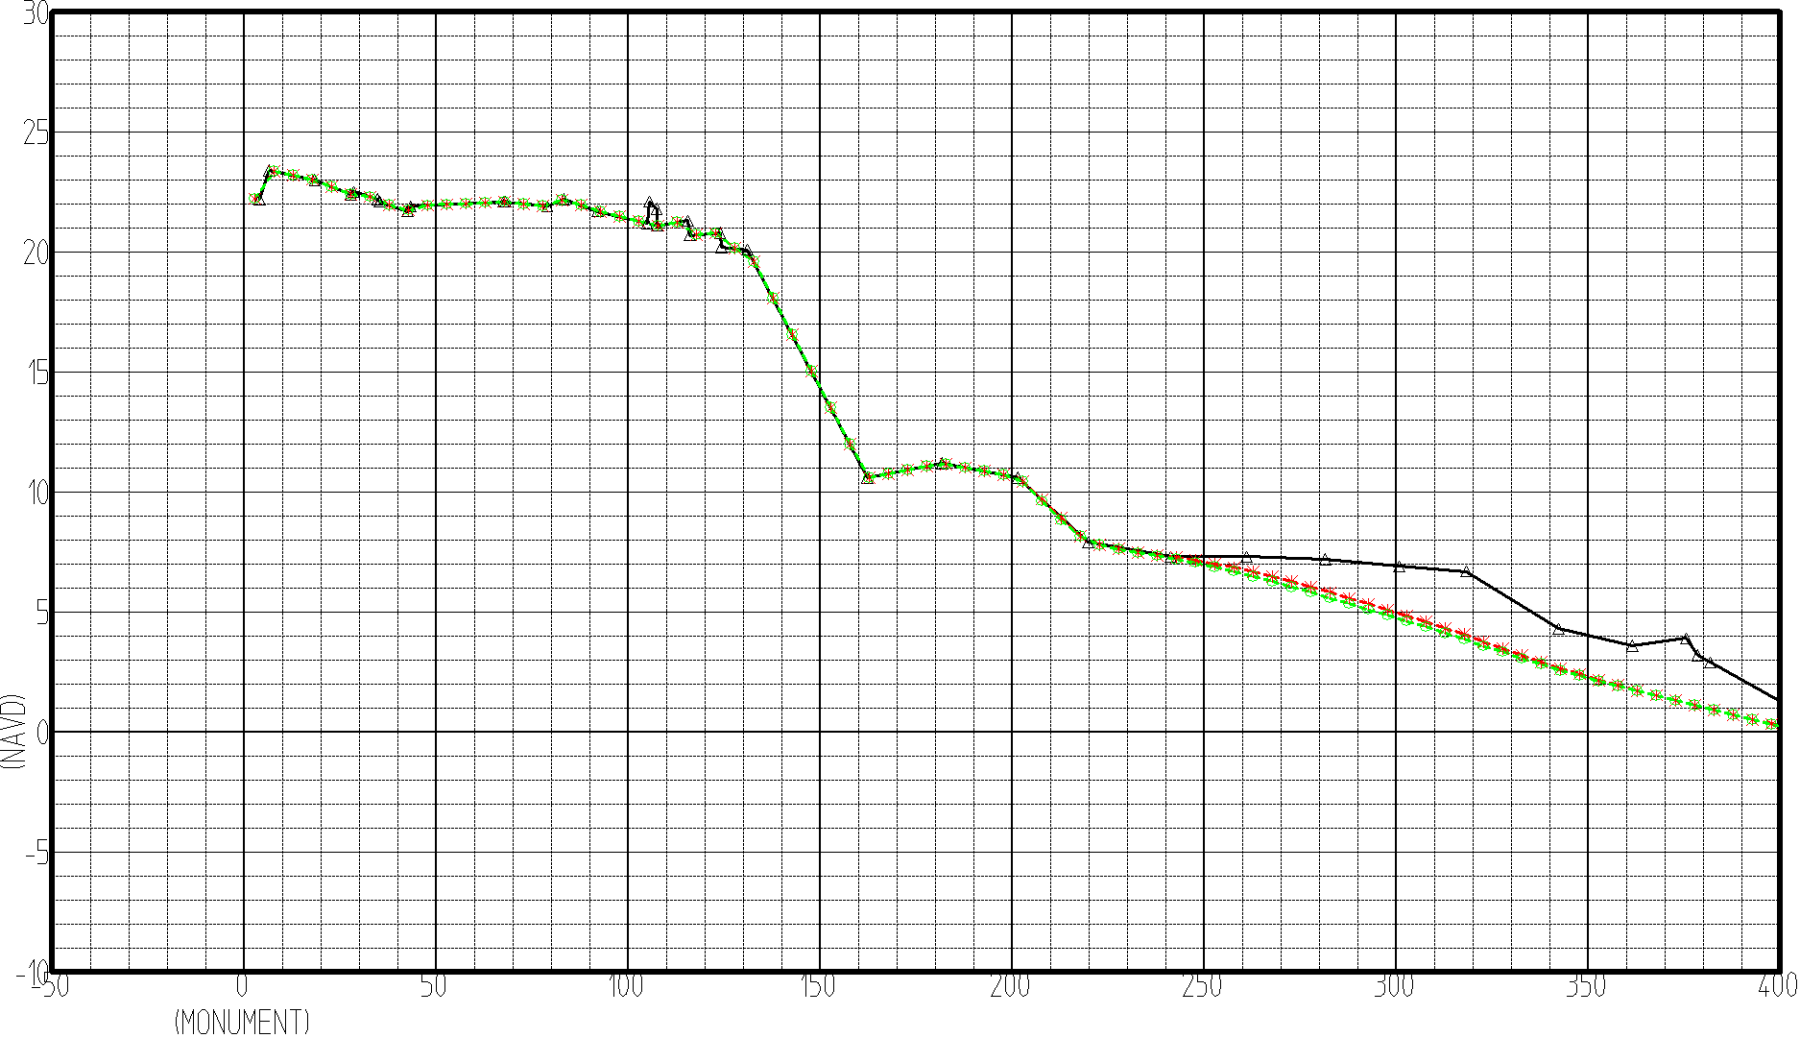
Range: R-1
 BEARING: 190.00
 1/2

BEACH PROFILE
 —△—△— WALTON JULY 2007 PRF
 - - * - - SBEACH 15-YR ERODED PRF
 - - o - - SBEACH 25-YR ERODED PRF

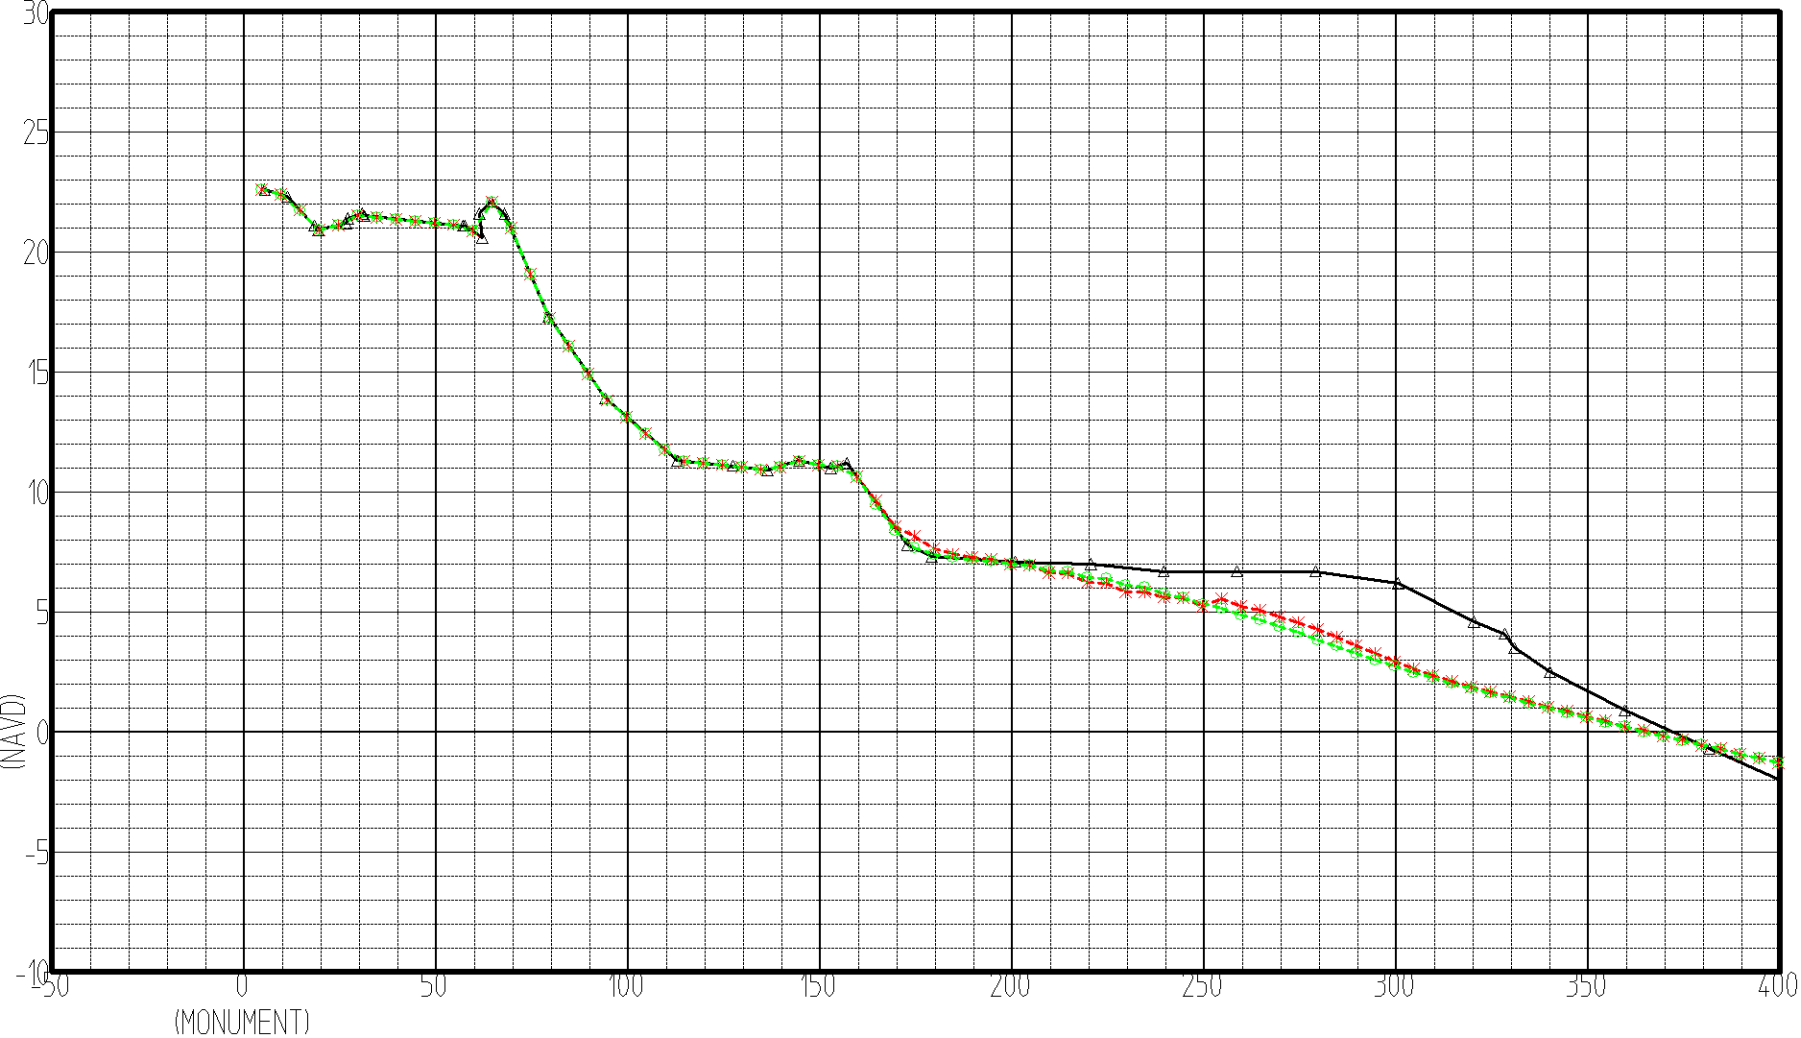
Range: R-1 2/2
 BEARING: 190.00

BEACH PROFILE
 —△—△— WALTON JULY 2007 PRF
 - - * - - * - - SBEACH 15-YR ERODED PRF
 - - o - - o - - SBEACH 25-YR ERODED PRF

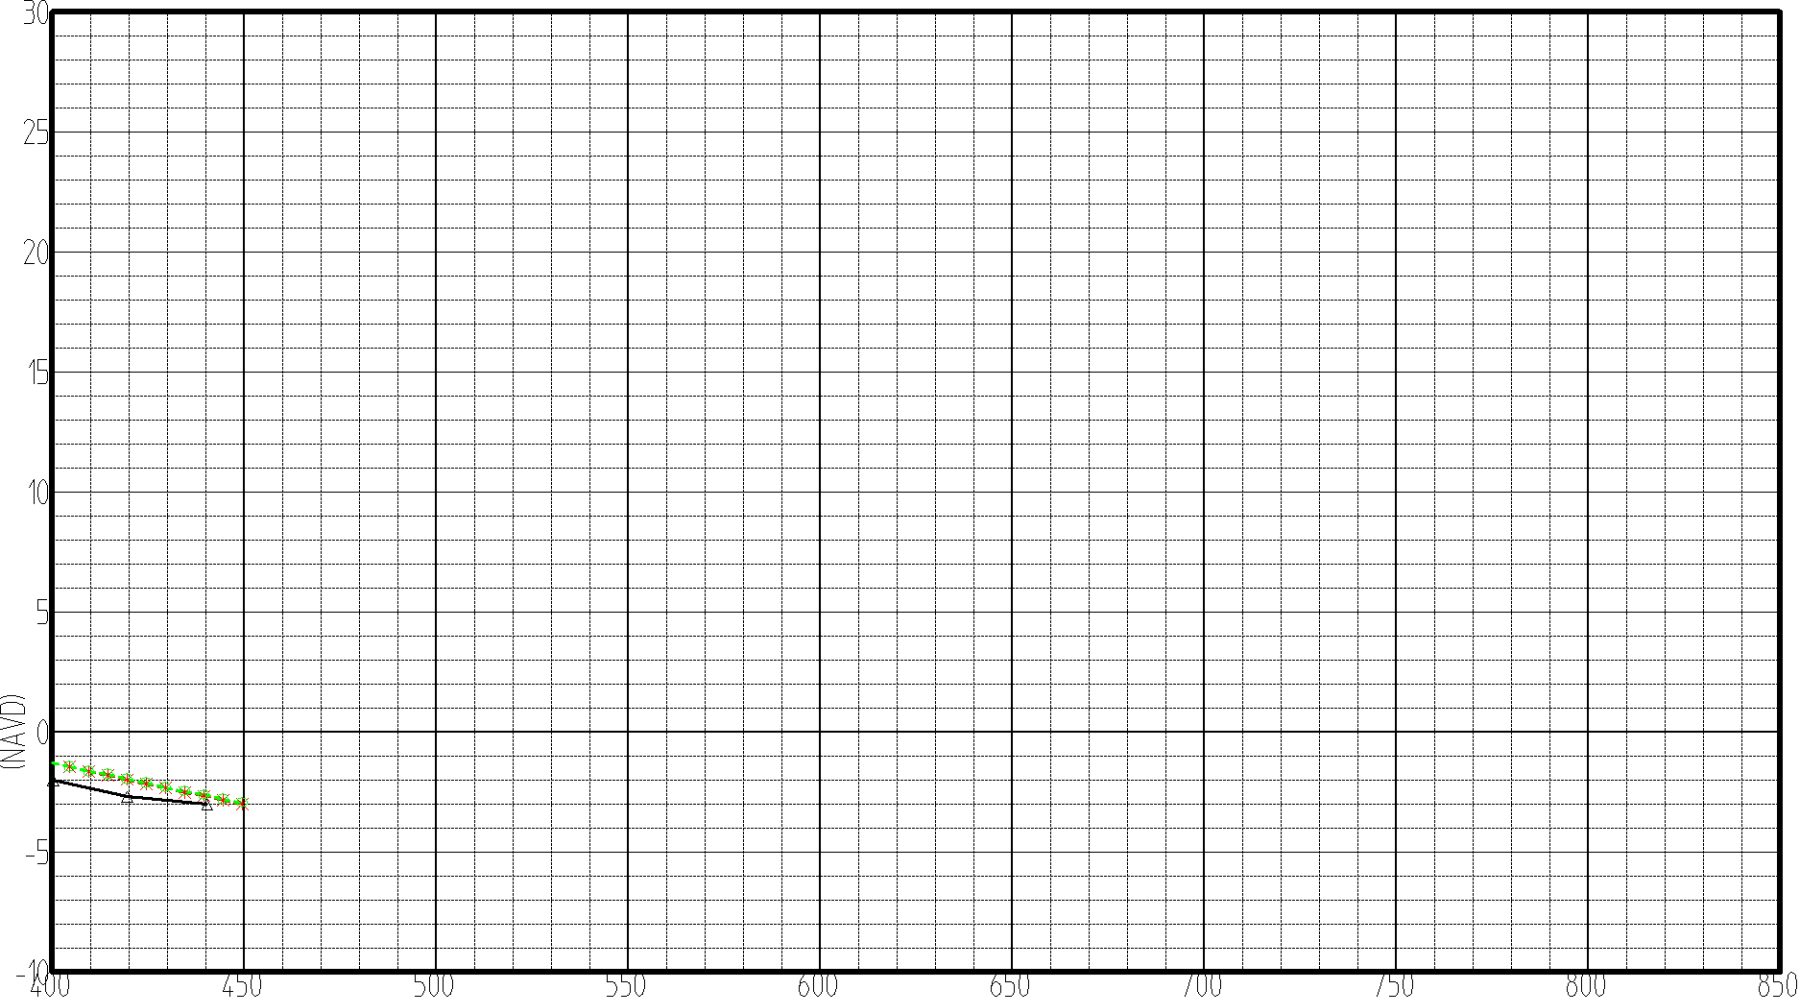
Range: R-2 1/2

—△—△— WALTON JULY 2007 PRF
 - - * - - SBEACH 15-YR ERODED PRF
 - - o - - SBEACH 25-YR ERODED PRF

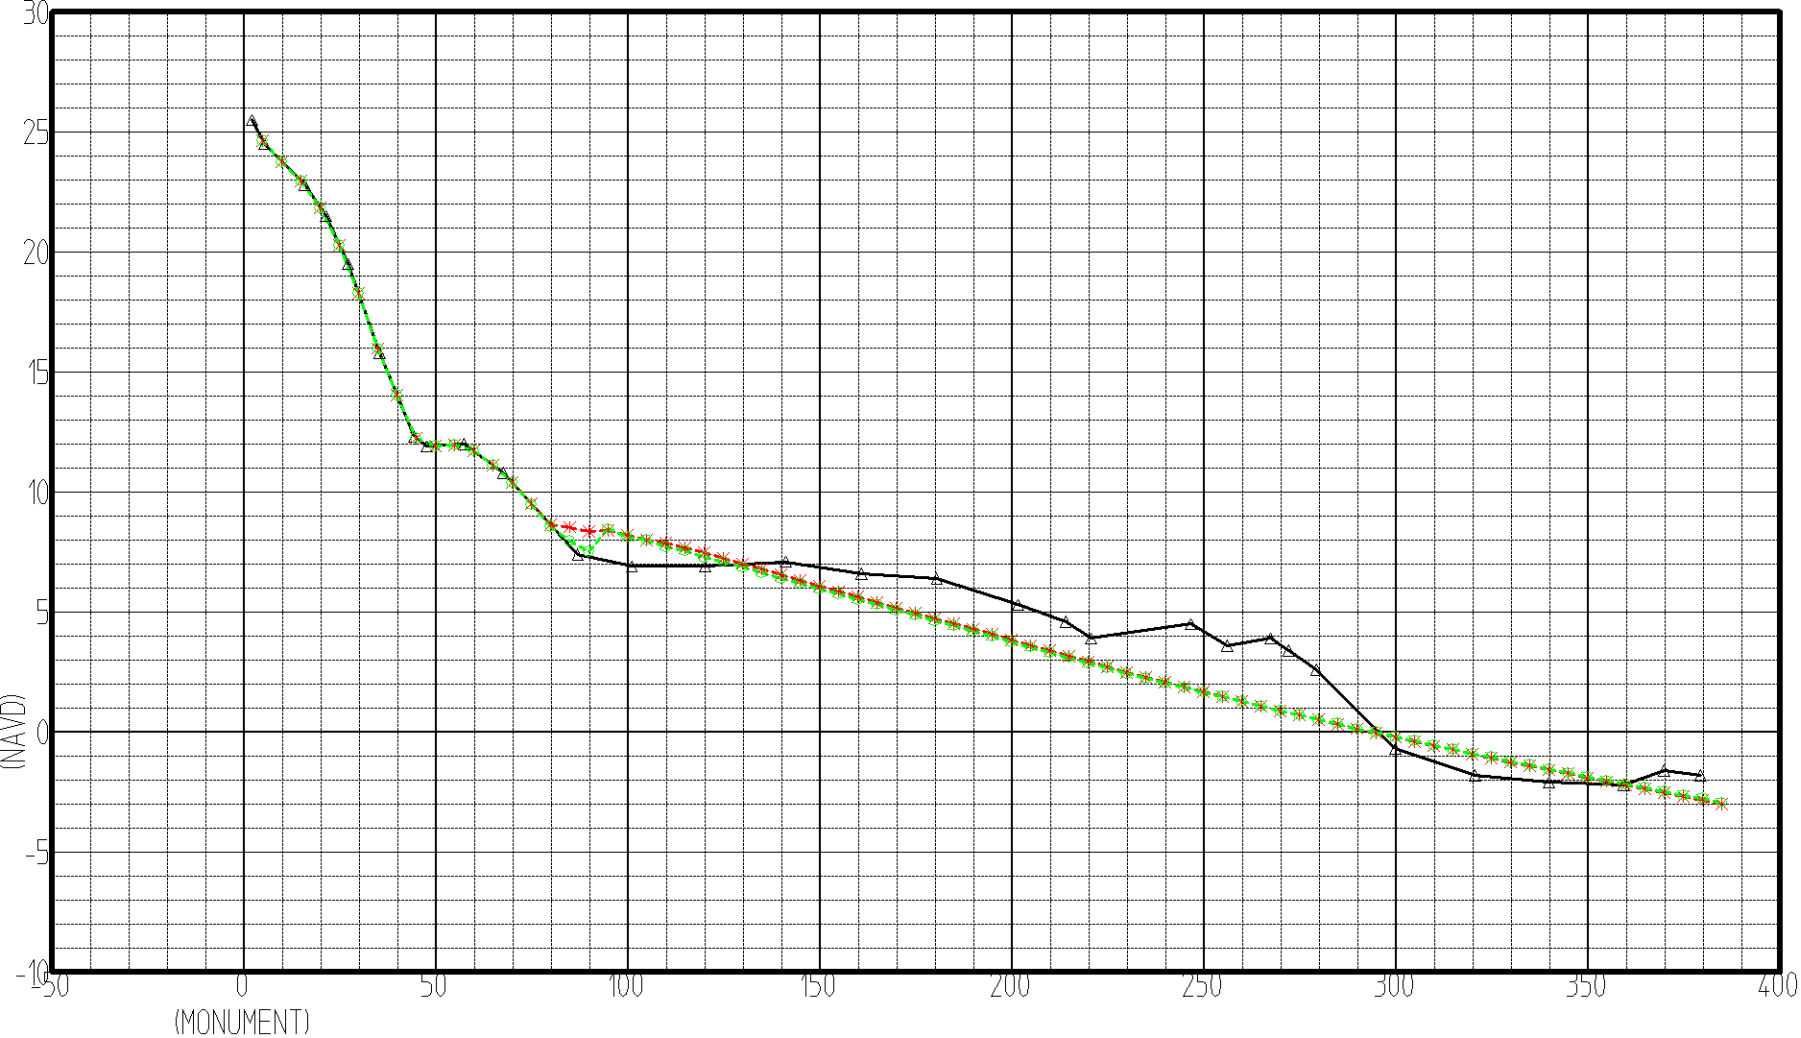
Range: R-2 2/2
 BEARING: 190.00

BEACH PROFILE
 —△—△— WALTON JULY 2007 PRF
 - - * - - SBEACH 15-YR ERODED PRF
 - - o - - SBEACH 25-YR ERODED PRF

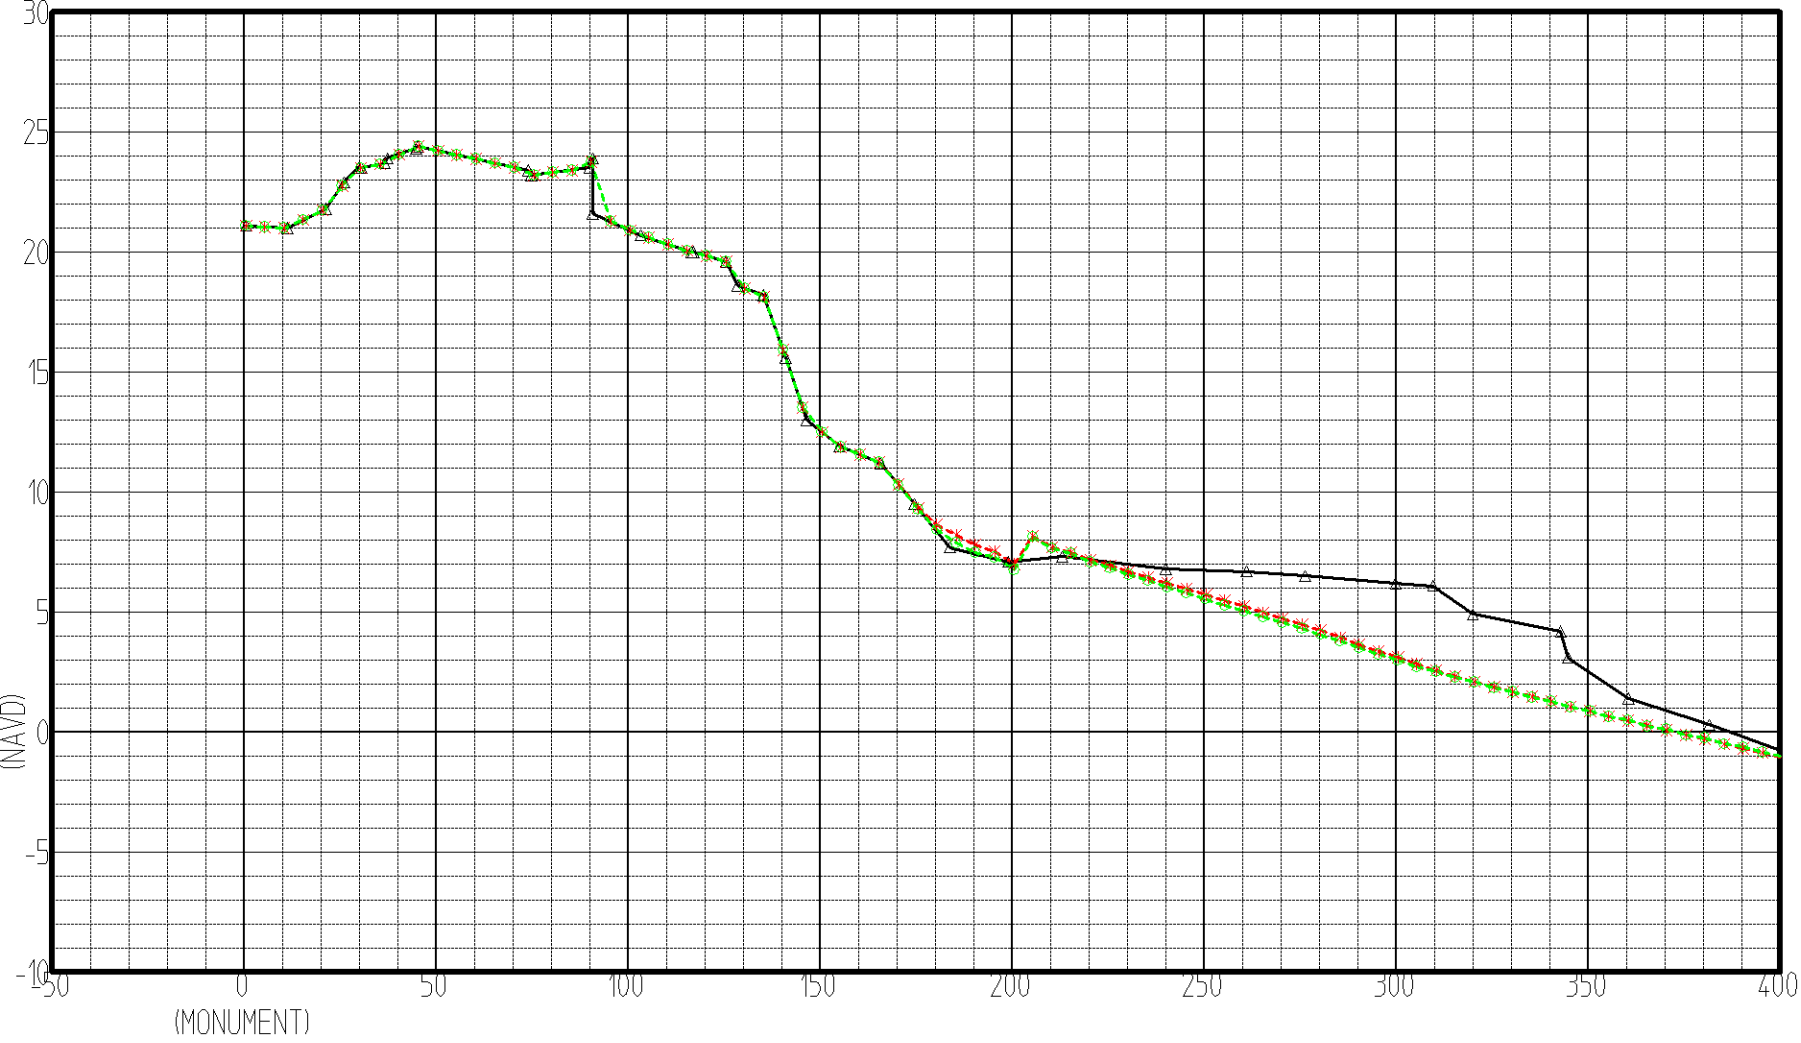
Range: R-3A 1/2

- △—△— WALTON JULY 2007 PRF
- - * - - * - - SBEACH 15-YR ERODED PRF
- - o - - o - - SBEACH 25-YR ERODED PRF

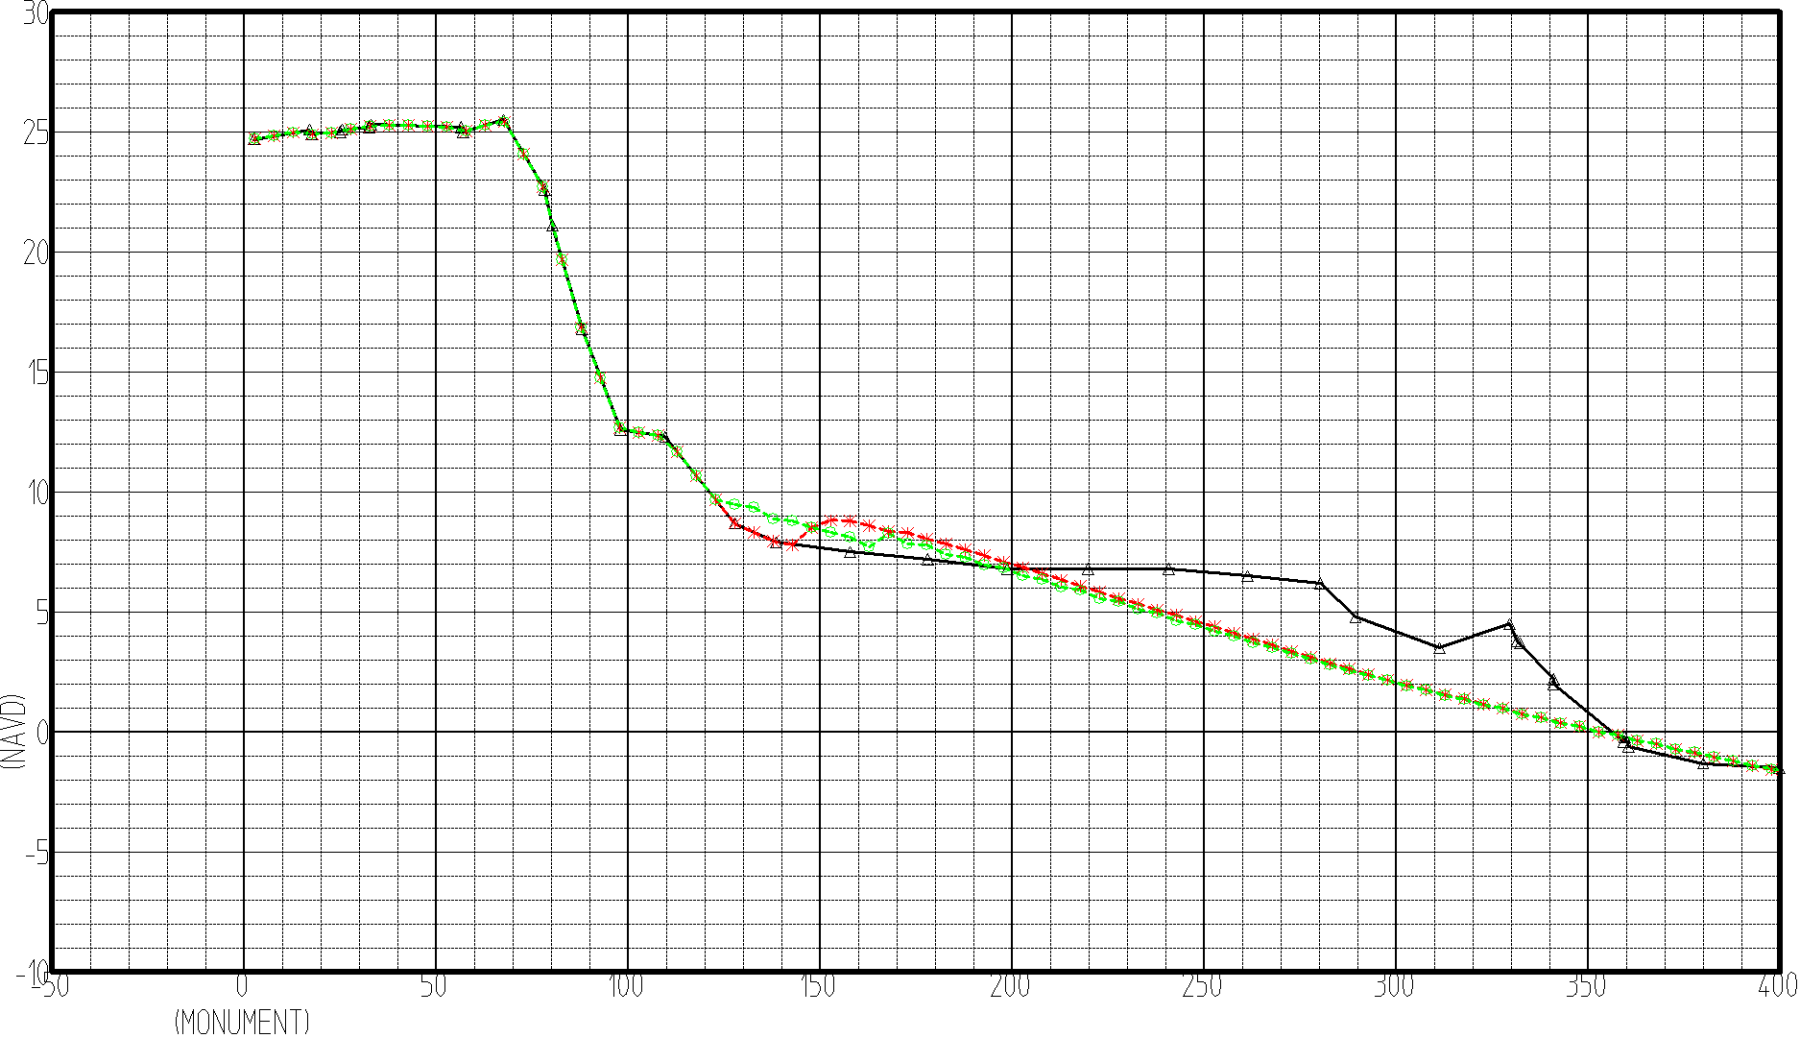
Range: R-4
 BEARING: 190.00
 1/2

BEACH PROFILE
 —△—△— WALTON JULY 2007 PRF
 - - * - - * - - SBEACH 15-YR ERODED PRF
 - - o - - o - - SBEACH 25-YR ERODED PRF

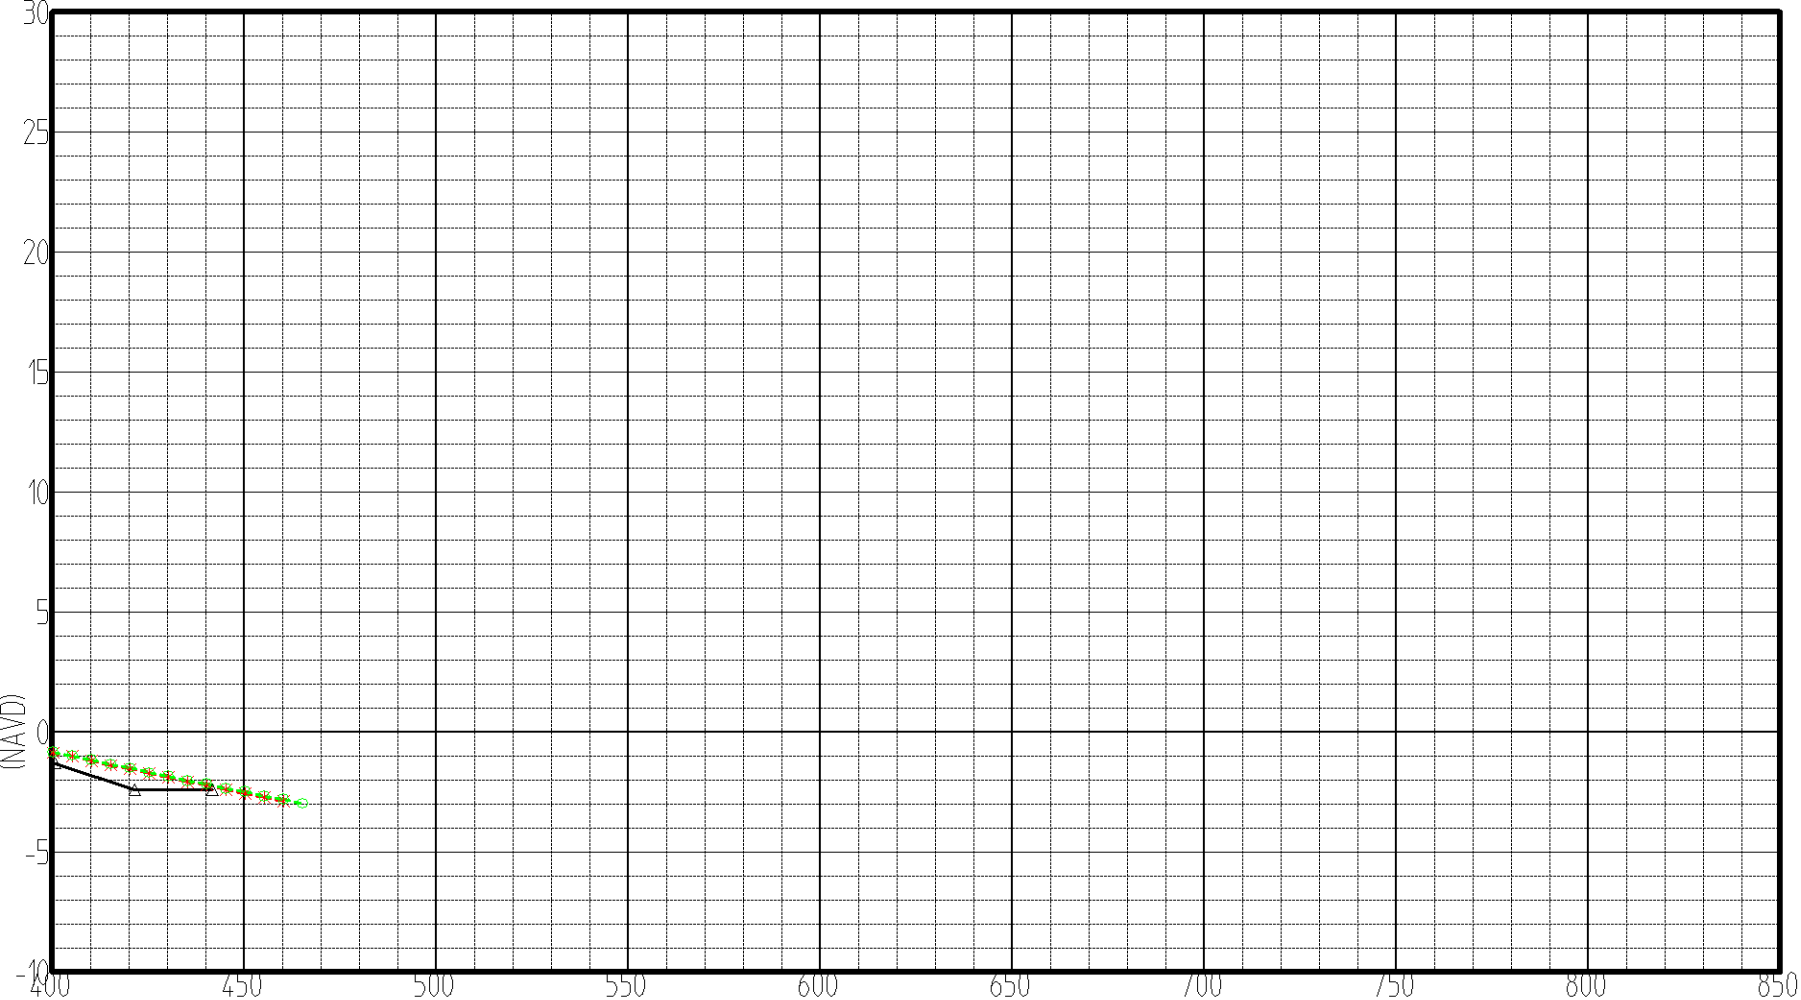
Range: R-5
 BEARING: 190.00
 1/2

BEACH PROFILE
 —△—△— WALTON JULY 2007 PRF
 - - * - - SBEACH 15-YR ERODED PRF
 - - o - - SBEACH 25-YR ERODED PRF

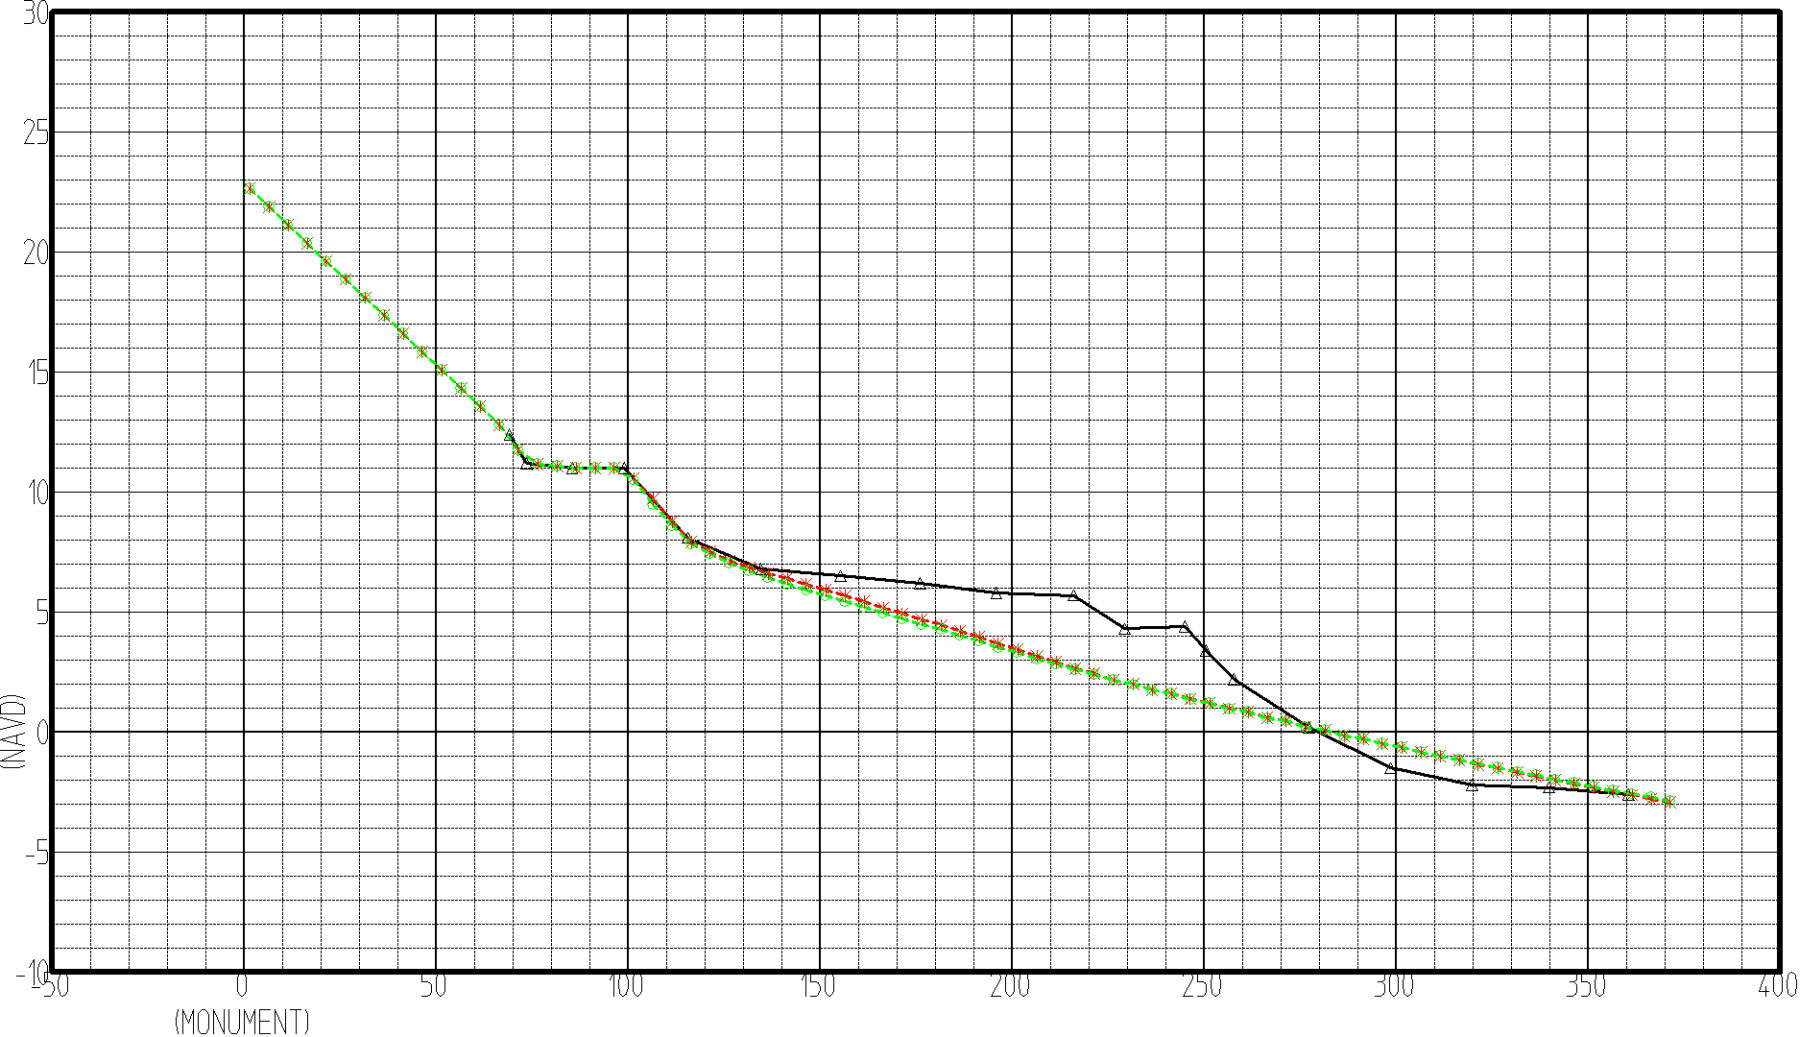
Range: R-5
 BEARING: 190.00
 2/2

BEACH PROFILE
 —△—△— WALTON JULY 2007 PRF
 - - * - - * - - SBEACH 15-YR ERODED PRF
 - - o - - o - - SBEACH 25-YR ERODED PRF

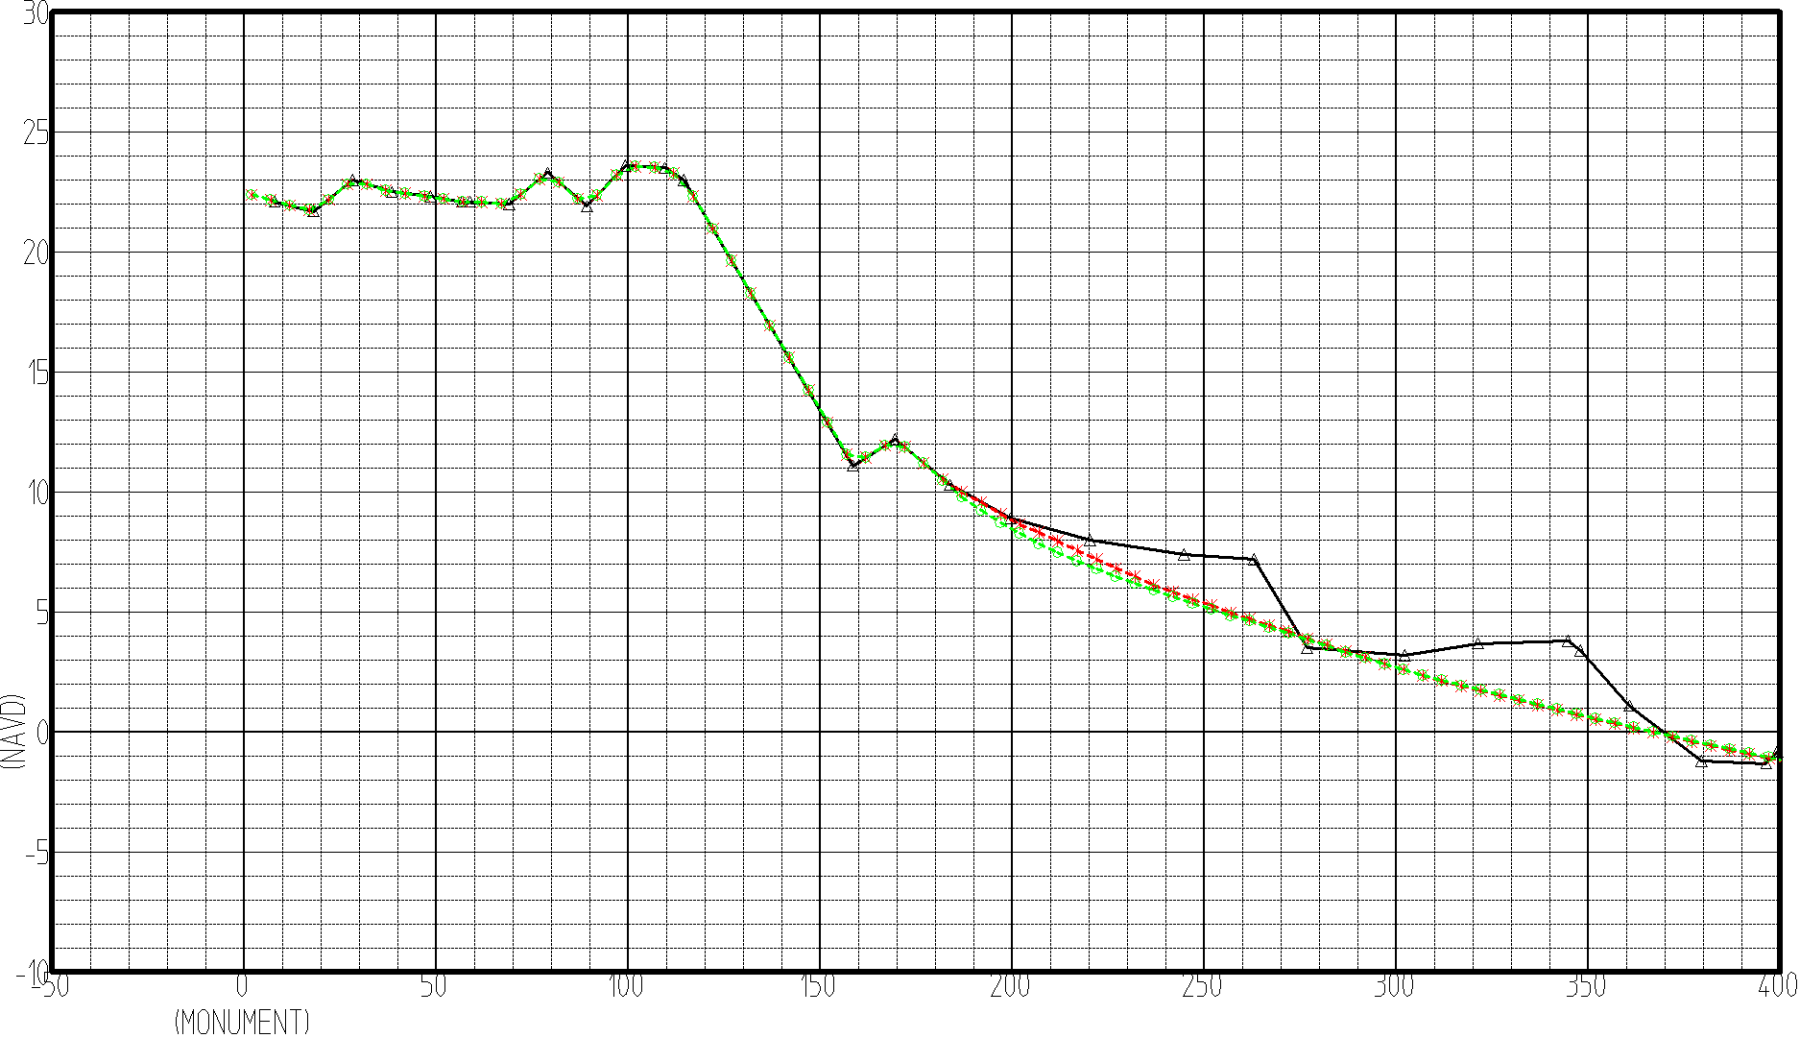
Range: R-6
 BEARING: 190.00
 1/1

BEACH PROFILE
 —△—△— WALTON JULY 2007 PRF
 - - * - - SBEACH 15-YR ERODED PRF
 - - o - - SBEACH 25-YR ERODED PRF

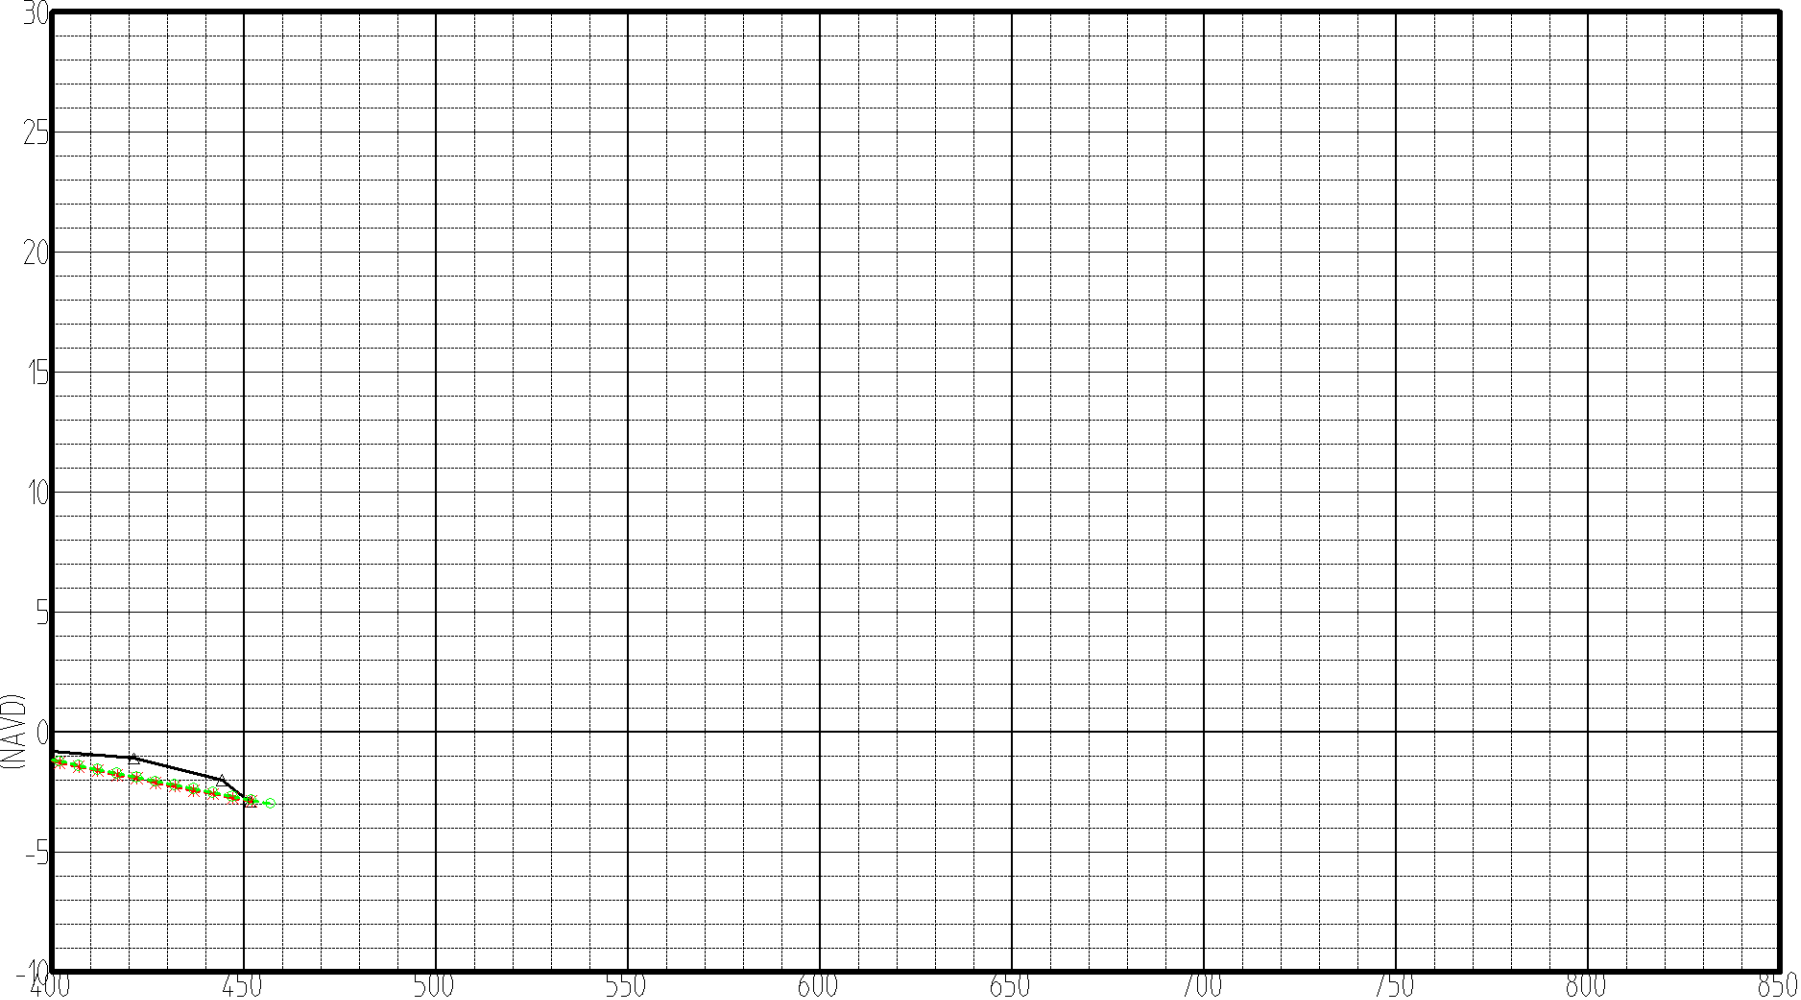
Range: R-6A 1/2
 BEARING: 190.00

BEACH PROFILE
 —△—△— WALTON JULY 2007 PRF
 - - * - - SBEACH 15-YR ERODED PRF
 - - o - - SBEACH 25-YR ERODED PRF

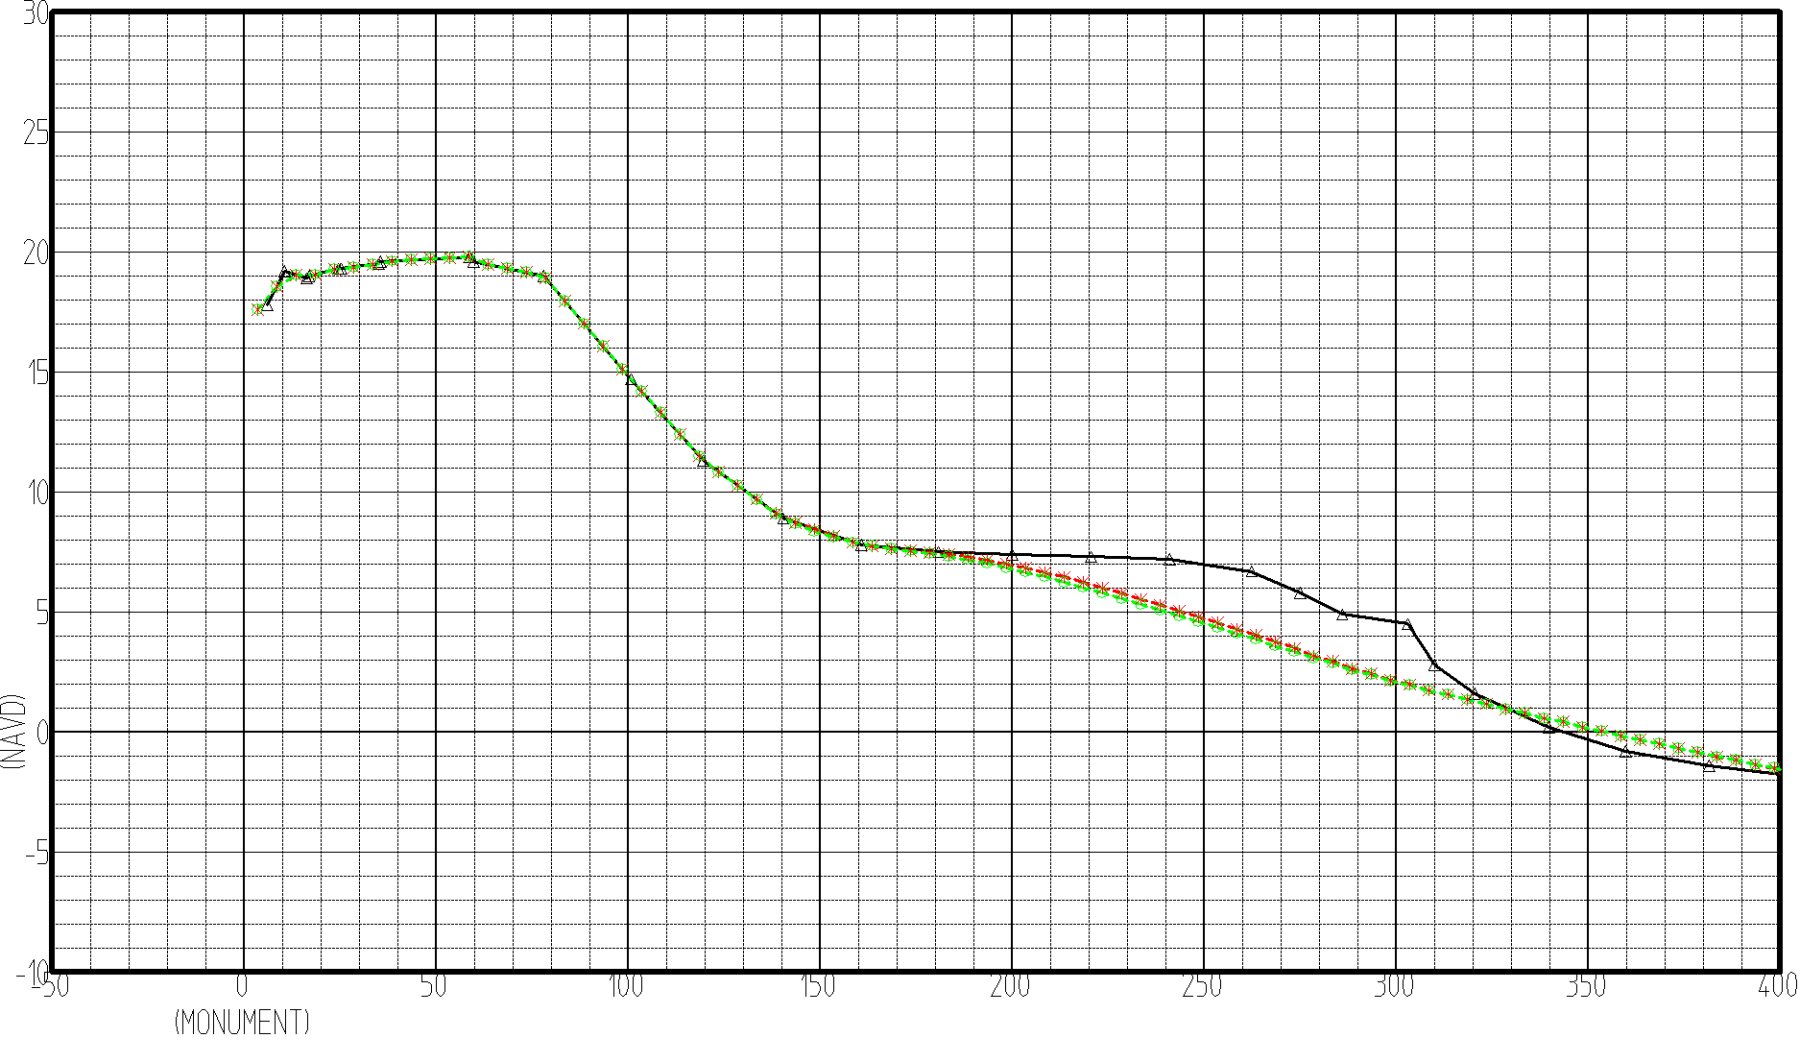
Range: R-7
 BEARING: 190.00
 1/2

BEACH PROFILE
 —△—△— WALTON JULY 2007 PRF
 - - * - - SBEACH 15-YR ERODED PRF
 - - o - - SBEACH 25-YR ERODED PRF

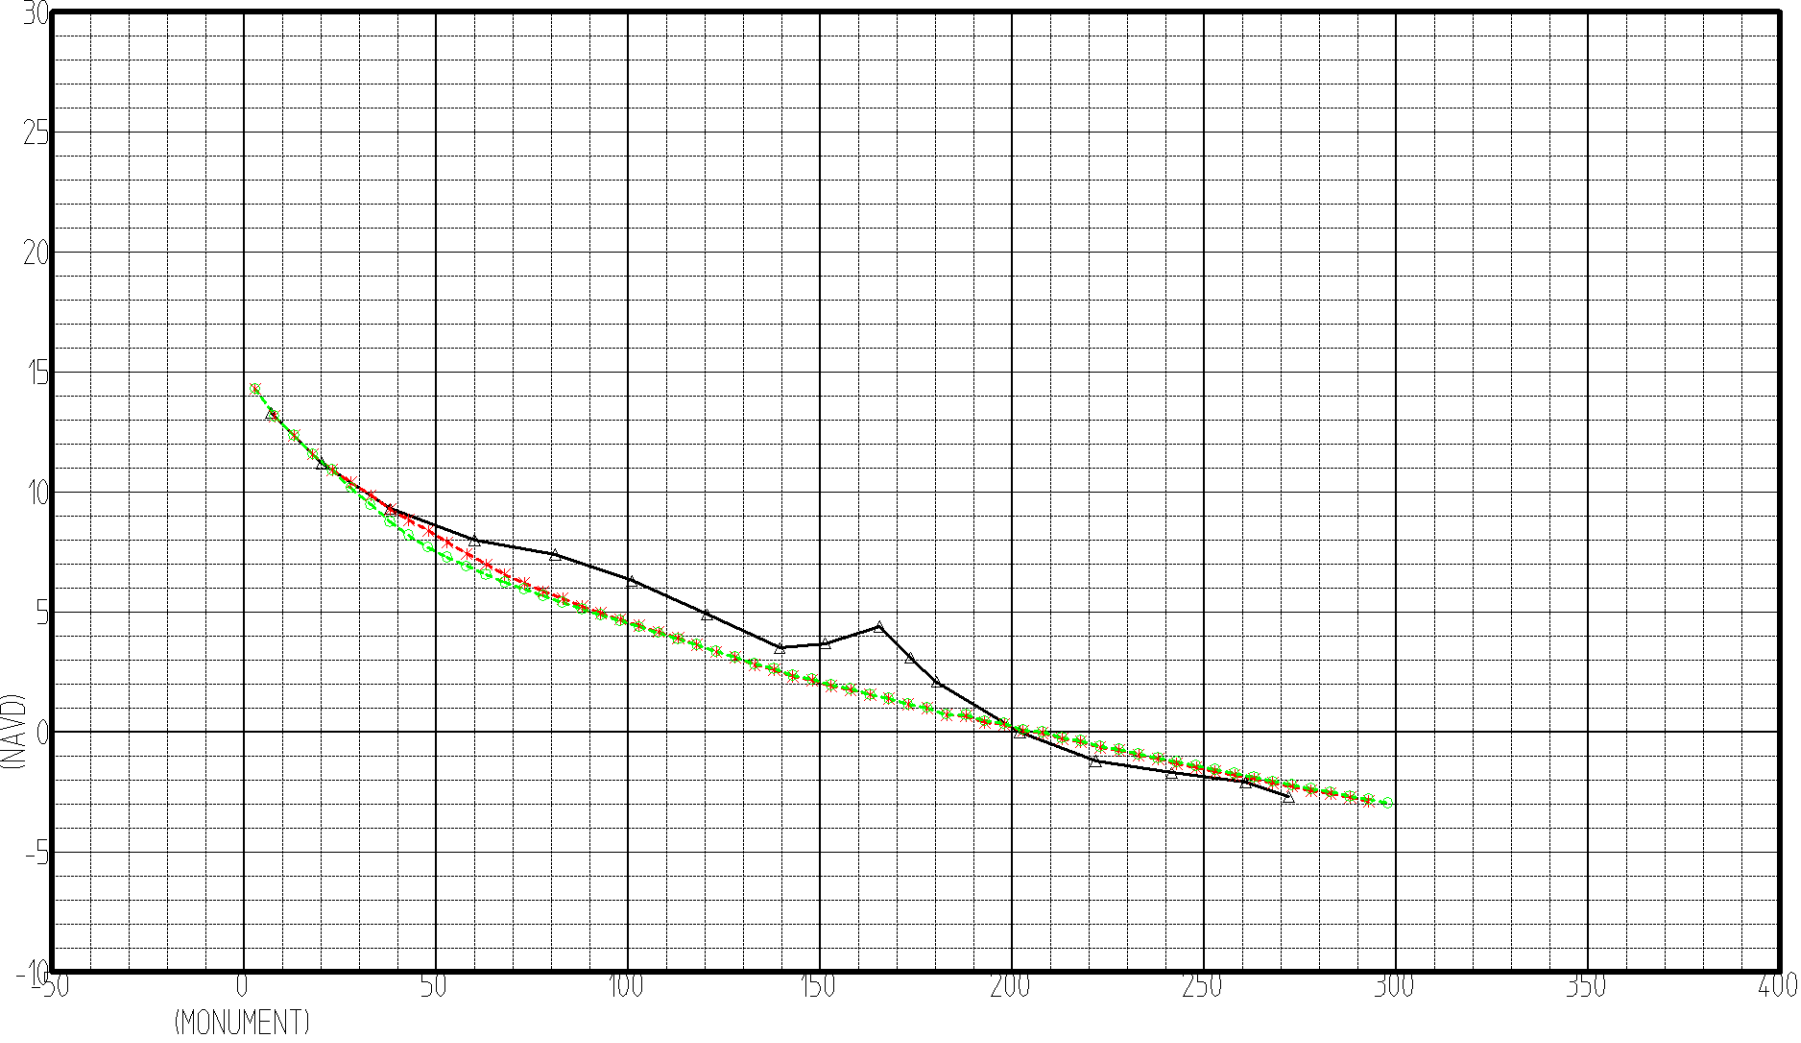
Range: R-8
 BEARING: 190.00
 1/1

BEACH PROFILE
 —△—△— WALTON JULY 2007 PRF
 - - * - - SBEACH 15-YR ERODED PRF
 - - o - - SBEACH 25-YR ERODED PRF
