Appendix II

SBEACH Model Erosion Profile Plots

Walton County

15-year and 25-year Storm Events

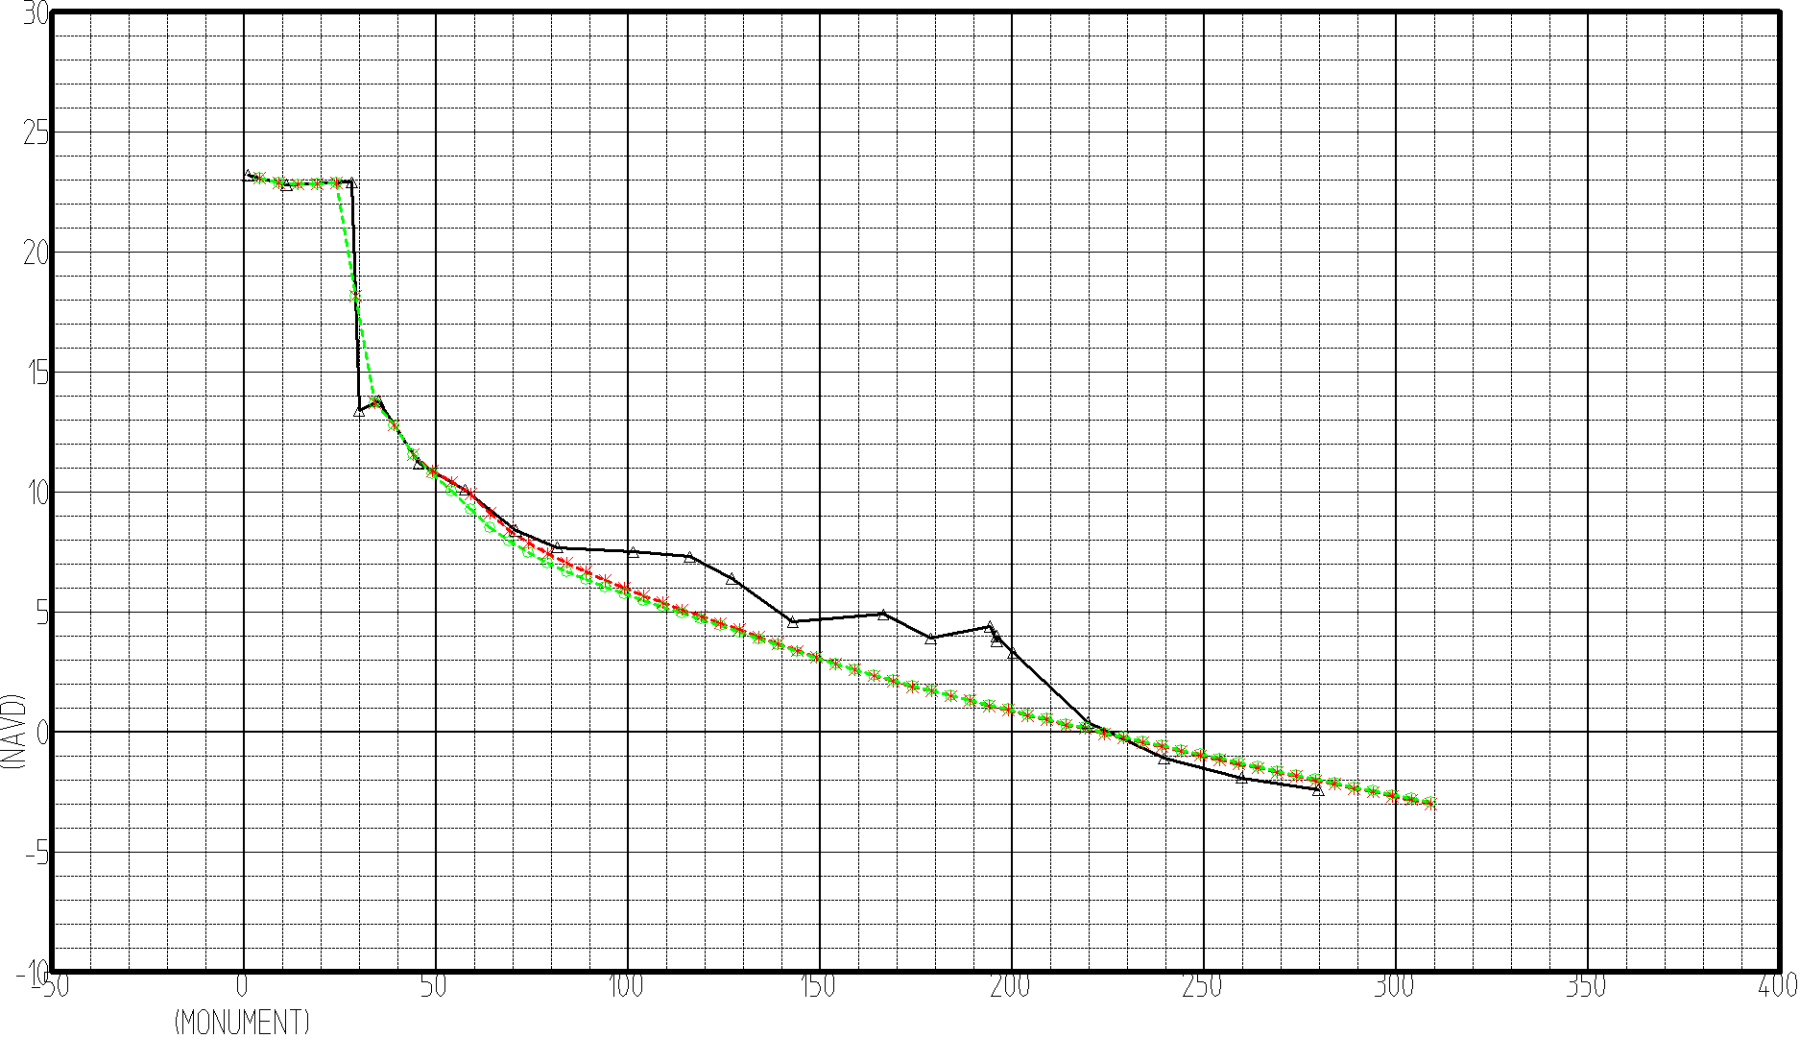
Range: R-10
 BEARING: 190.00
 1/1

BEACH PROFILE
 —△—△— WALTON JULY 2007 PRF
 - - * - - * - - SBEACH 15-YR ERODED PRF
 - - o - - o - - SBEACH 25-YR ERODED PRF

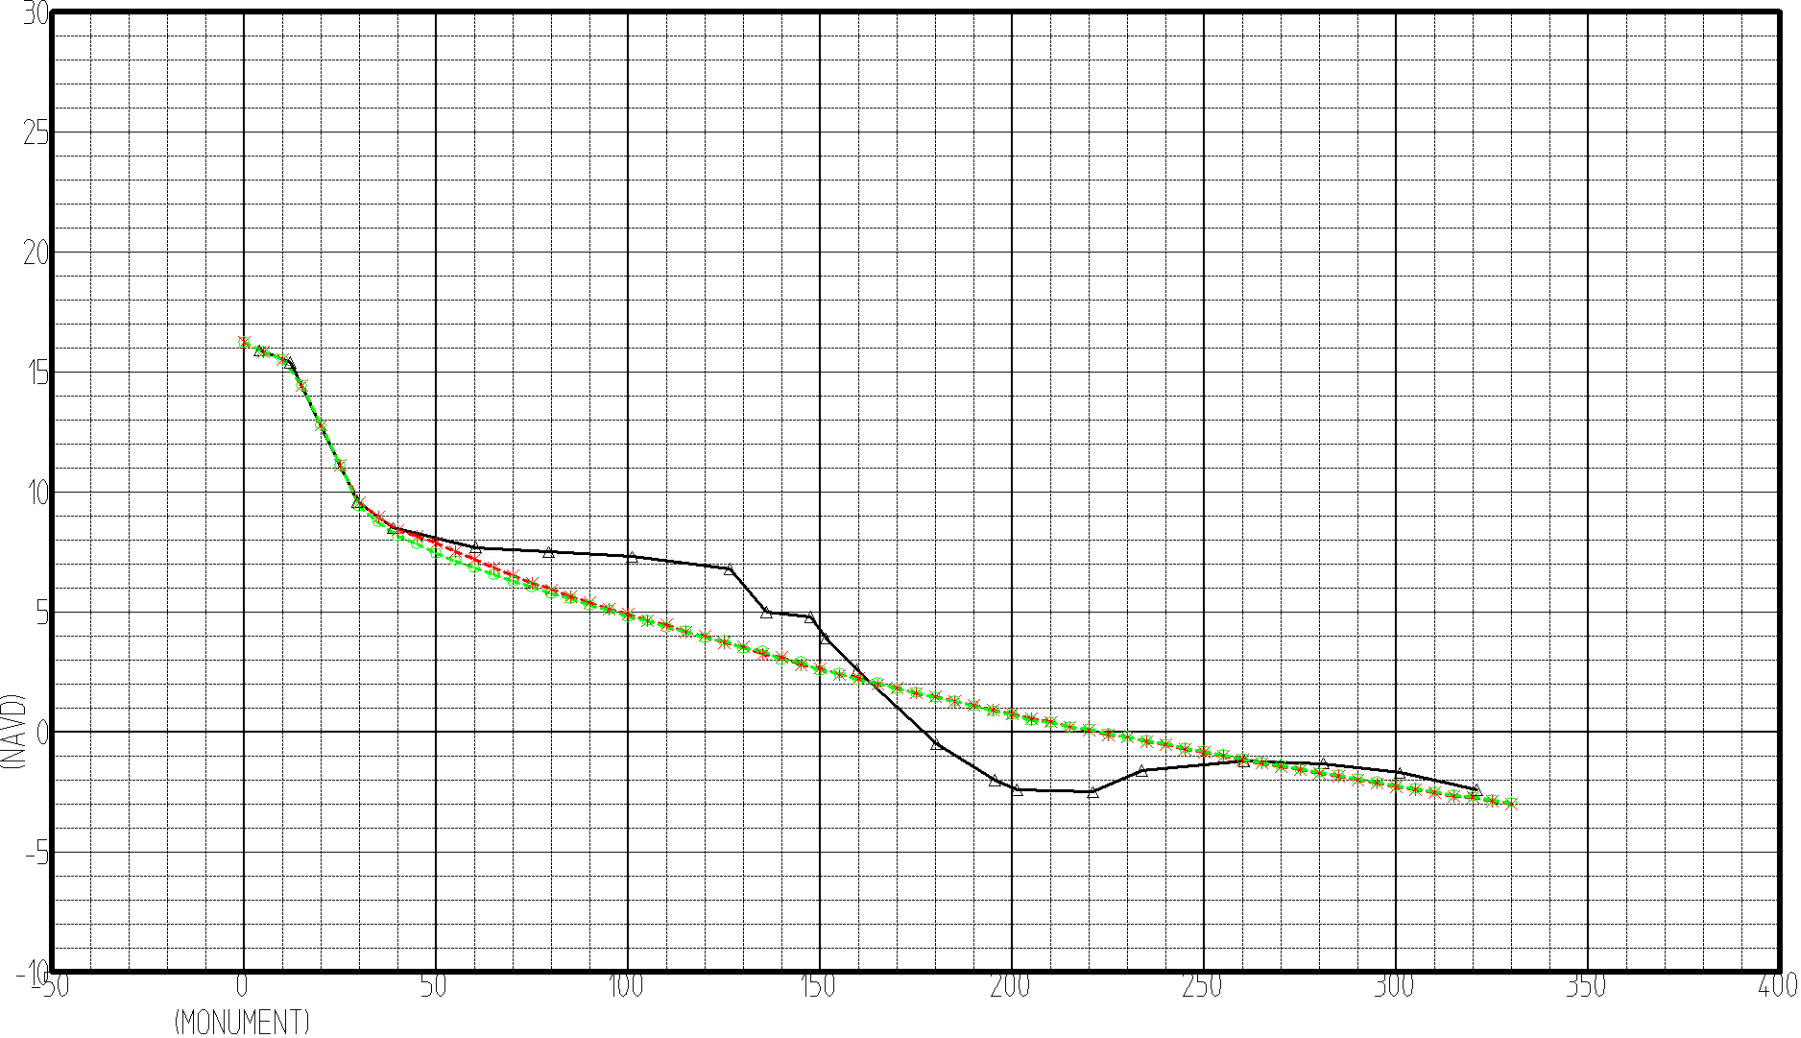
Range: R-11
 BEARING: 190.00
 1/1

BEACH PROFILE
 —△—△— WALTON JULY 2007 PRF
 - - * - - SBEACH 15-YR ERODED PRF
 - - o - - SBEACH 25-YR ERODED PRF

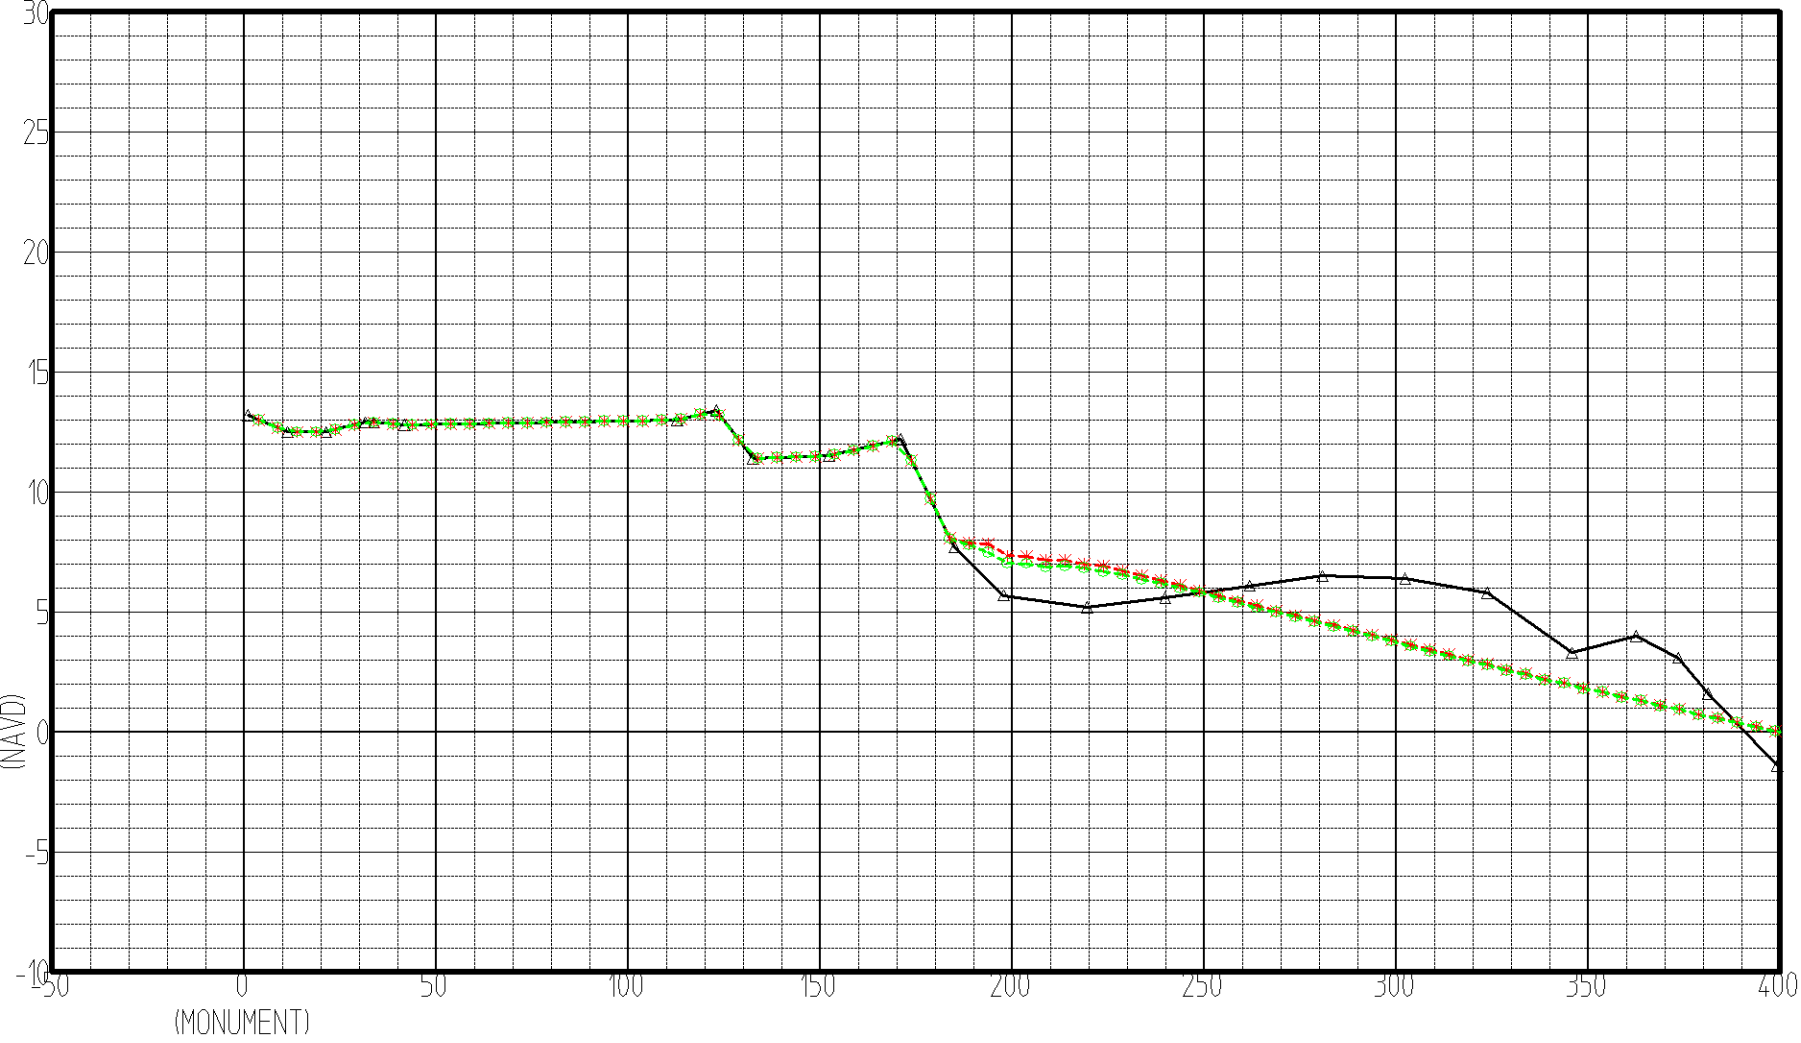
Range: R-13
 BEARING: 190.00
 1/2

BEACH PROFILE
 —△—△— WALTON JULY 2007 PRF
 - - * - - SBEACH 15-YR ERODED PRF
 - - o - - SBEACH 25-YR ERODED PRF

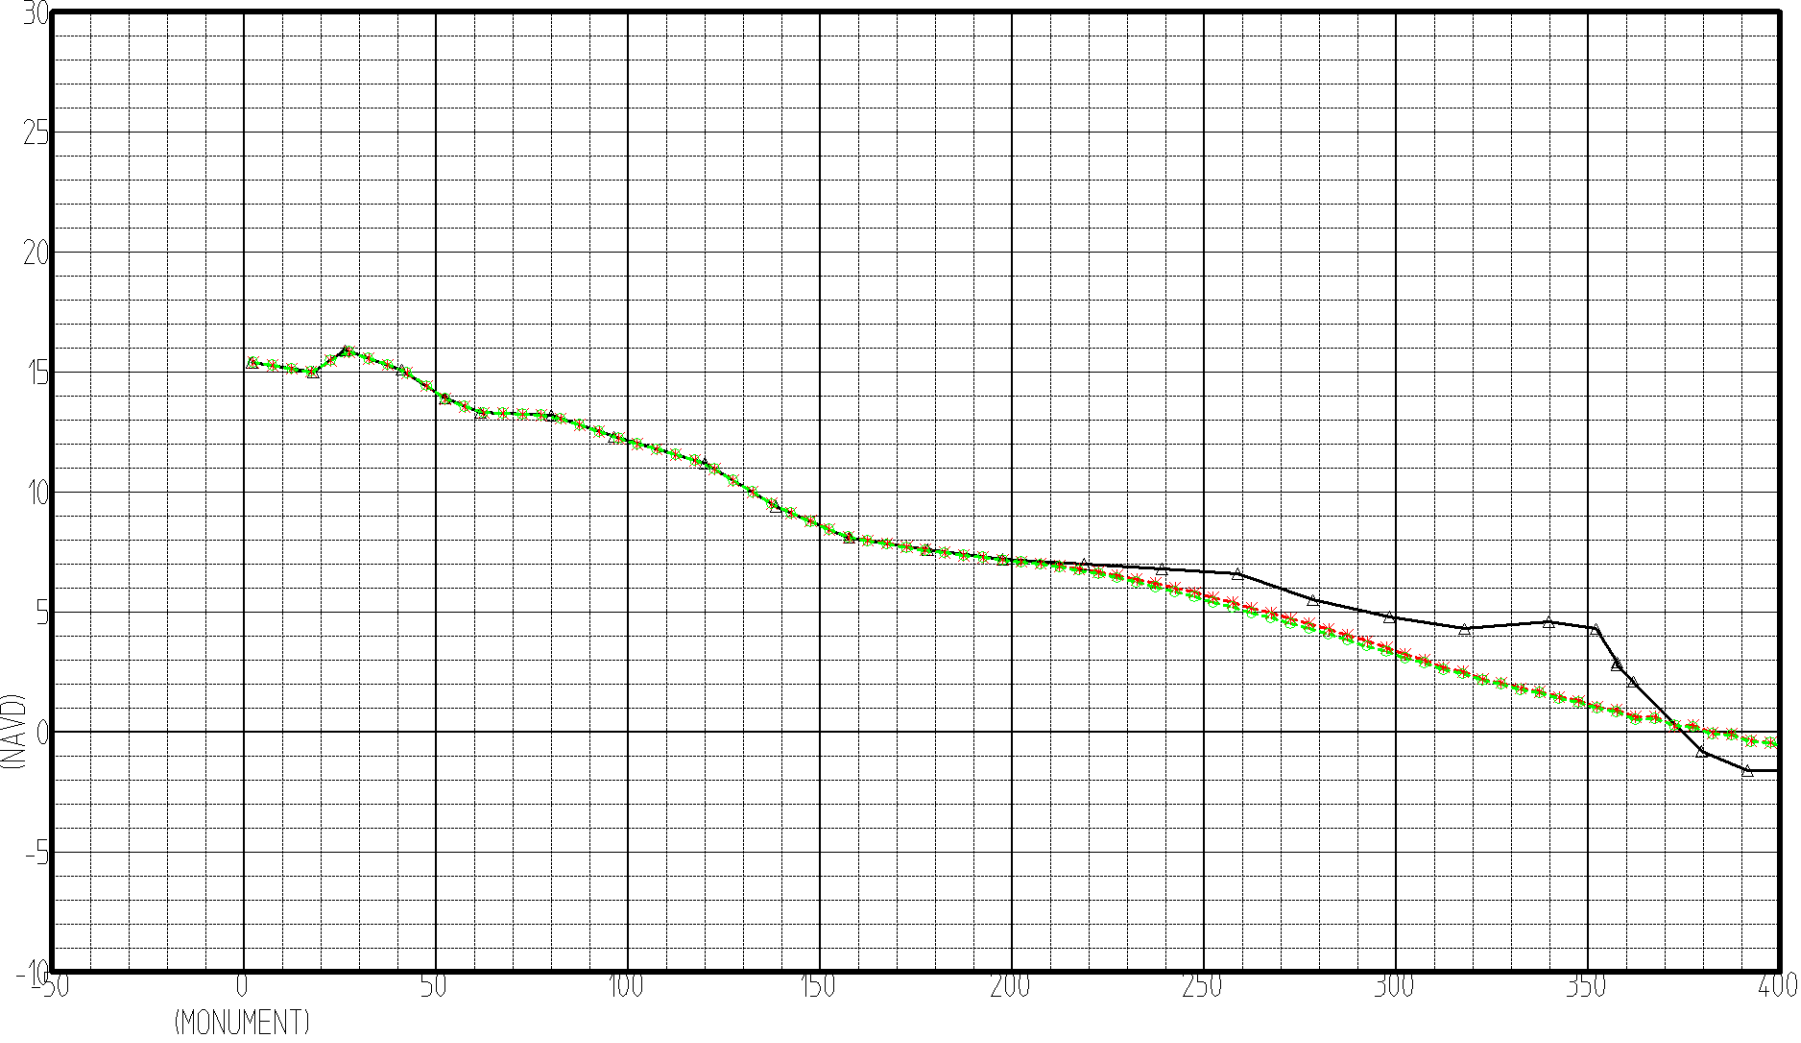
Range: R-14
 BEARING: 190.00
 1/2

BEACH PROFILE
 —△—△— WALTON JULY 2007 PRF
 - - * - - SBEACH 15-YR ERODED PRF
 - - o - - SBEACH 25-YR ERODED PRF

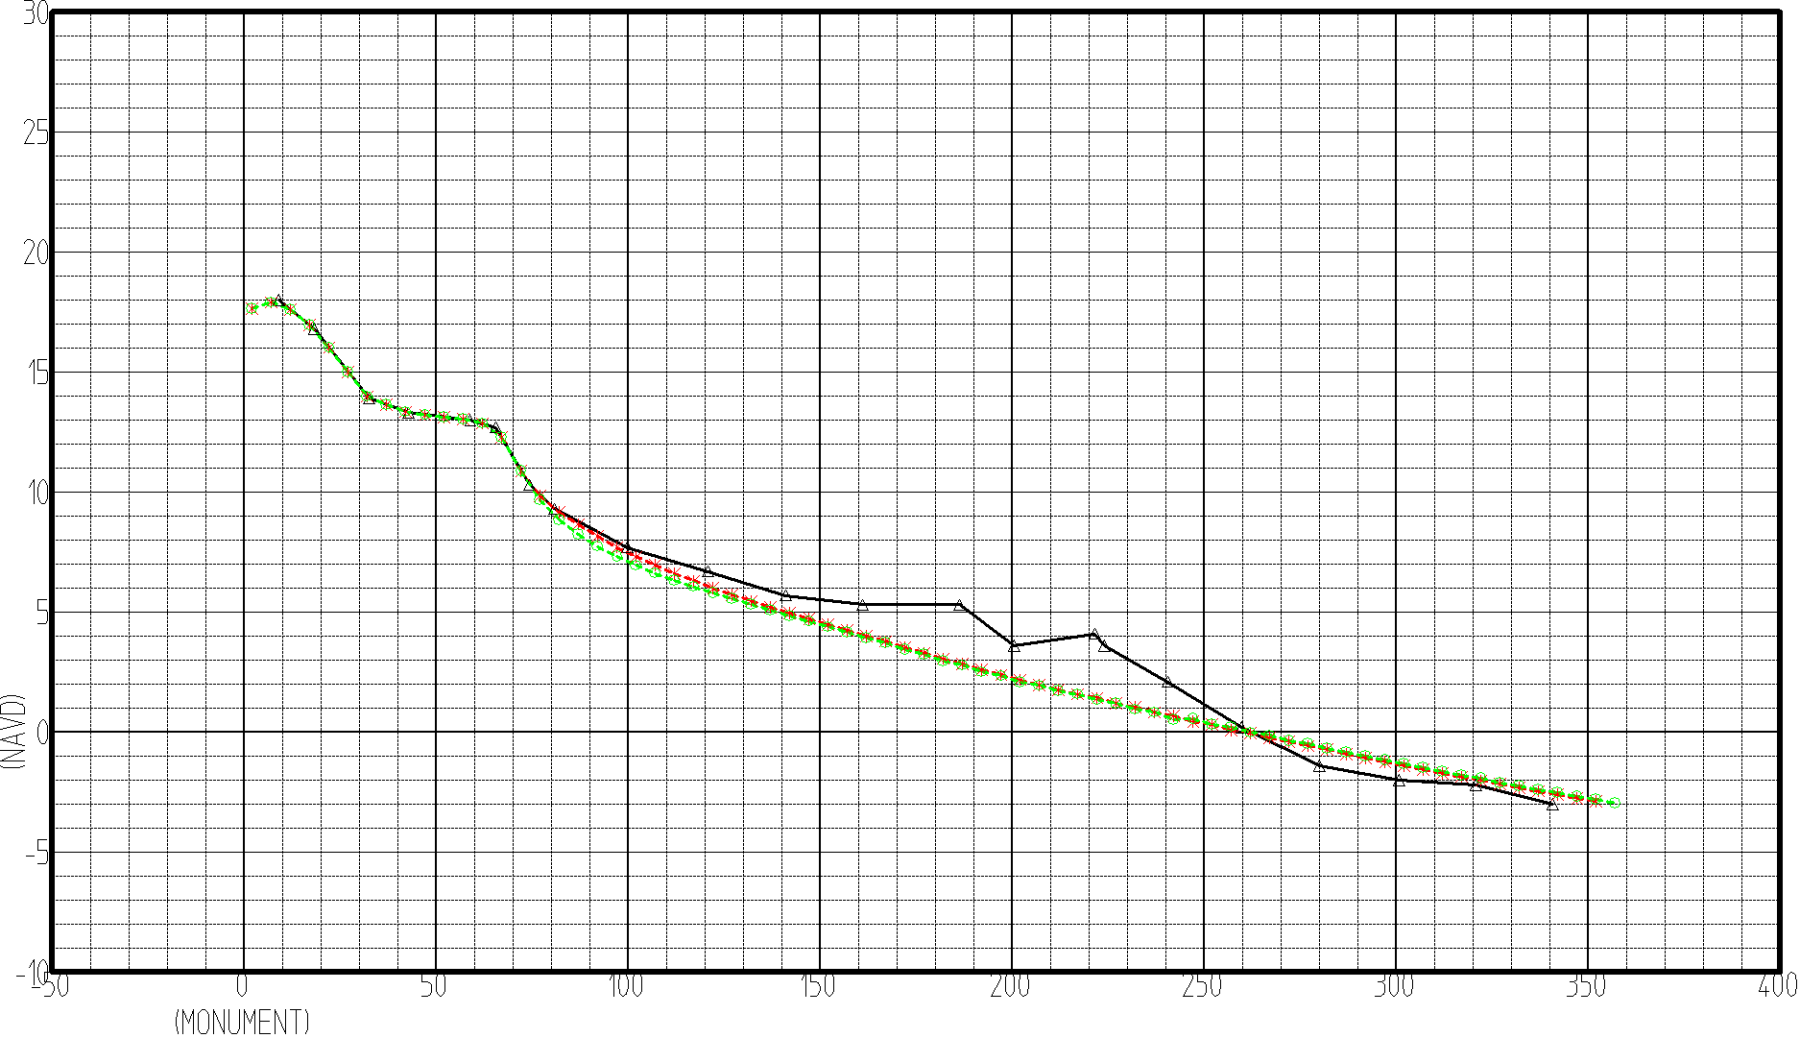
Range: R-15
 BEARING: 190.00
 1/1

BEACH PROFILE
 —△—△— WALTON JULY 2007 PRF
 - - * - - SBEACH 15-YR ERODED PRF
 - - o - - SBEACH 25-YR ERODED PRF

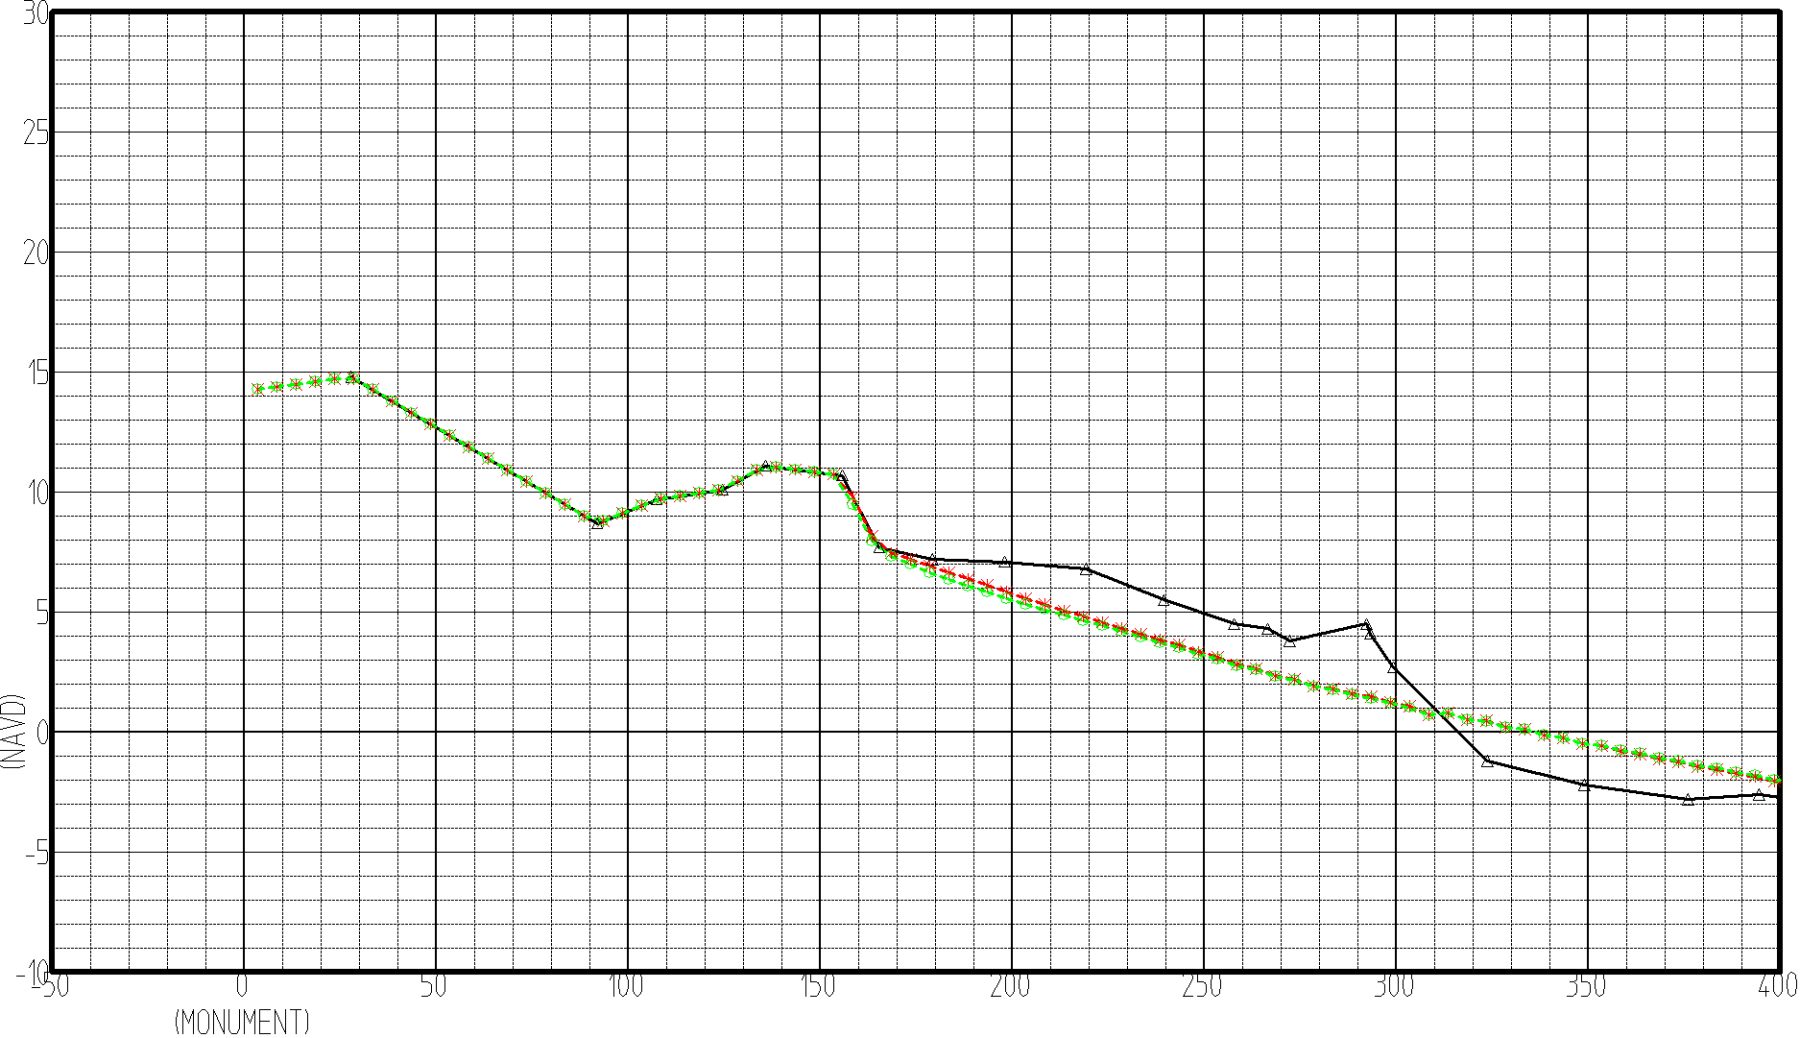
Range: R-16
 BEARING: 190.00
 1/2

BEACH PROFILE
 —△—△— WALTON JULY 2007 PRF
 - - * - - * - - SBEACH 15-YR ERODED PRF
 - - o - - o - - SBEACH 25-YR ERODED PRF

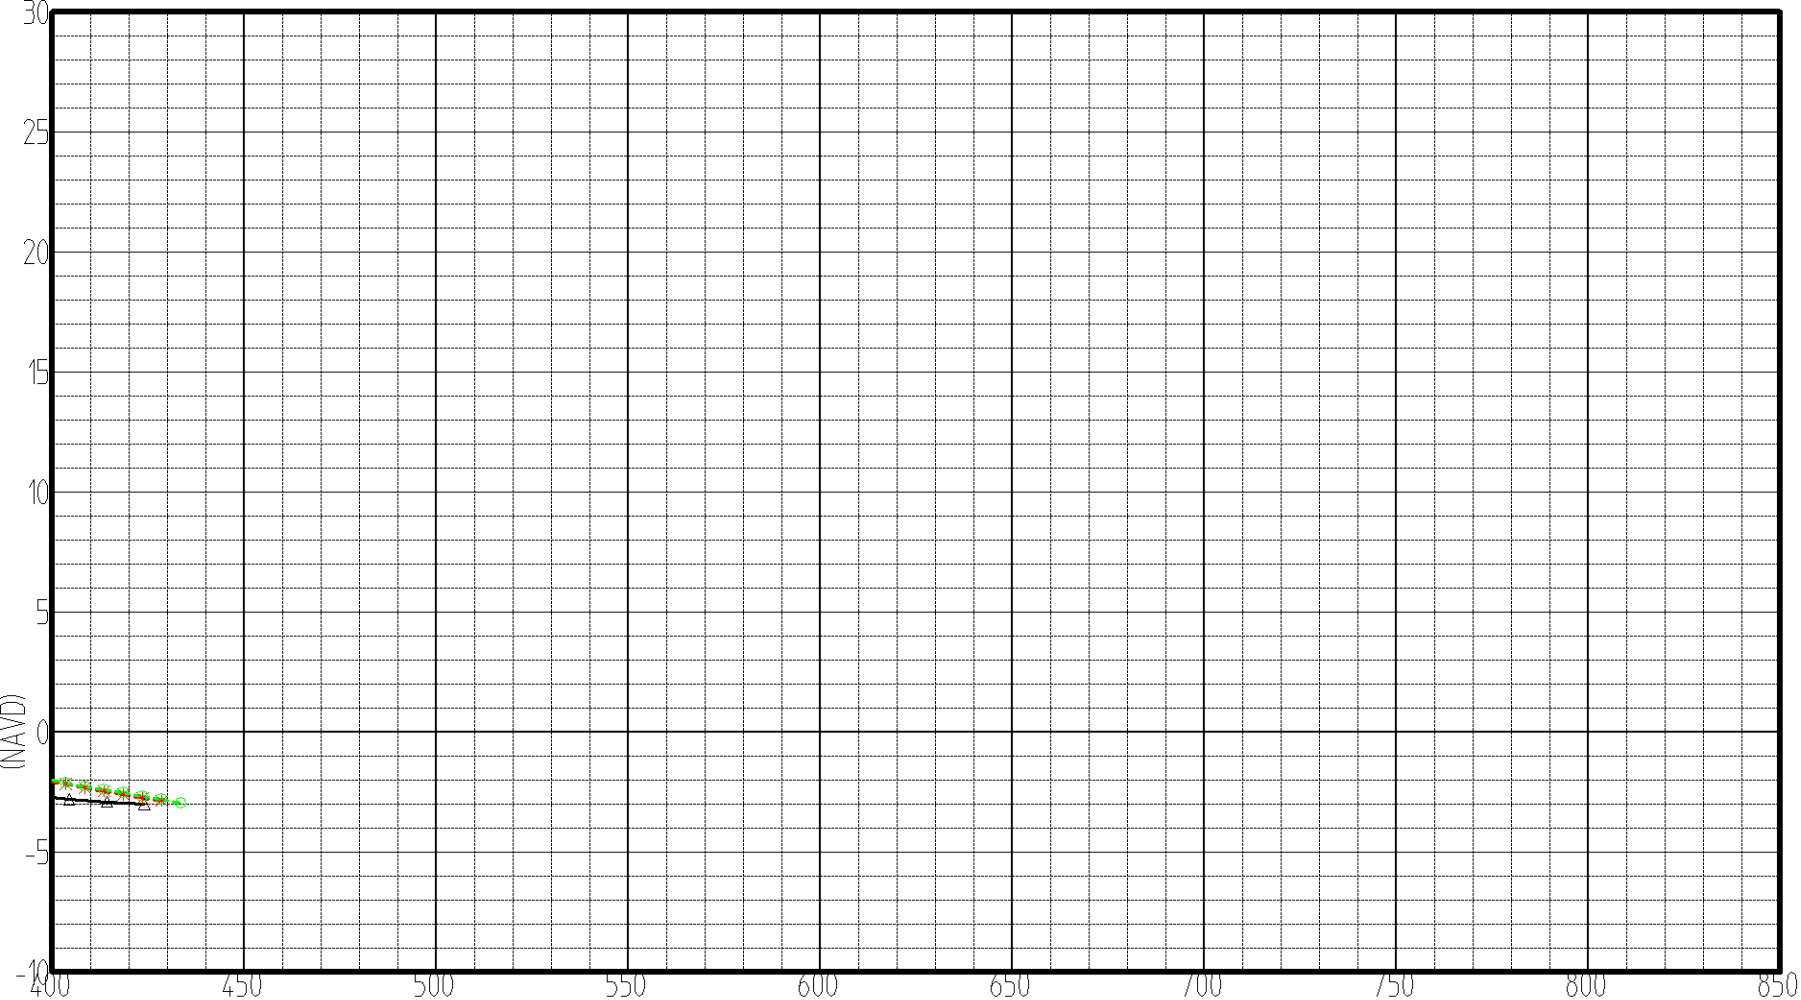
Range: R-17
 BEARING: 190.00
 1/2

BEACH PROFILE
 —△—△— WALTON JULY 2007 PRF
 - - * - - * - - SBEACH 15-YR ERODED PRF
 - - o - - o - - SBEACH 25-YR ERODED PRF

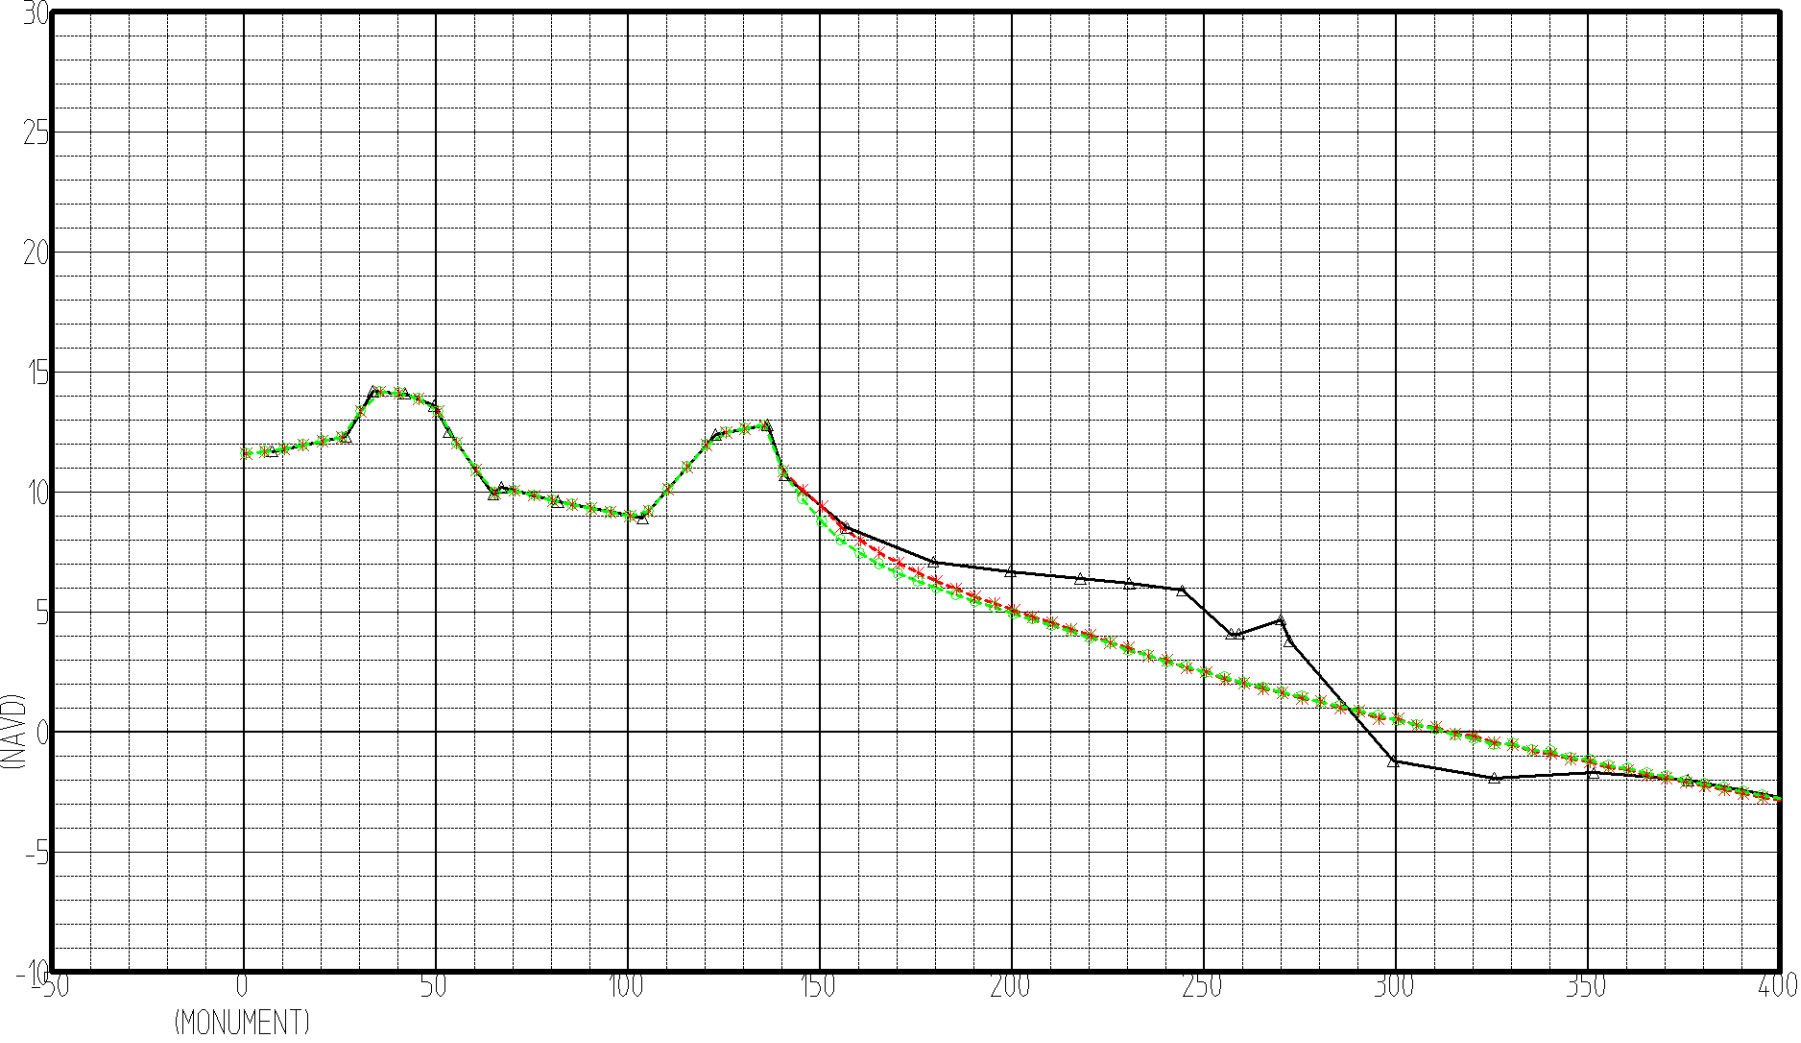
Range: R-18

BEACH PROFILE

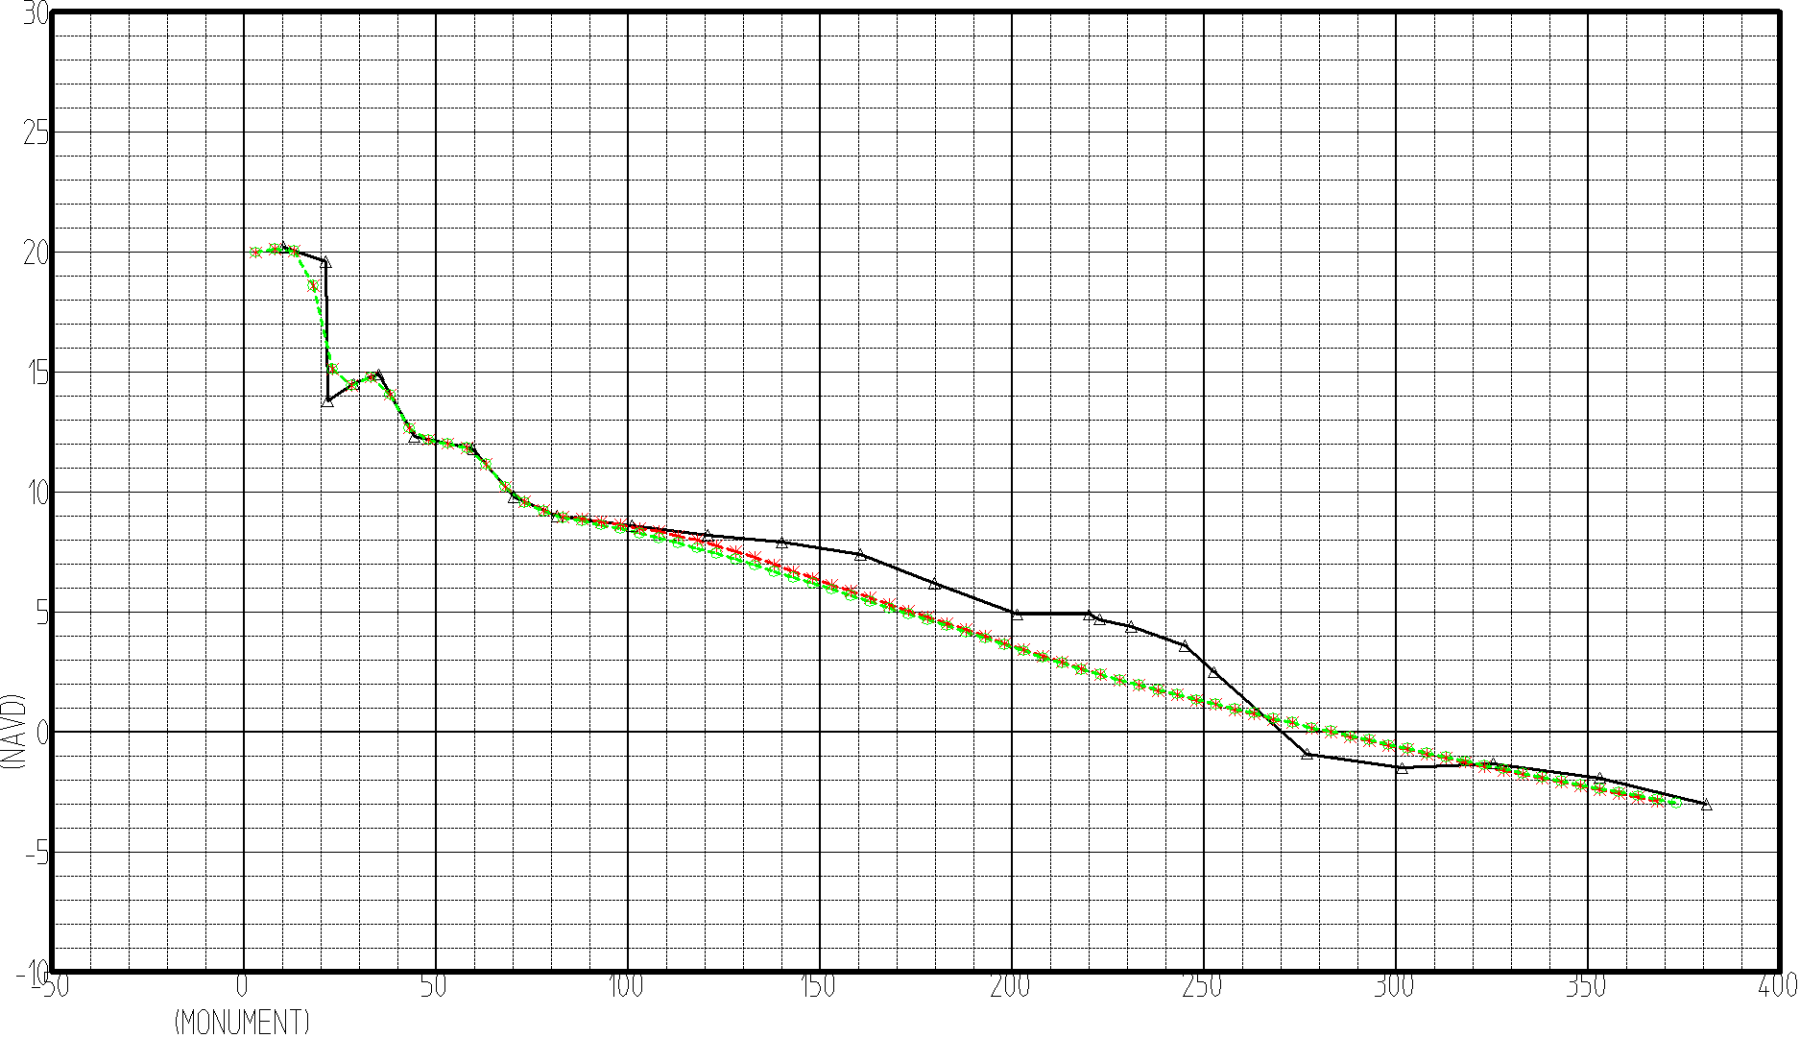
Range: R-19
 BEARING: 190.00
 1/1

BEACH PROFILE
 —△—△— WALTON JULY 2007 PRF
 - - * - - SBEACH 15-YR ERODED PRF
 - - o - - SBEACH 25-YR ERODED PRF

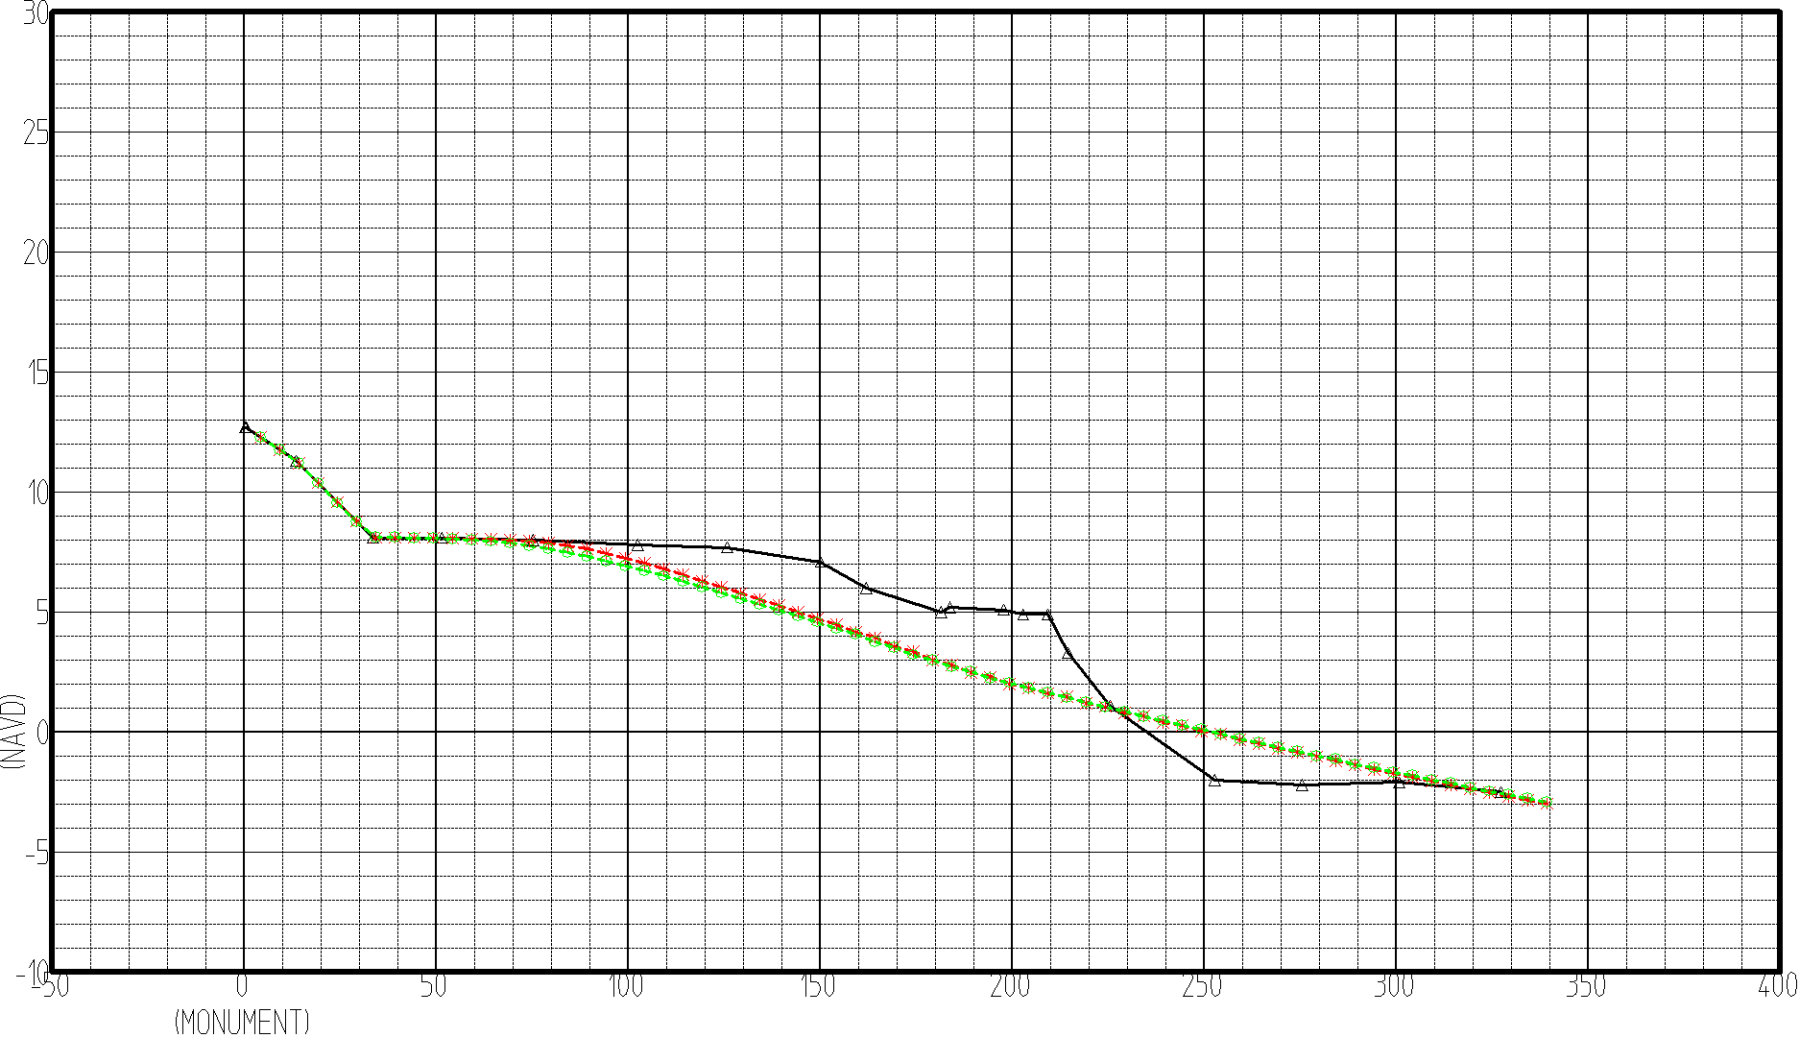
Range: R-21
 BEARING: 190.00
 1/1

BEACH PROFILE
 —△—△— WALTON JULY 2007 PRF
 - - * - - SBEACH 15-YR ERODED PRF
 - - o - - SBEACH 25-YR ERODED PRF

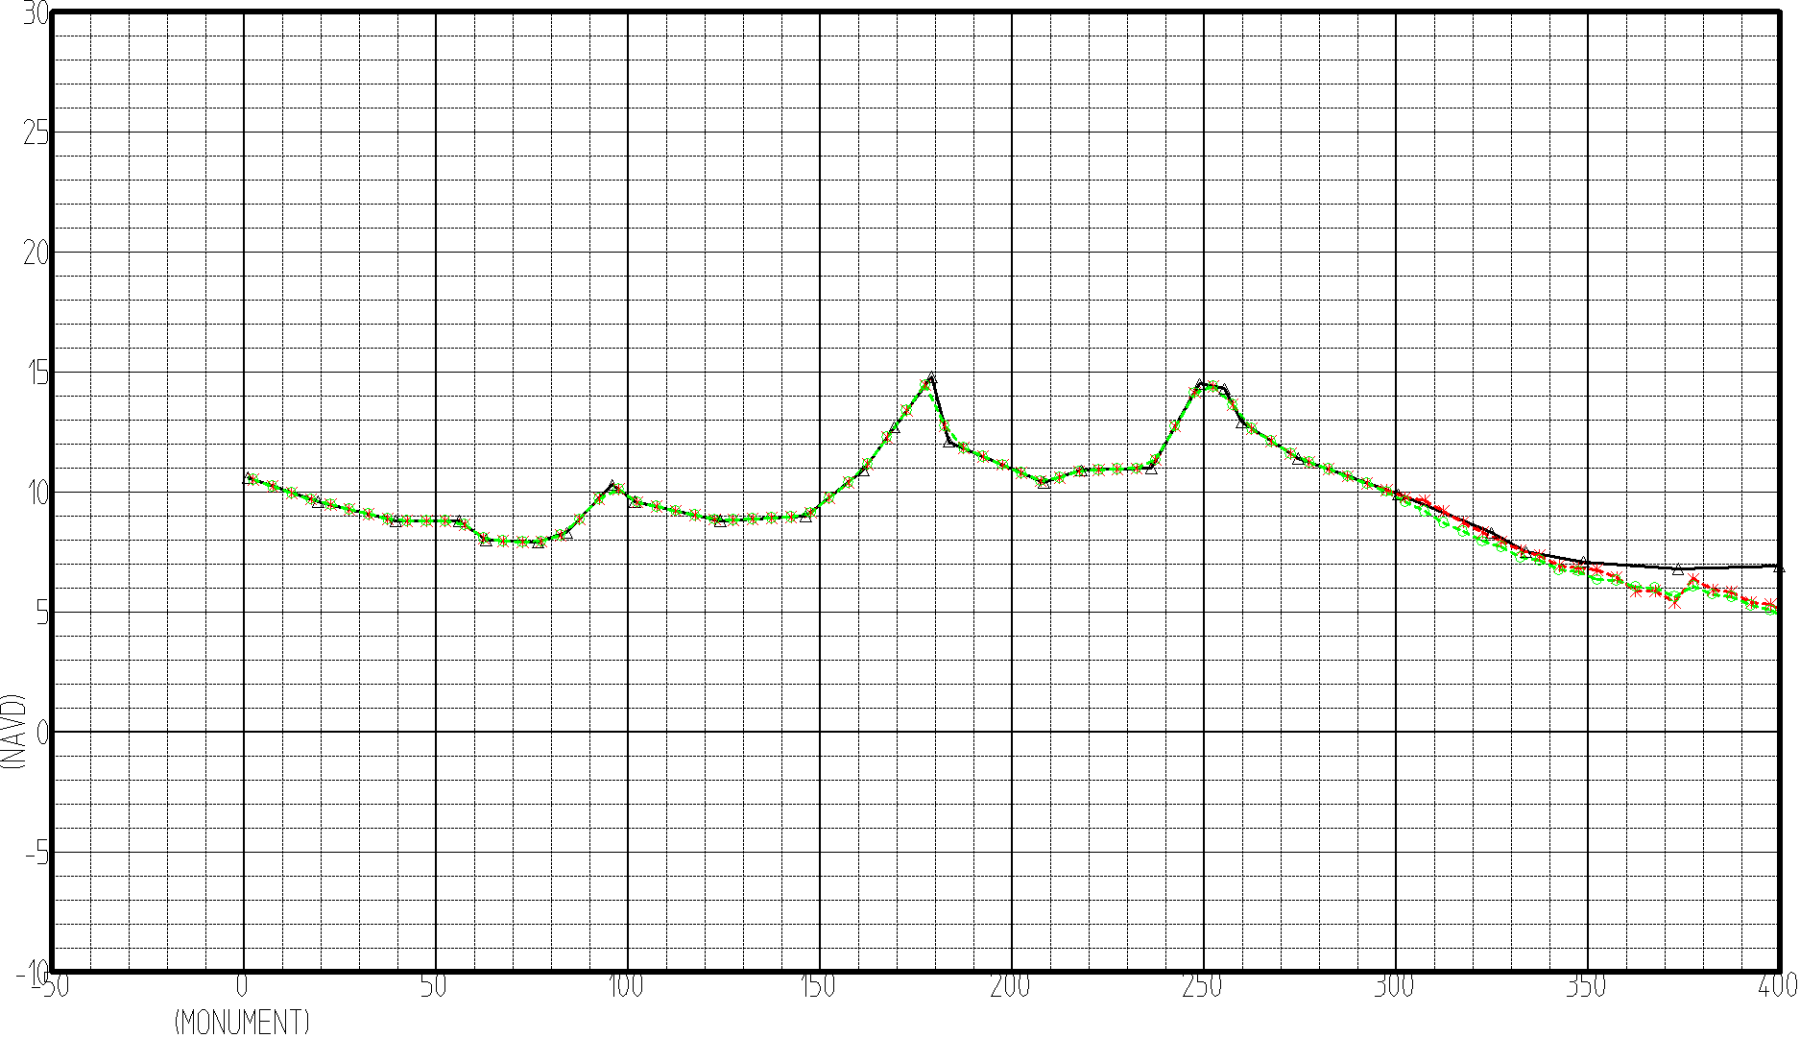
Range: R-23

—△—△— WALTON JULY 2007 PRF
 - - * - - SBEACH 15-YR ERODED PRF
 - - o - - SBEACH 25-YR ERODED PRF

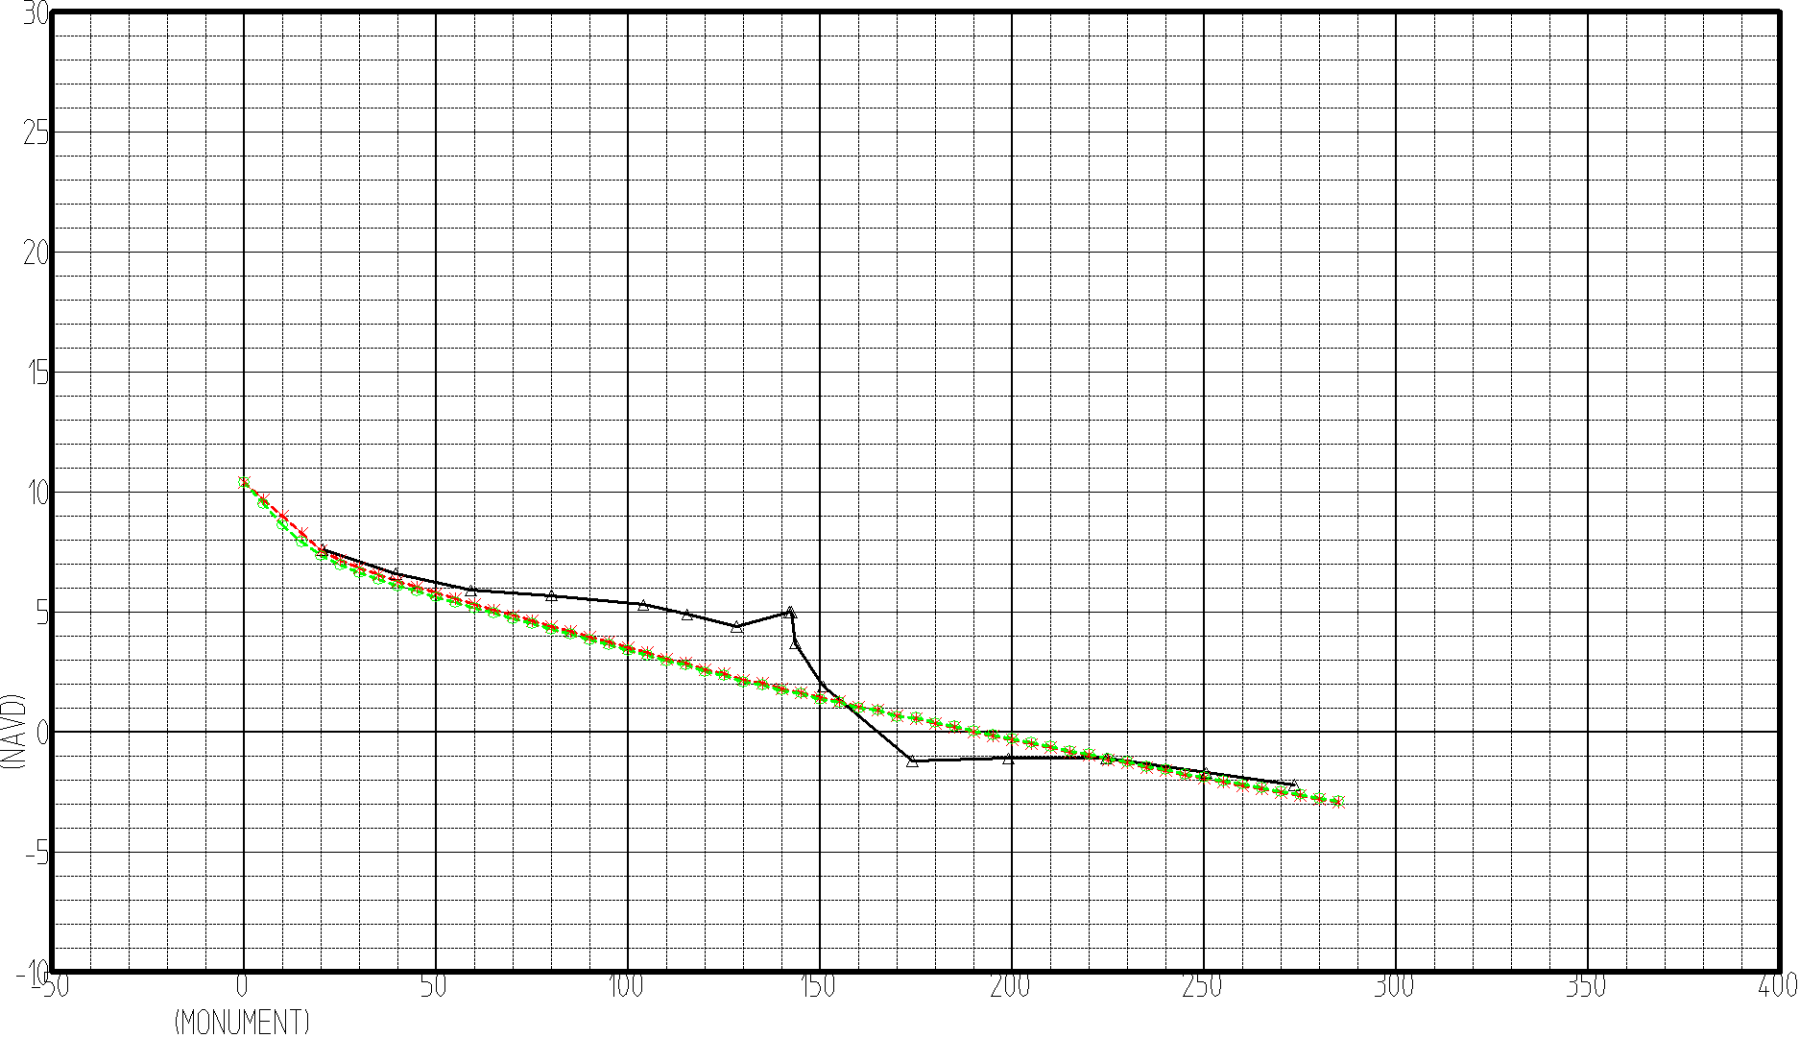
Range: R-23
 BEARING: 190.00
 2/2

BEACH PROFILE
 —△—△— WALTON JULY 2007 PRF
 - - * - - SBEACH 15-YR ERODED PRF
 - - o - - SBEACH 25-YR ERODED PRF
