Appendix II

SBEACH Model Erosion Profile Plots

Walton County

15-year and 25-year Storm Events

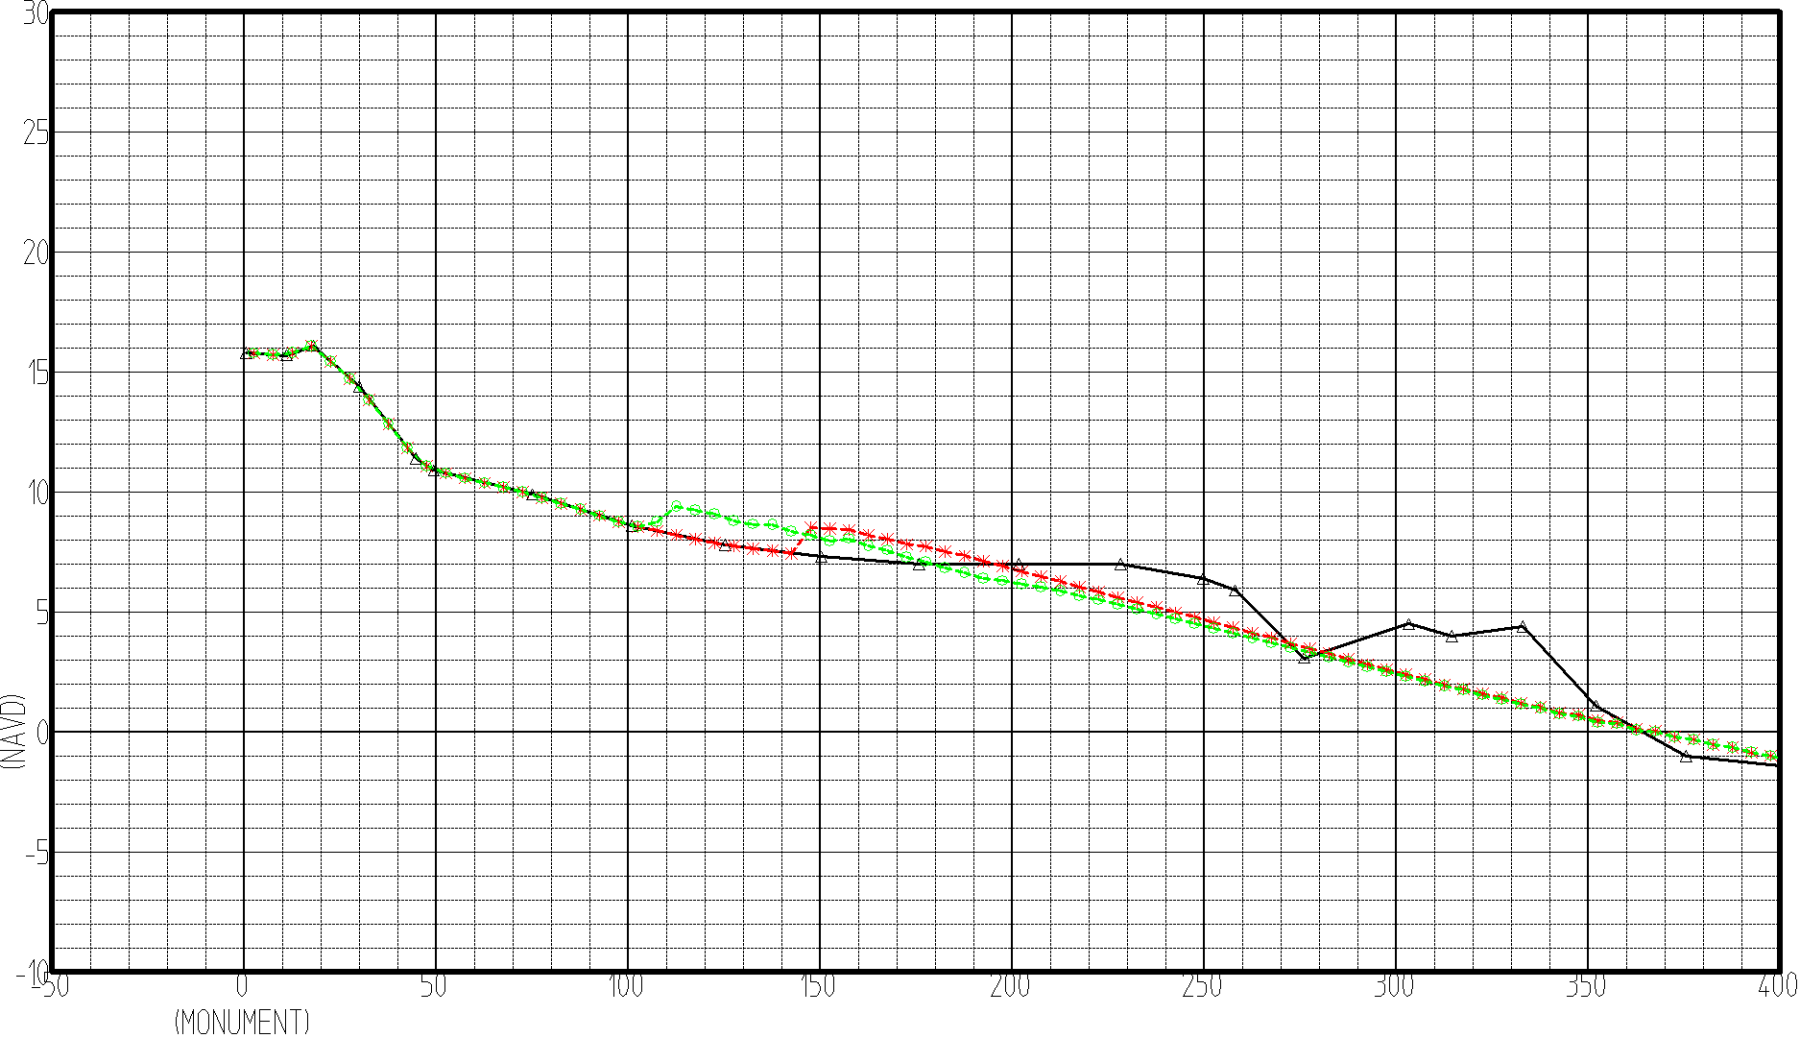
Range: R-24
 BEARING: 190.00
 1/1

BEACH PROFILE
 —△—△— WALTON JULY 2007 PRF
 - - * - - SBEACH 15-YR ERODED PRF
 - - o - - SBEACH 25-YR ERODED PRF

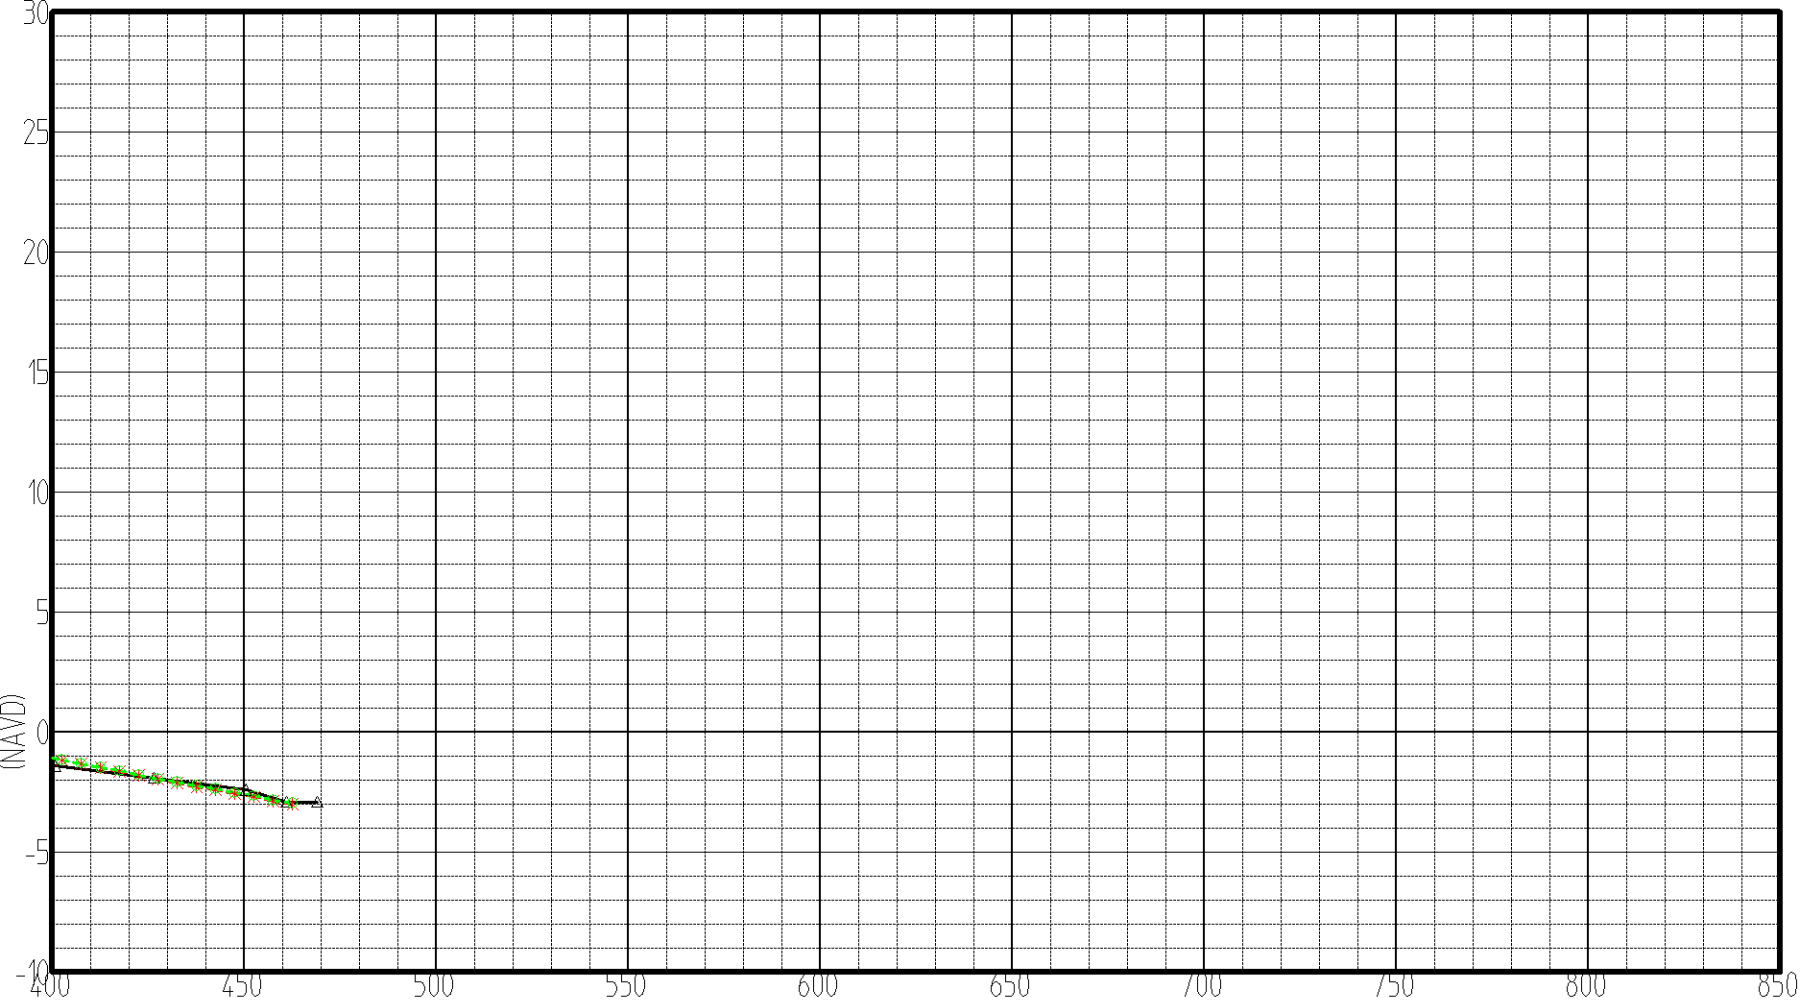
Range: R-25

—△—△— WALTON JULY 2007 PRF
 - - * - - * - - SBEACH 15-YR ERODED PRF
 - - o - - o - - SBEACH 25-YR ERODED PRF

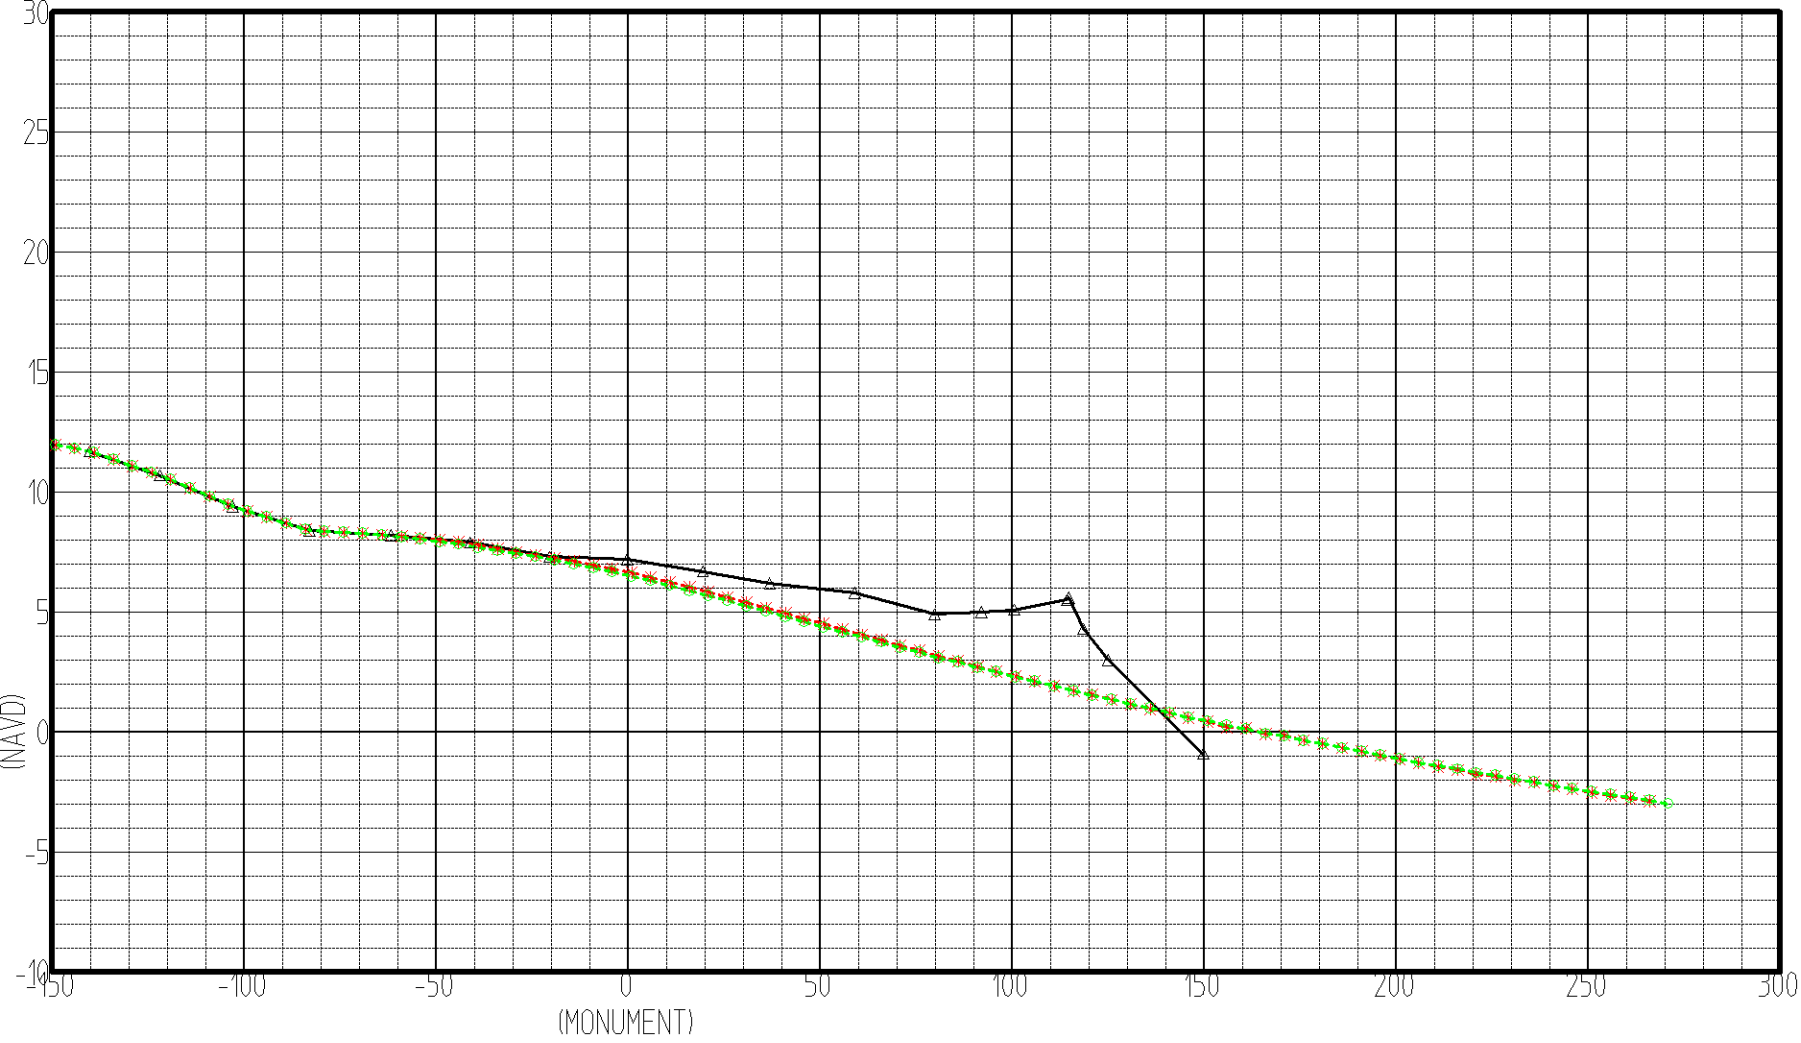
Range: R-26
 BEARING: 190.00
 1/1

BEACH PROFILE
 —△—△— WALTON JULY 2007 PRF
 - - * - - SBEACH 15-YR ERODED PRF
 - - o - - SBEACH 25-YR ERODED PRF

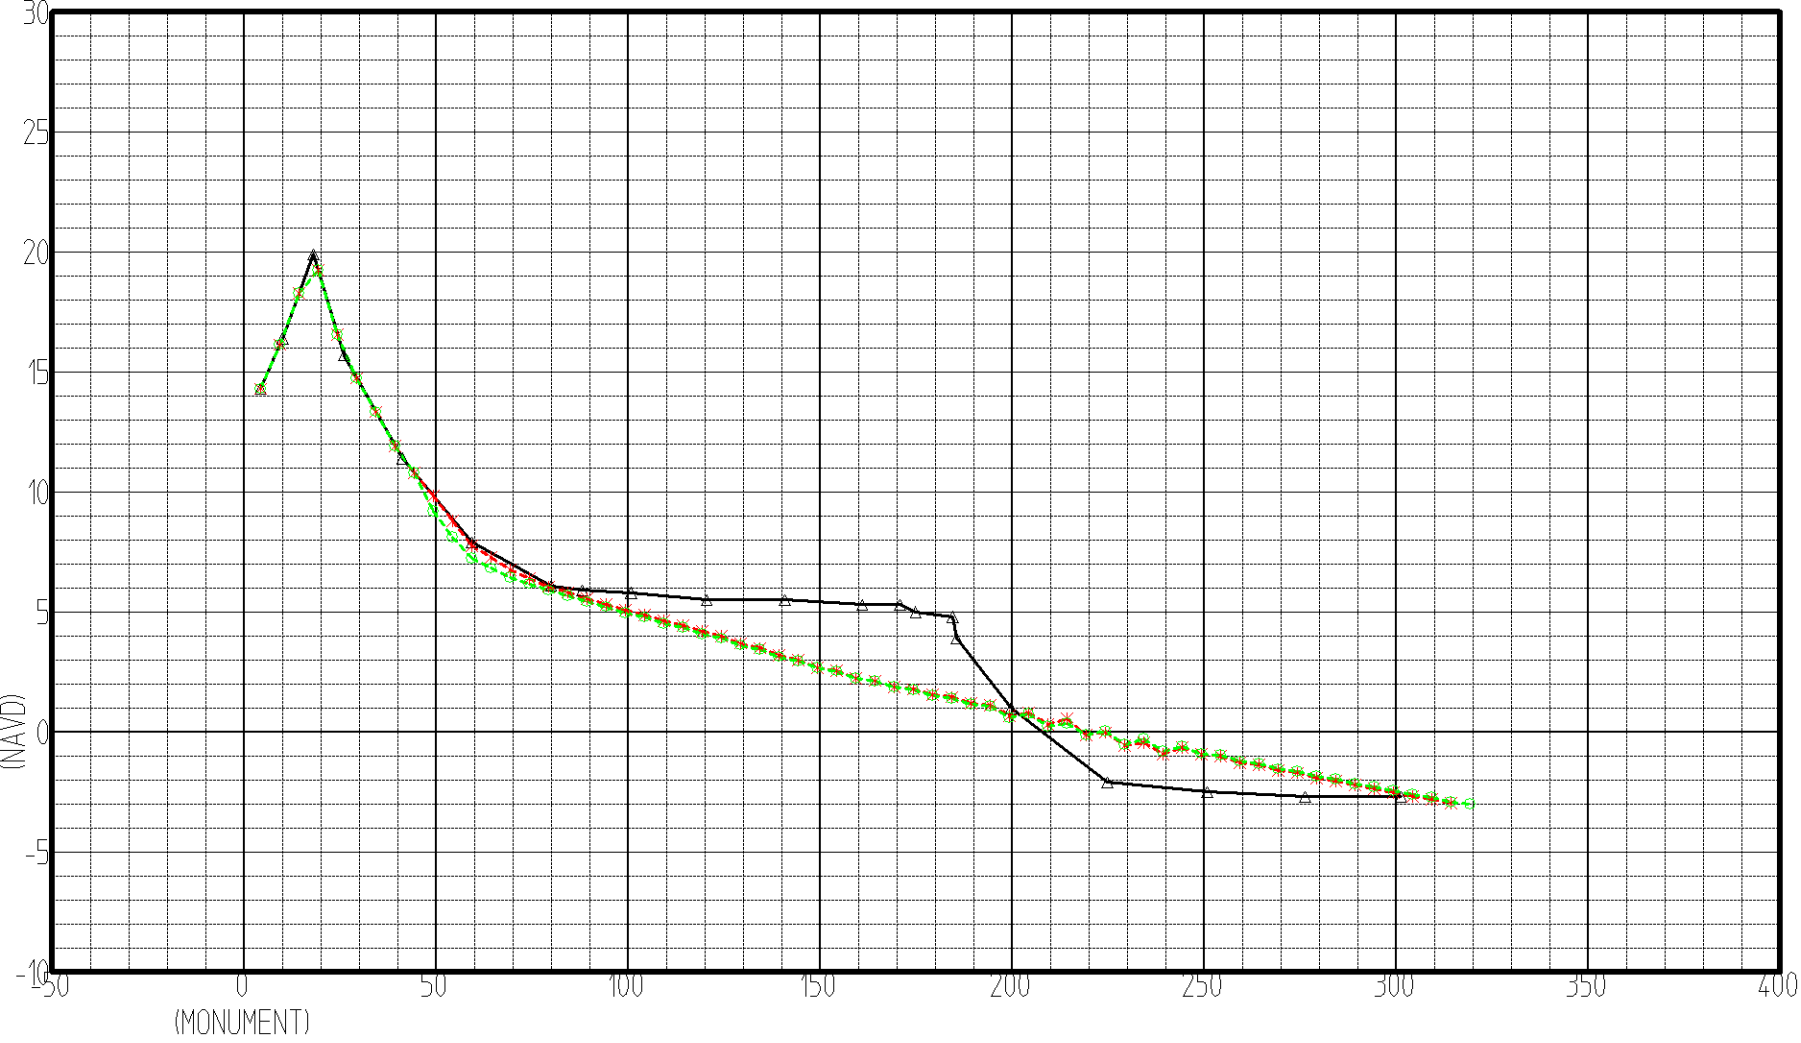
Range: R-28
 BEARING: 190.00
 1/1

BEACH PROFILE
 —△—△— WALTON JULY 2007 PRF
 - - * - - * - - SBEACH 15-YR ERODED PRF
 - - o - - o - - SBEACH 25-YR ERODED PRF

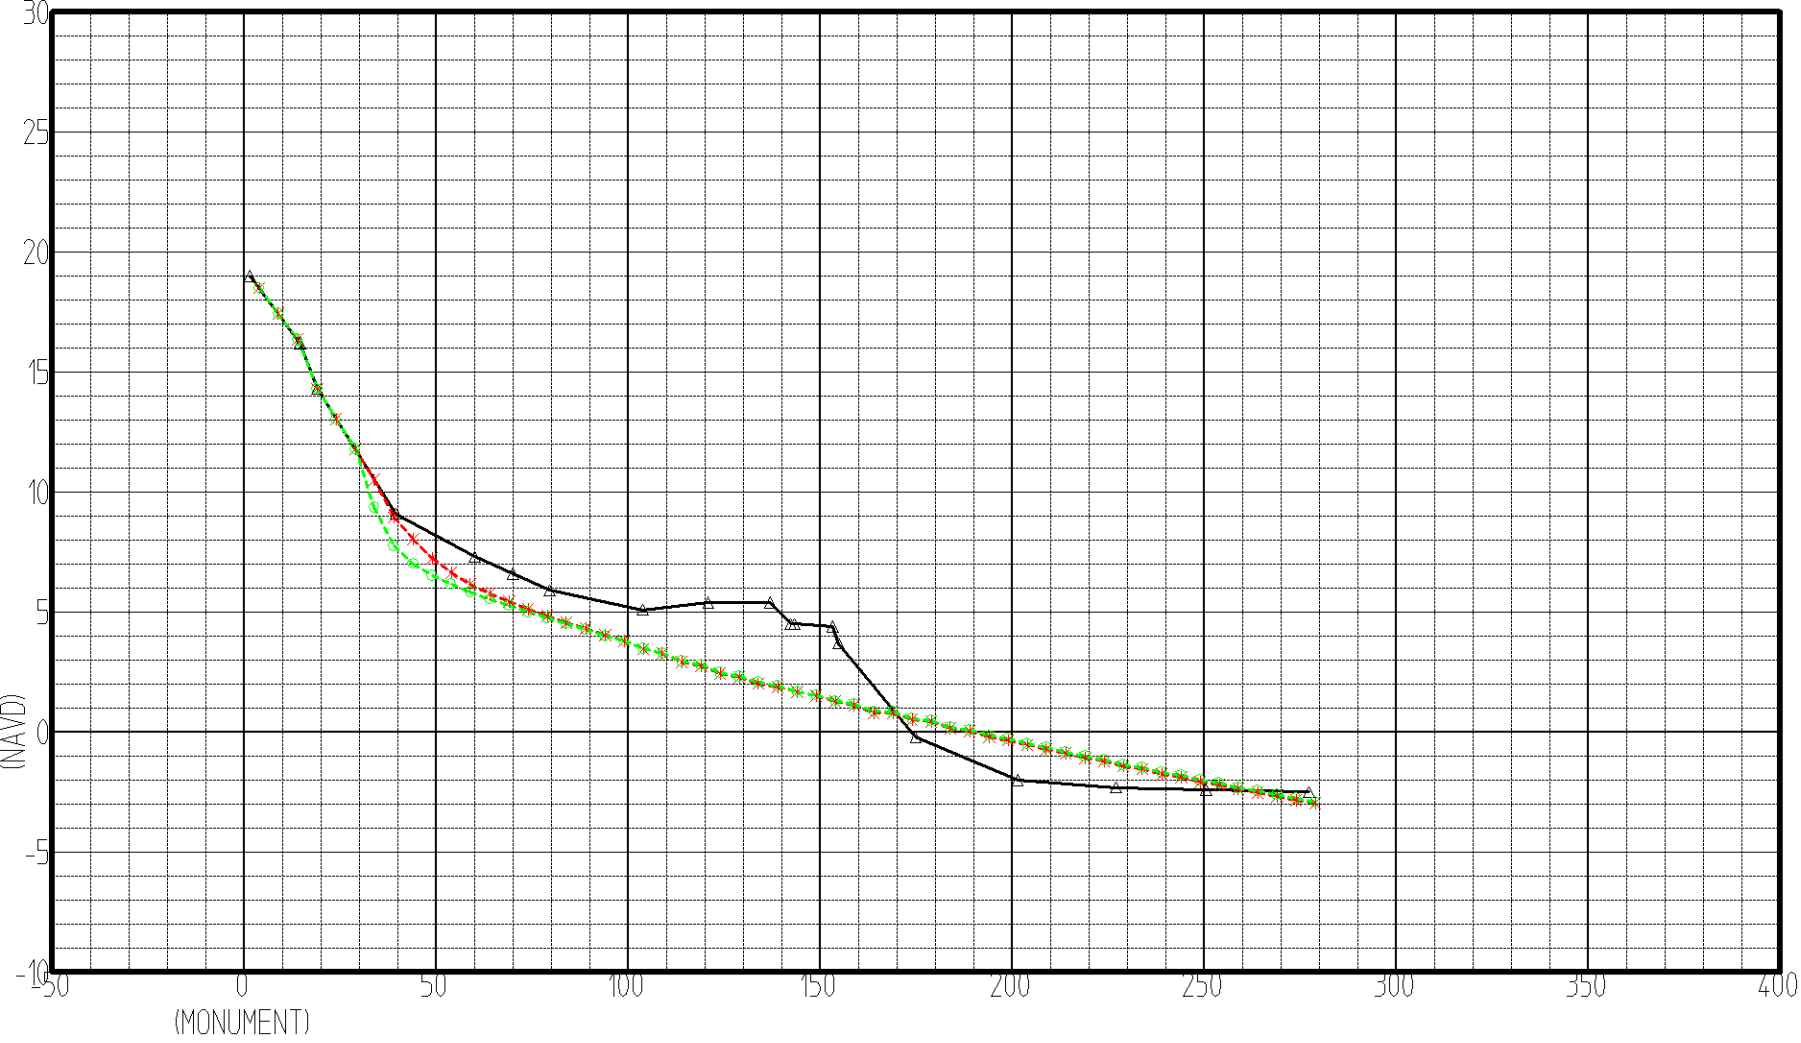
Range: R-30
 BEARING: 190.00
 1/1

BEACH PROFILE
 —△—△— WALTON JULY 2007 PRF
 - - * - - SBEACH 15-YR ERODED PRF
 - - o - - SBEACH 25-YR ERODED PRF

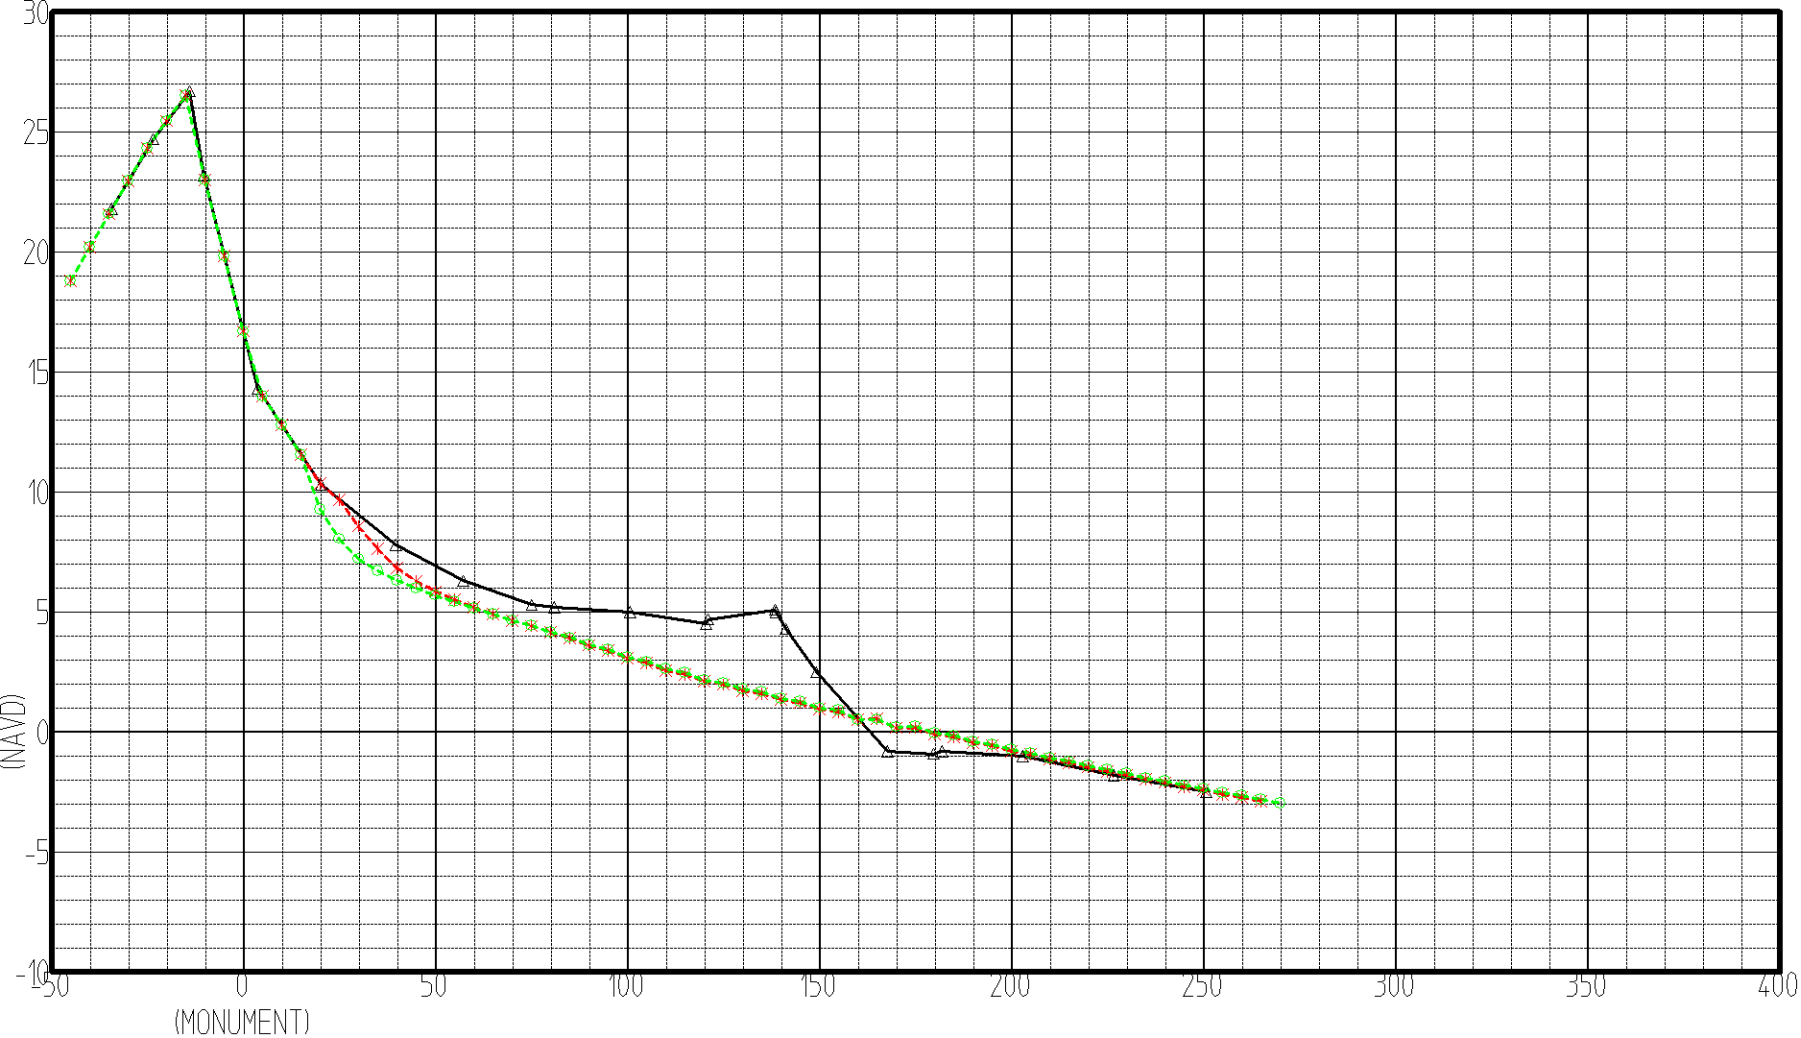
Range: R-31
 BEARING: 190.00
 1/1

BEACH PROFILE
 —△—△— WALTON JULY 2007 PRF
 - - * - - * - - SBEACH 15-YR ERODED PRF
 - - o - - o - - SBEACH 25-YR ERODED PRF

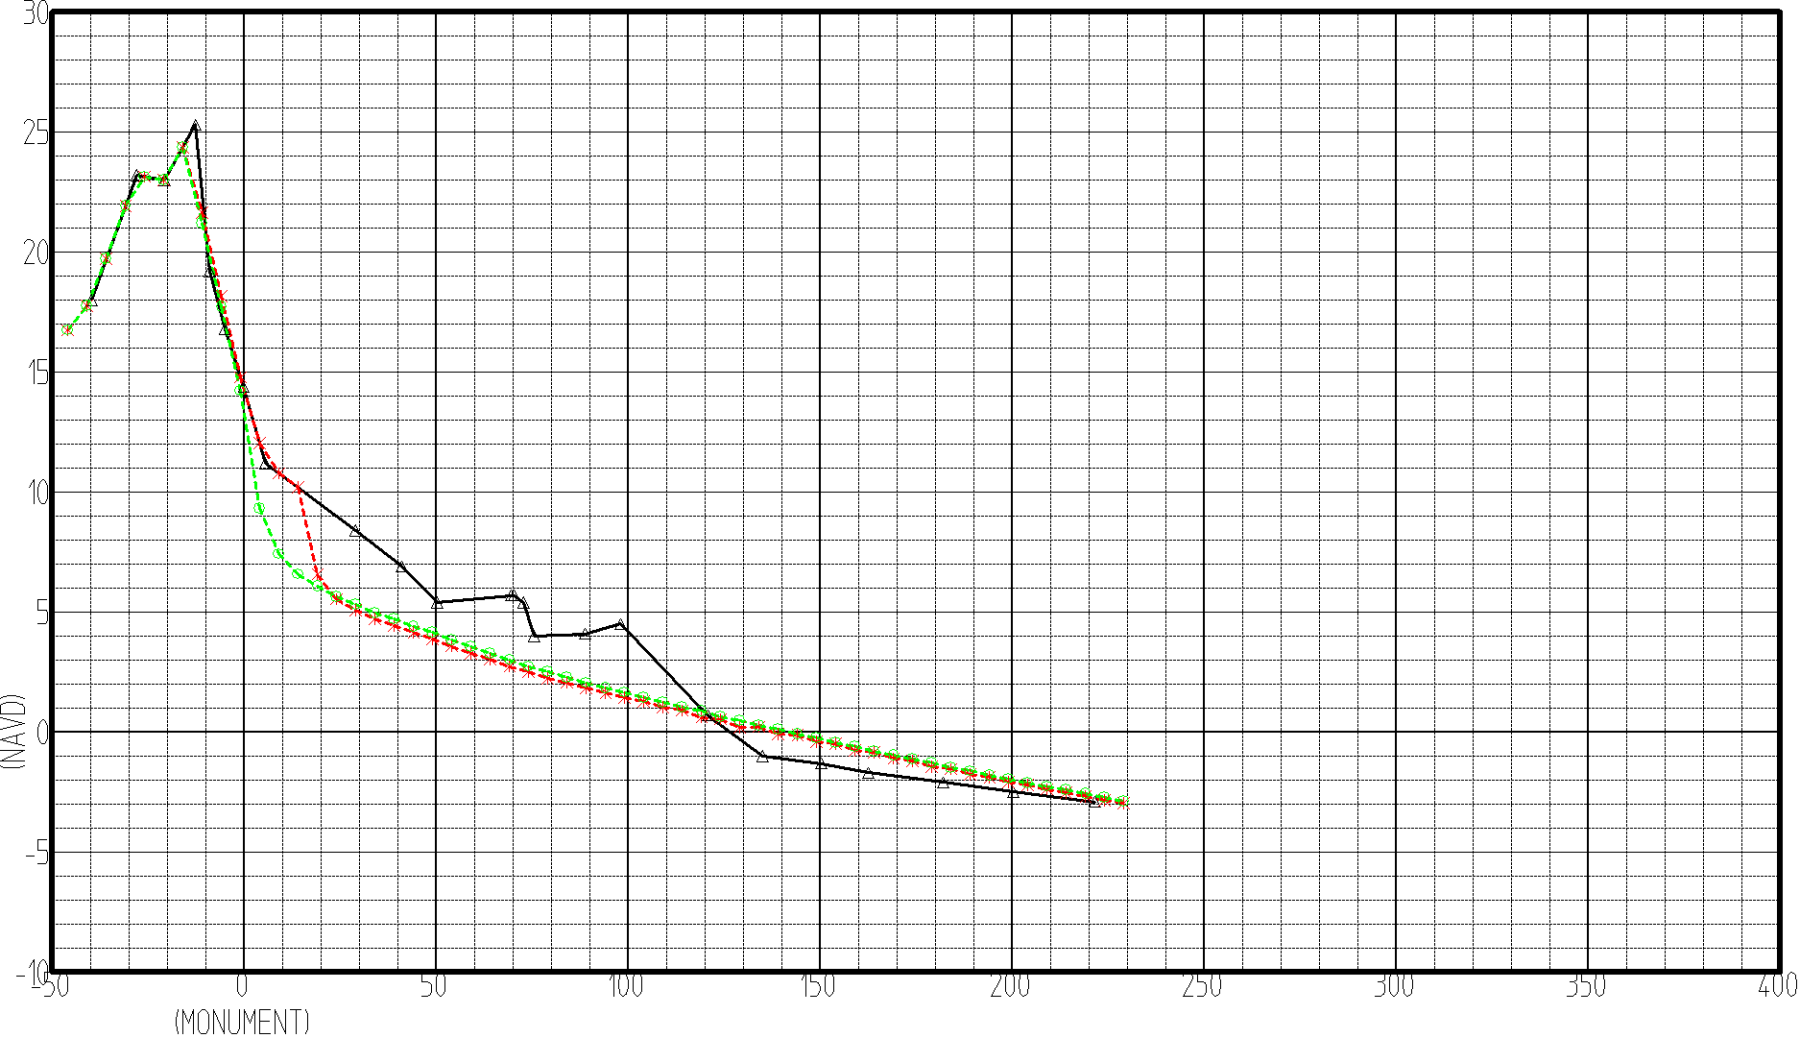
Range: R-32
 BEARING: 190.00
 1/1

BEACH PROFILE
 —△—△— WALTON JULY 2007 PRF
 - - * - - * - - SBEACH 15-YR ERODED PRF
 - - o - - o - - SBEACH 25-YR ERODED PRF

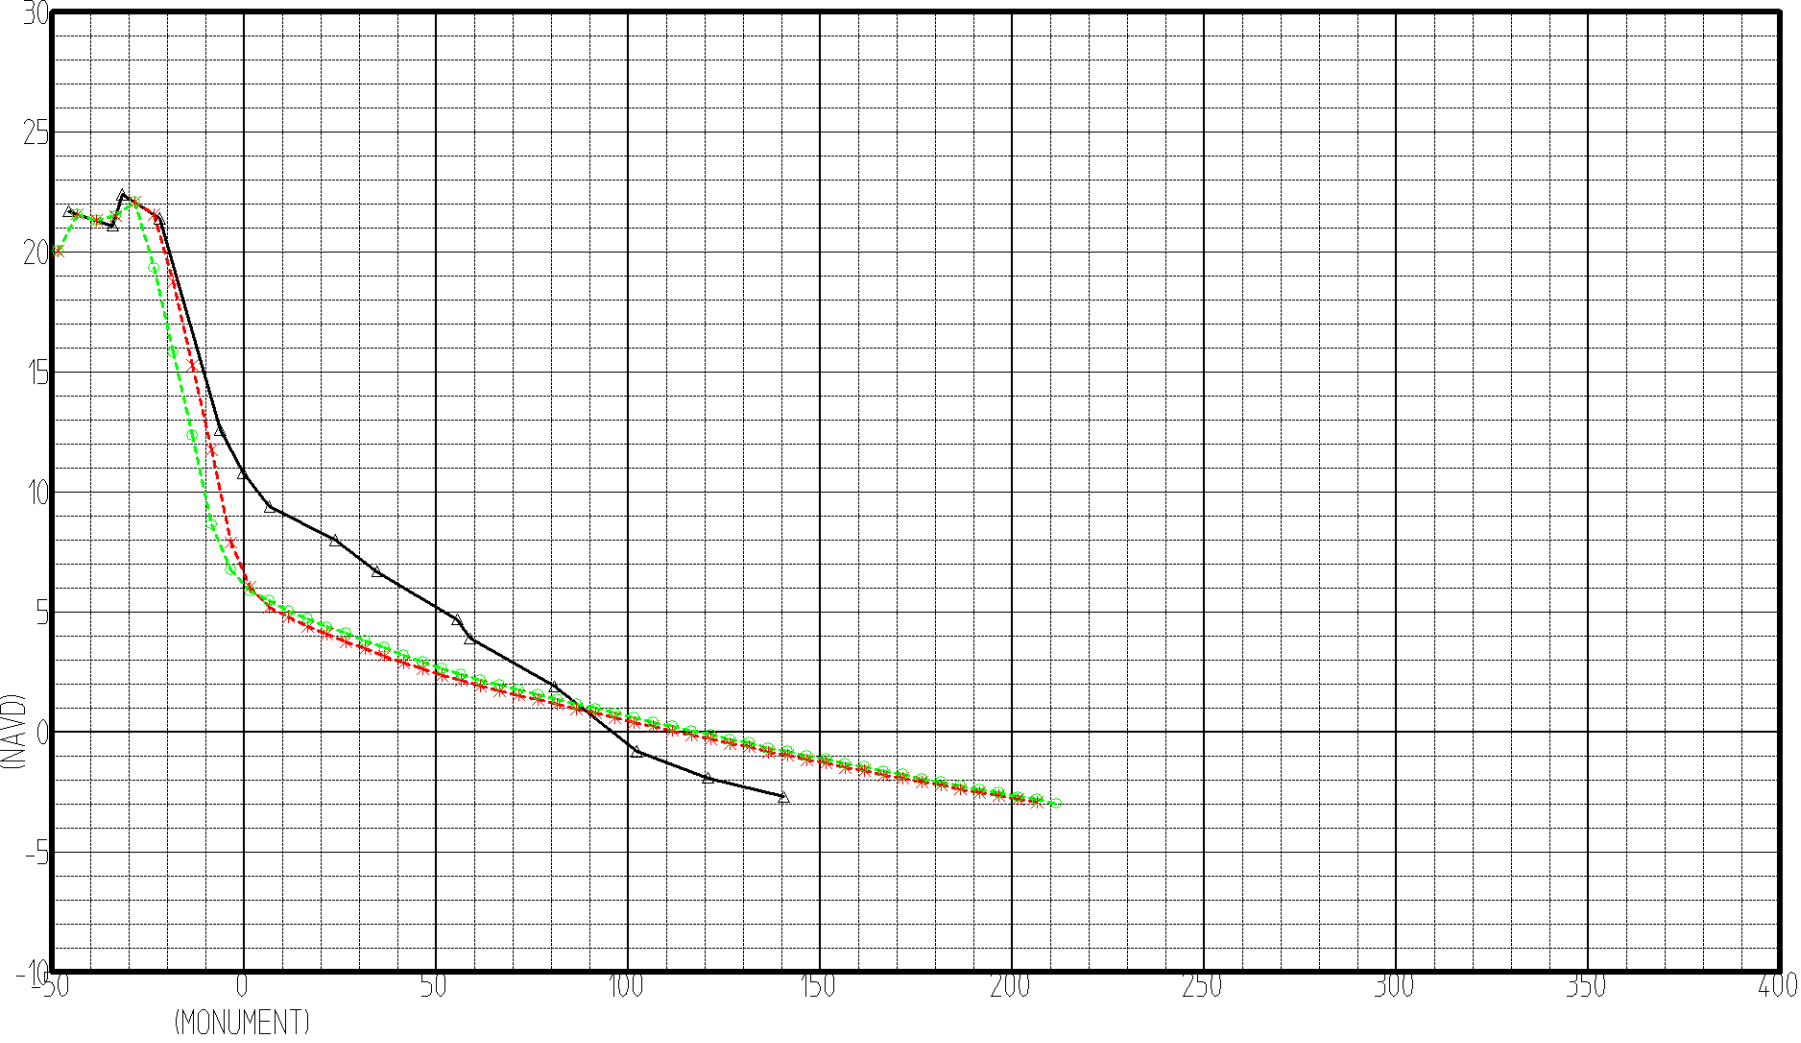
Range: R-34
 BEARING: 190.00
 1/1

BEACH PROFILE
 —△—△— WALTON JULY 2007 PRF
 - - * - - * - - SBEACH 15-YR ERODED PRF
 - - o - - o - - SBEACH 25-YR ERODED PRF

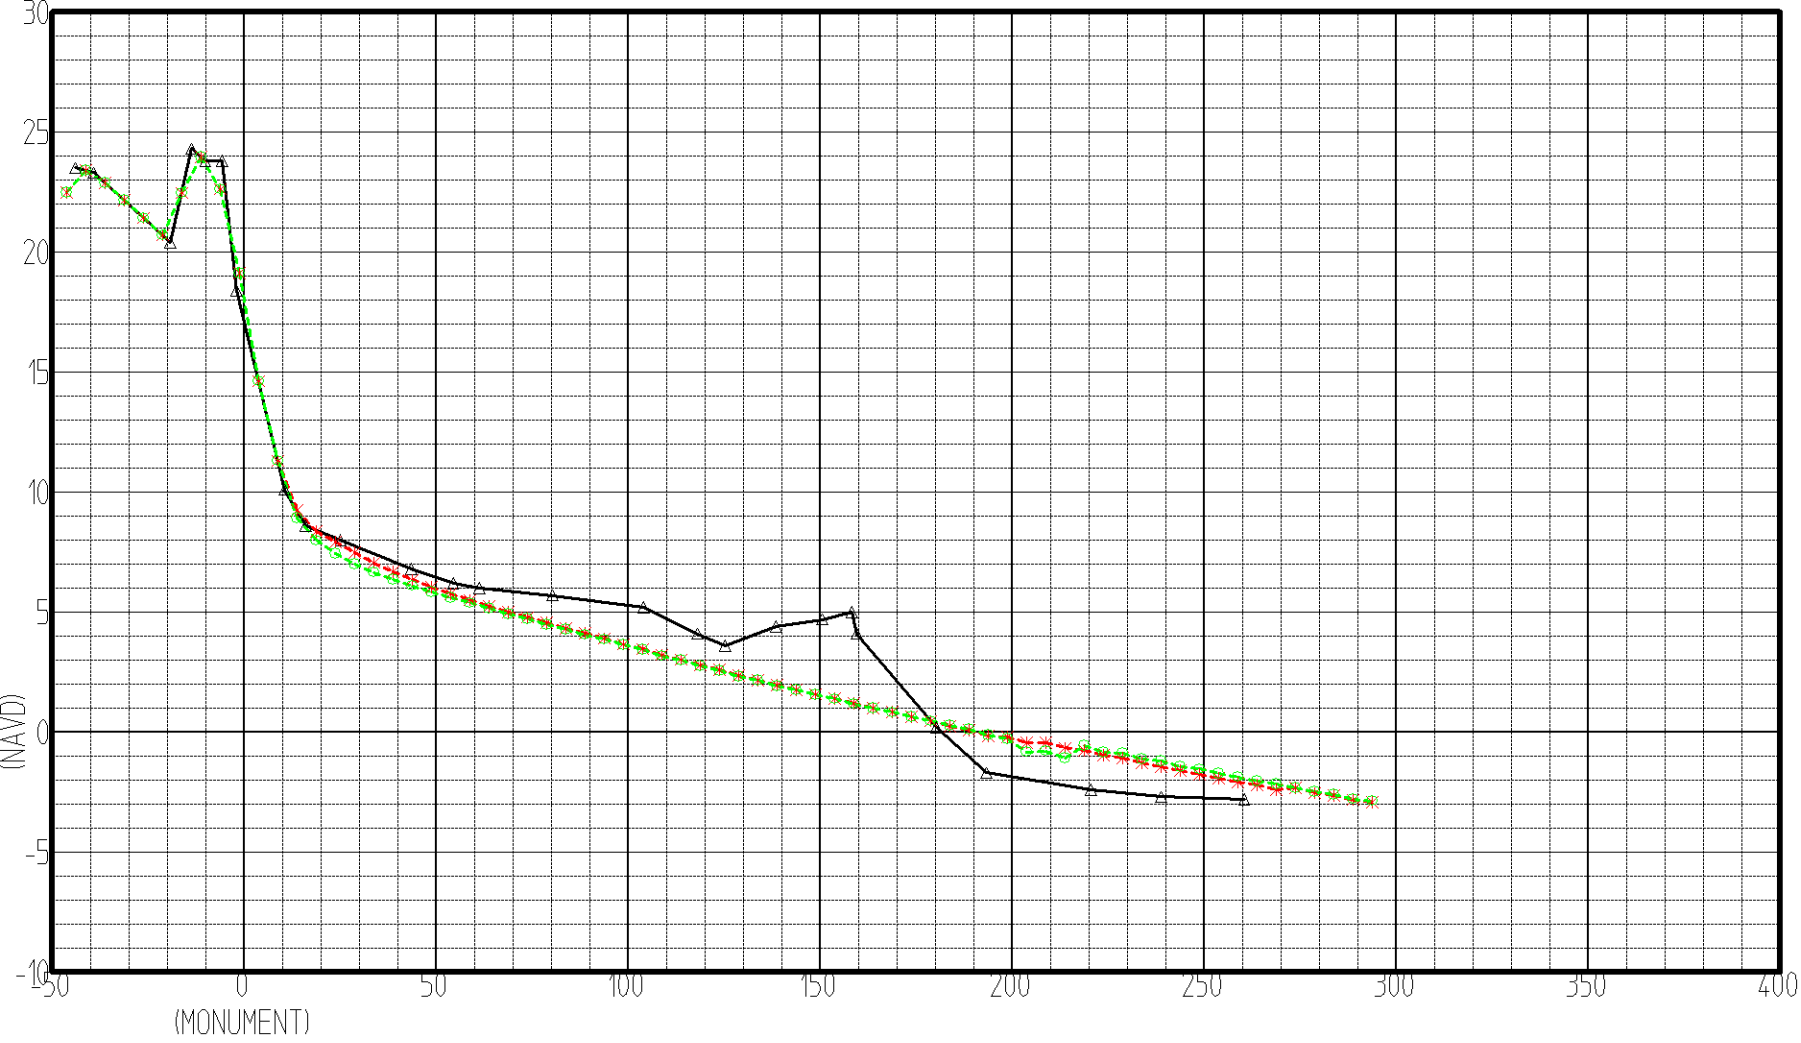
Range: R-35
 BEARING: 190.00
 1/1

BEACH PROFILE
 —△—△— WALTON JULY 2007 PRF
 - - * - - SBEACH 15-YR ERODED PRF
 - - o - - SBEACH 25-YR ERODED PRF

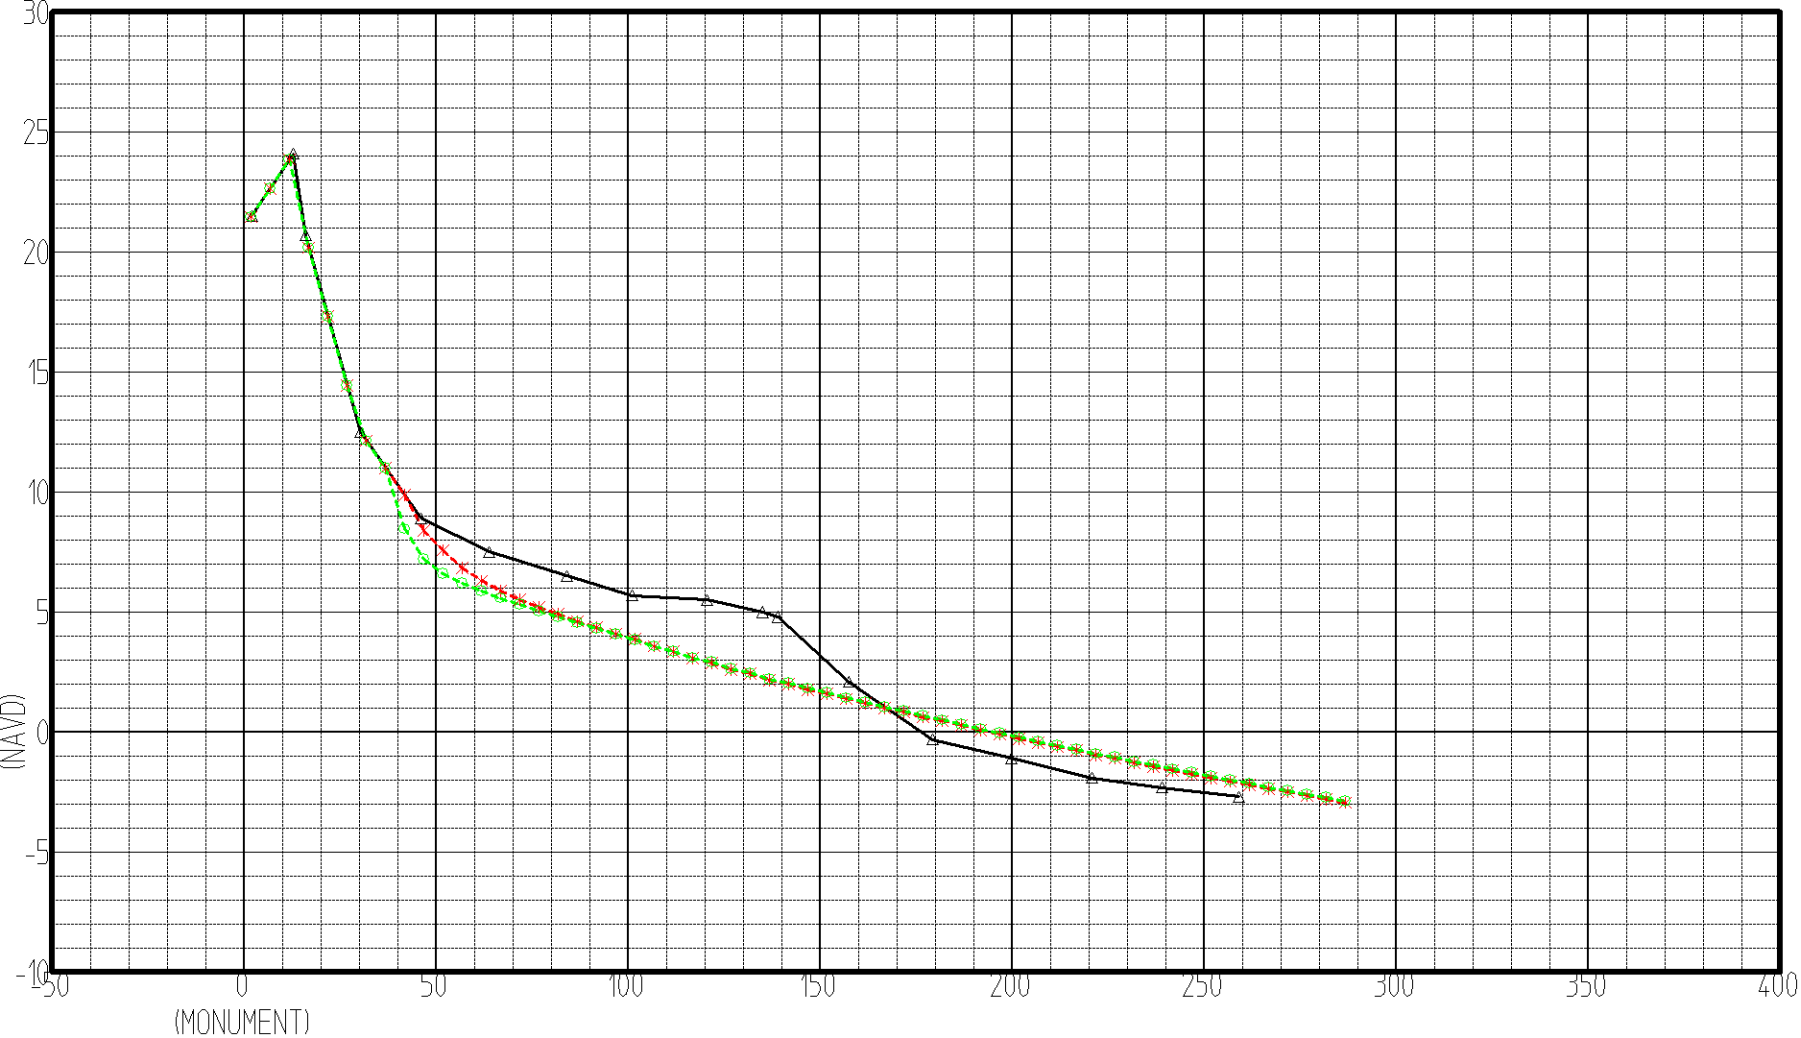
Range: R-36

BEACH PROFILE

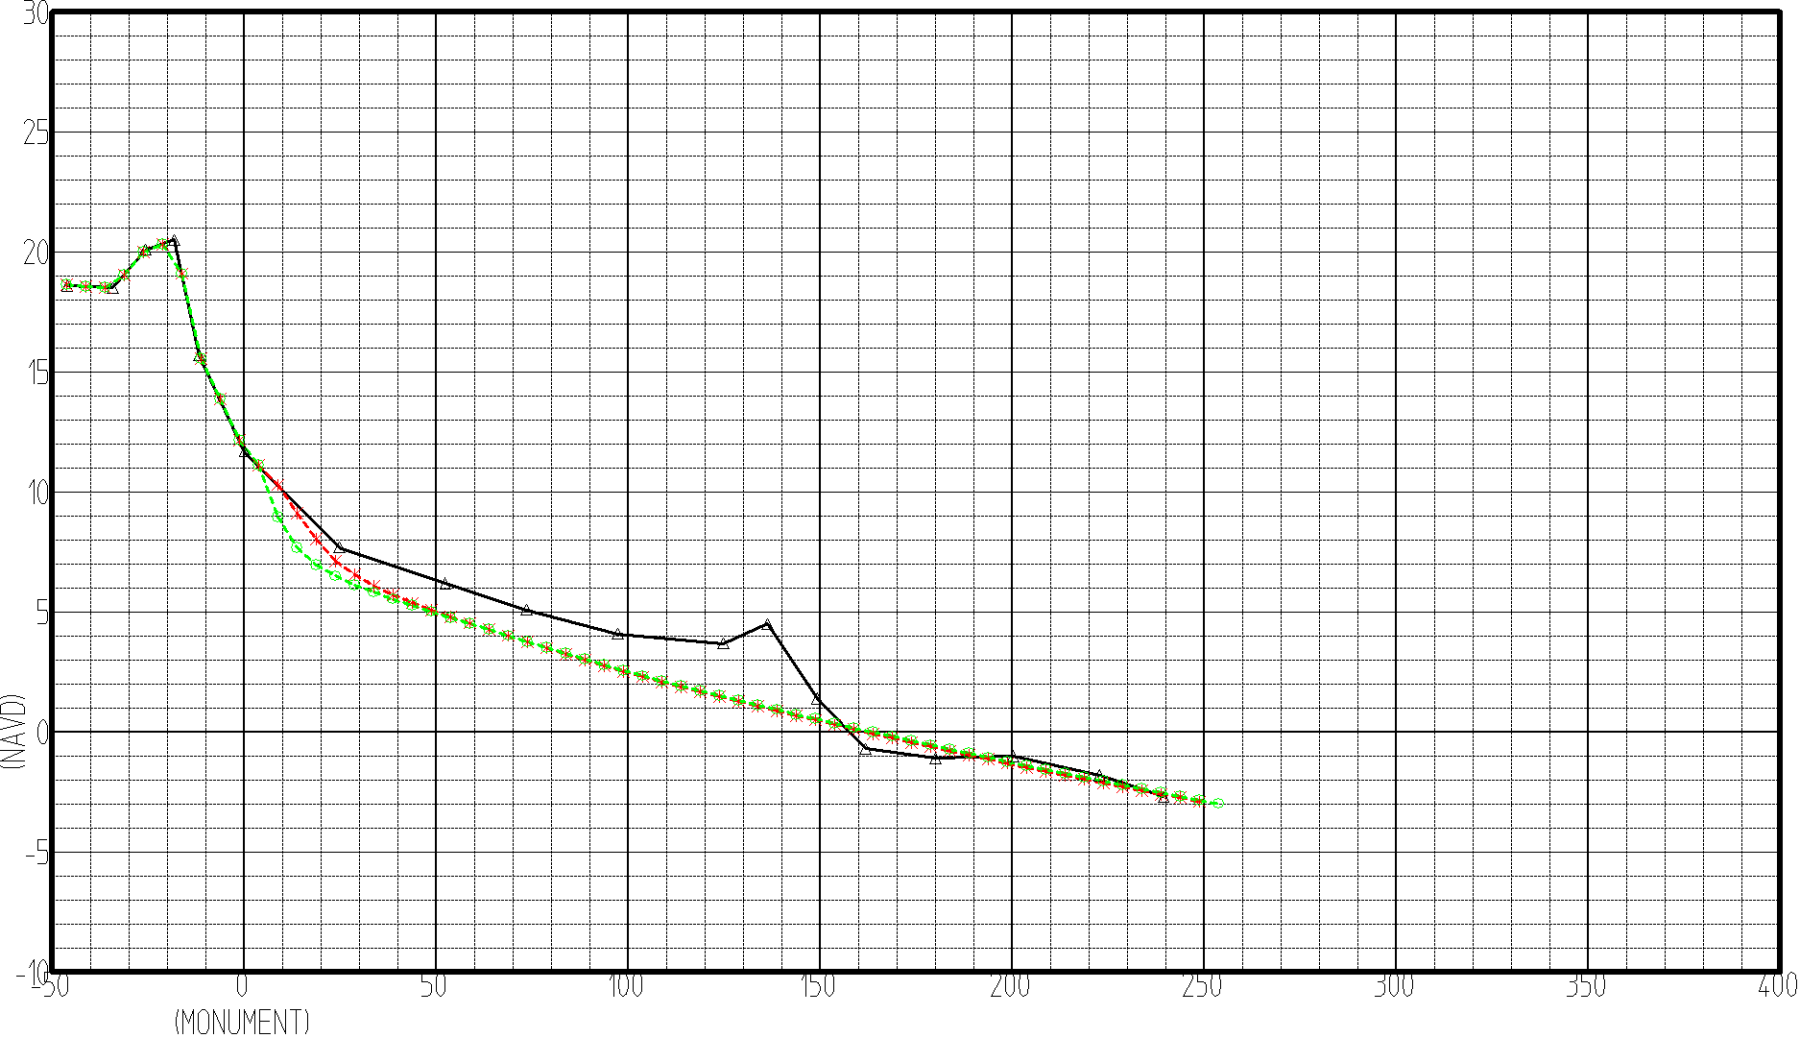
Range: R-37
 BEARING: 190.00
 1/1

BEACH PROFILE
 —△—△— WALTON JULY 2007 PRF
 - - * - - SBEACH 15-YR ERODED PRF
 - - o - - SBEACH 25-YR ERODED PRF

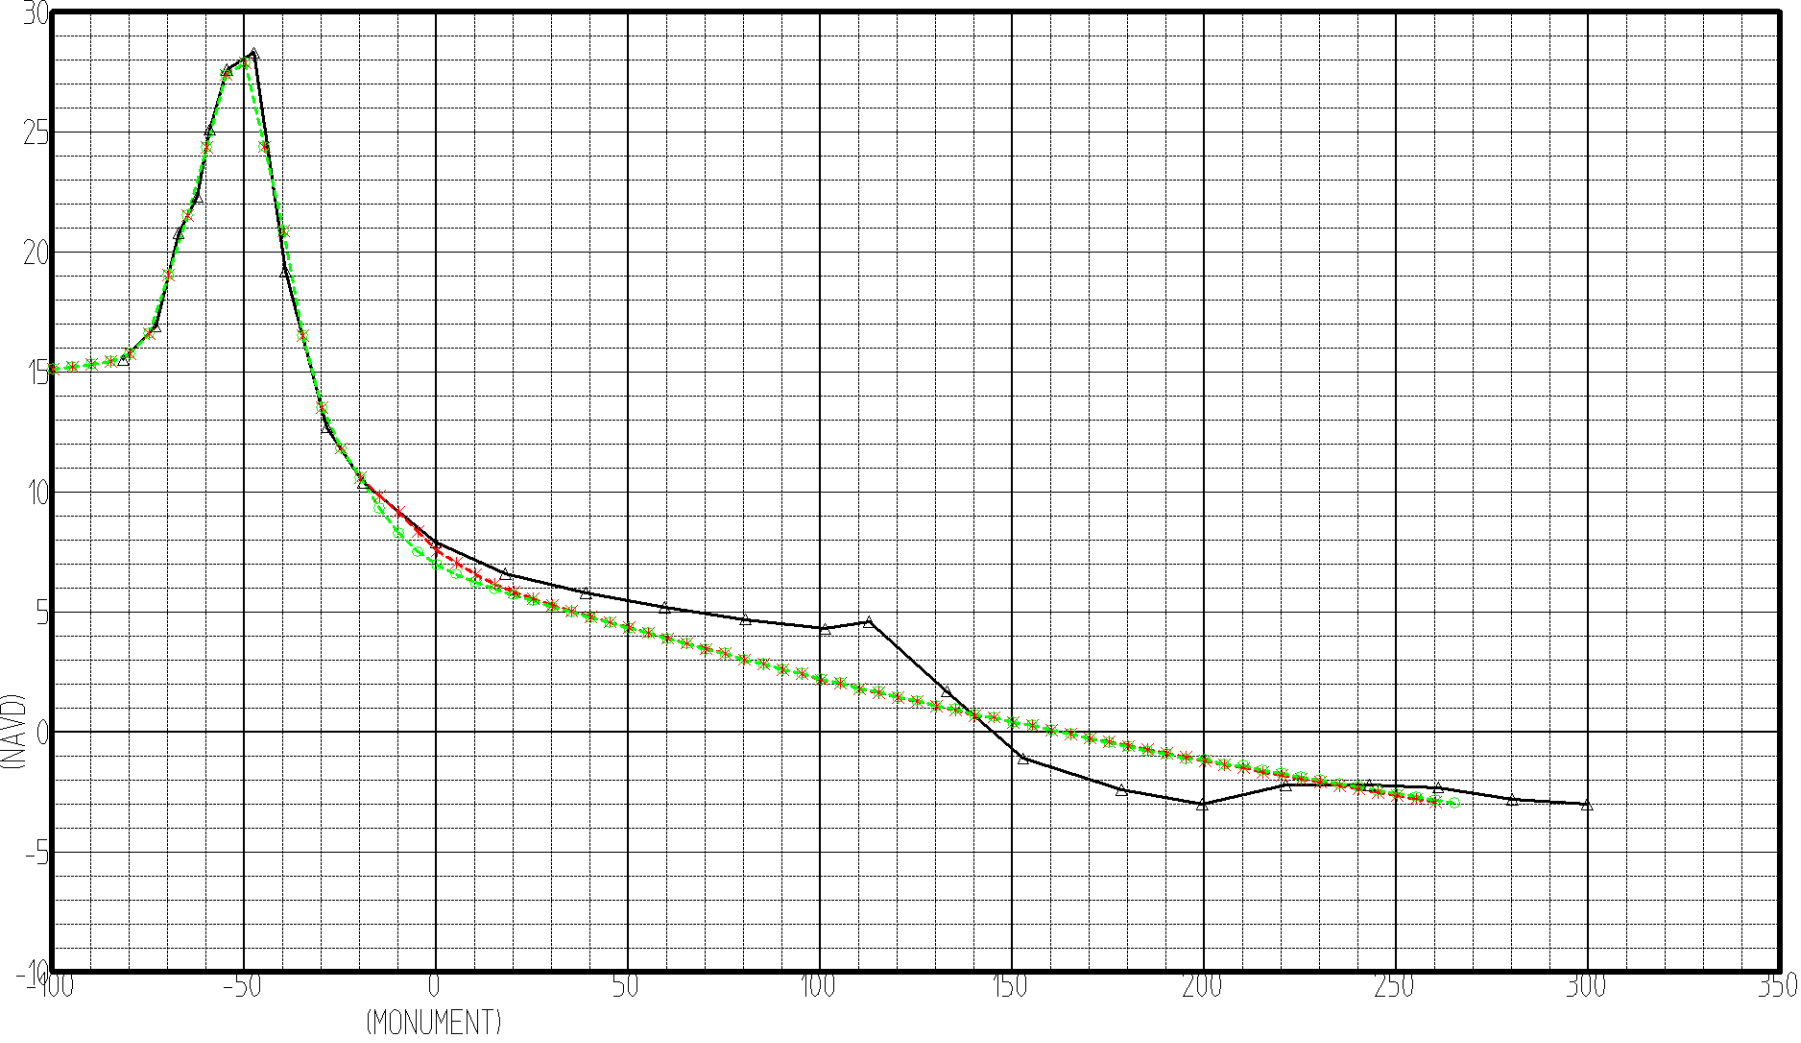
Range: R-39

—△—△— WALTON JULY 2007 PRF
