Appendix II

SBEACH Model Erosion Profile Plots

Walton County

15-year and 25-year Storm Events

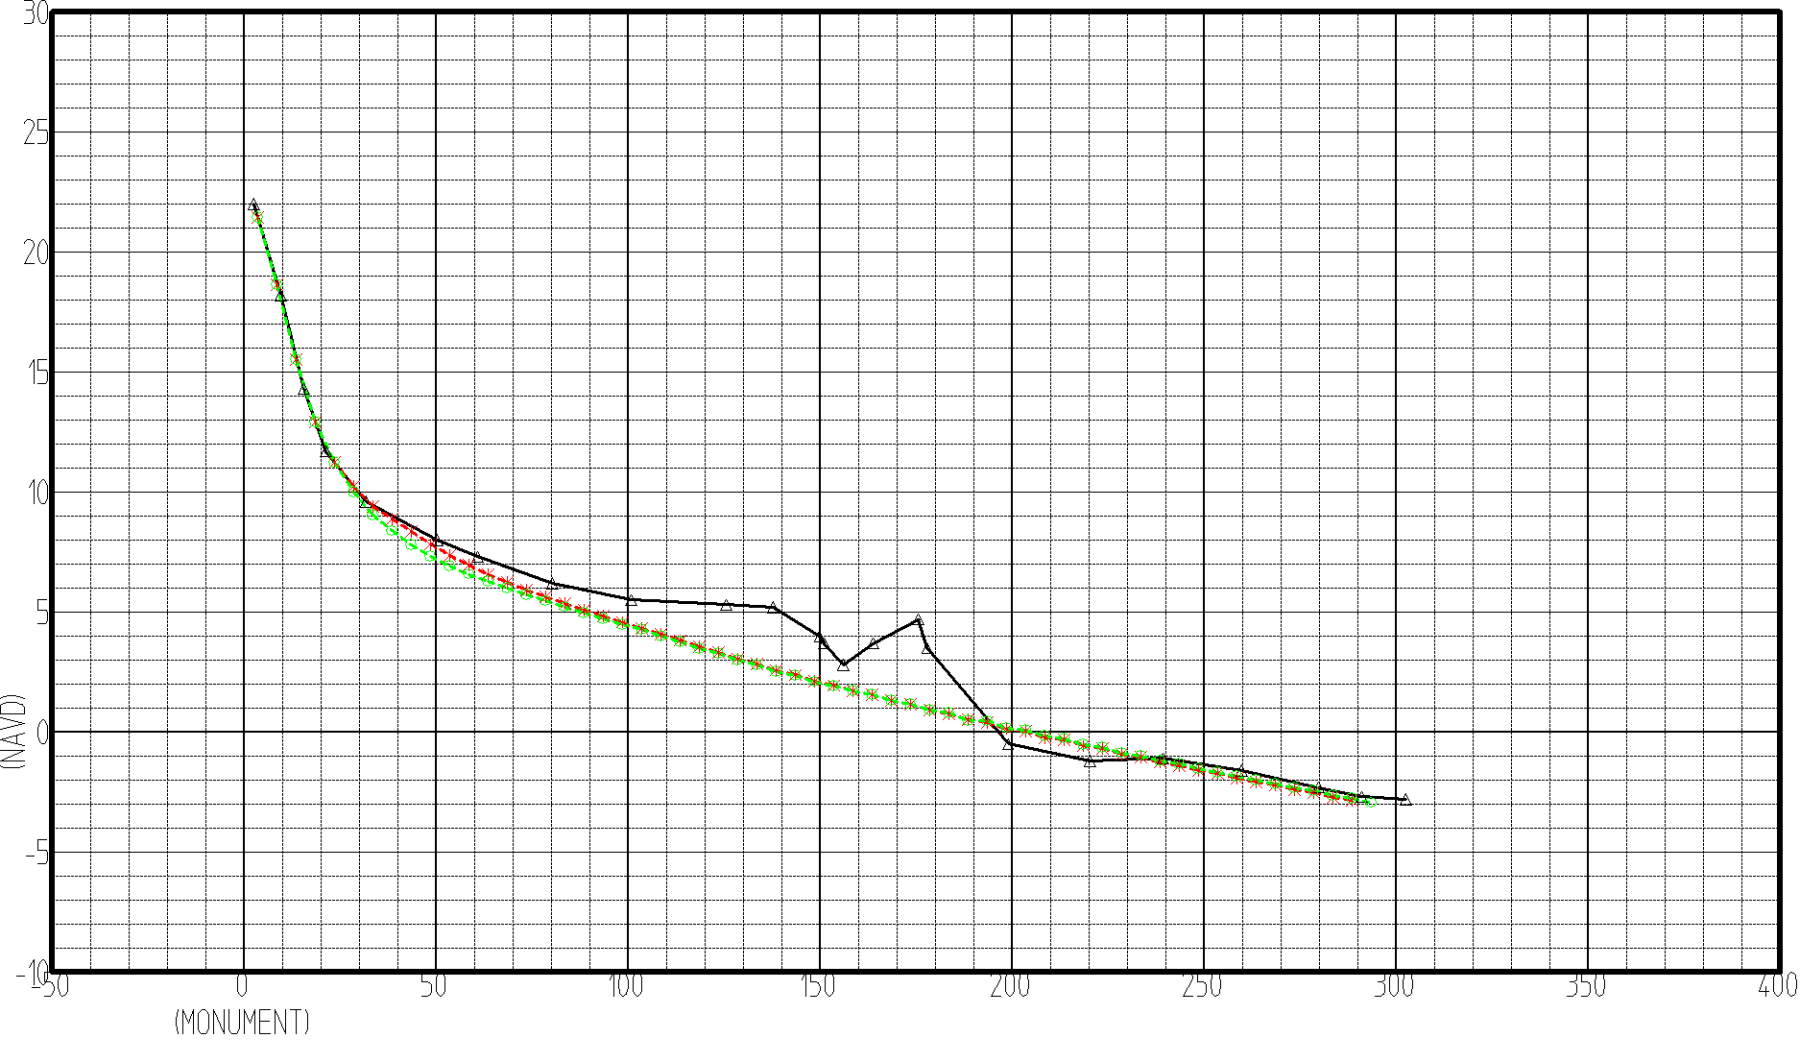
Range: R-39

BEACH PROFILE

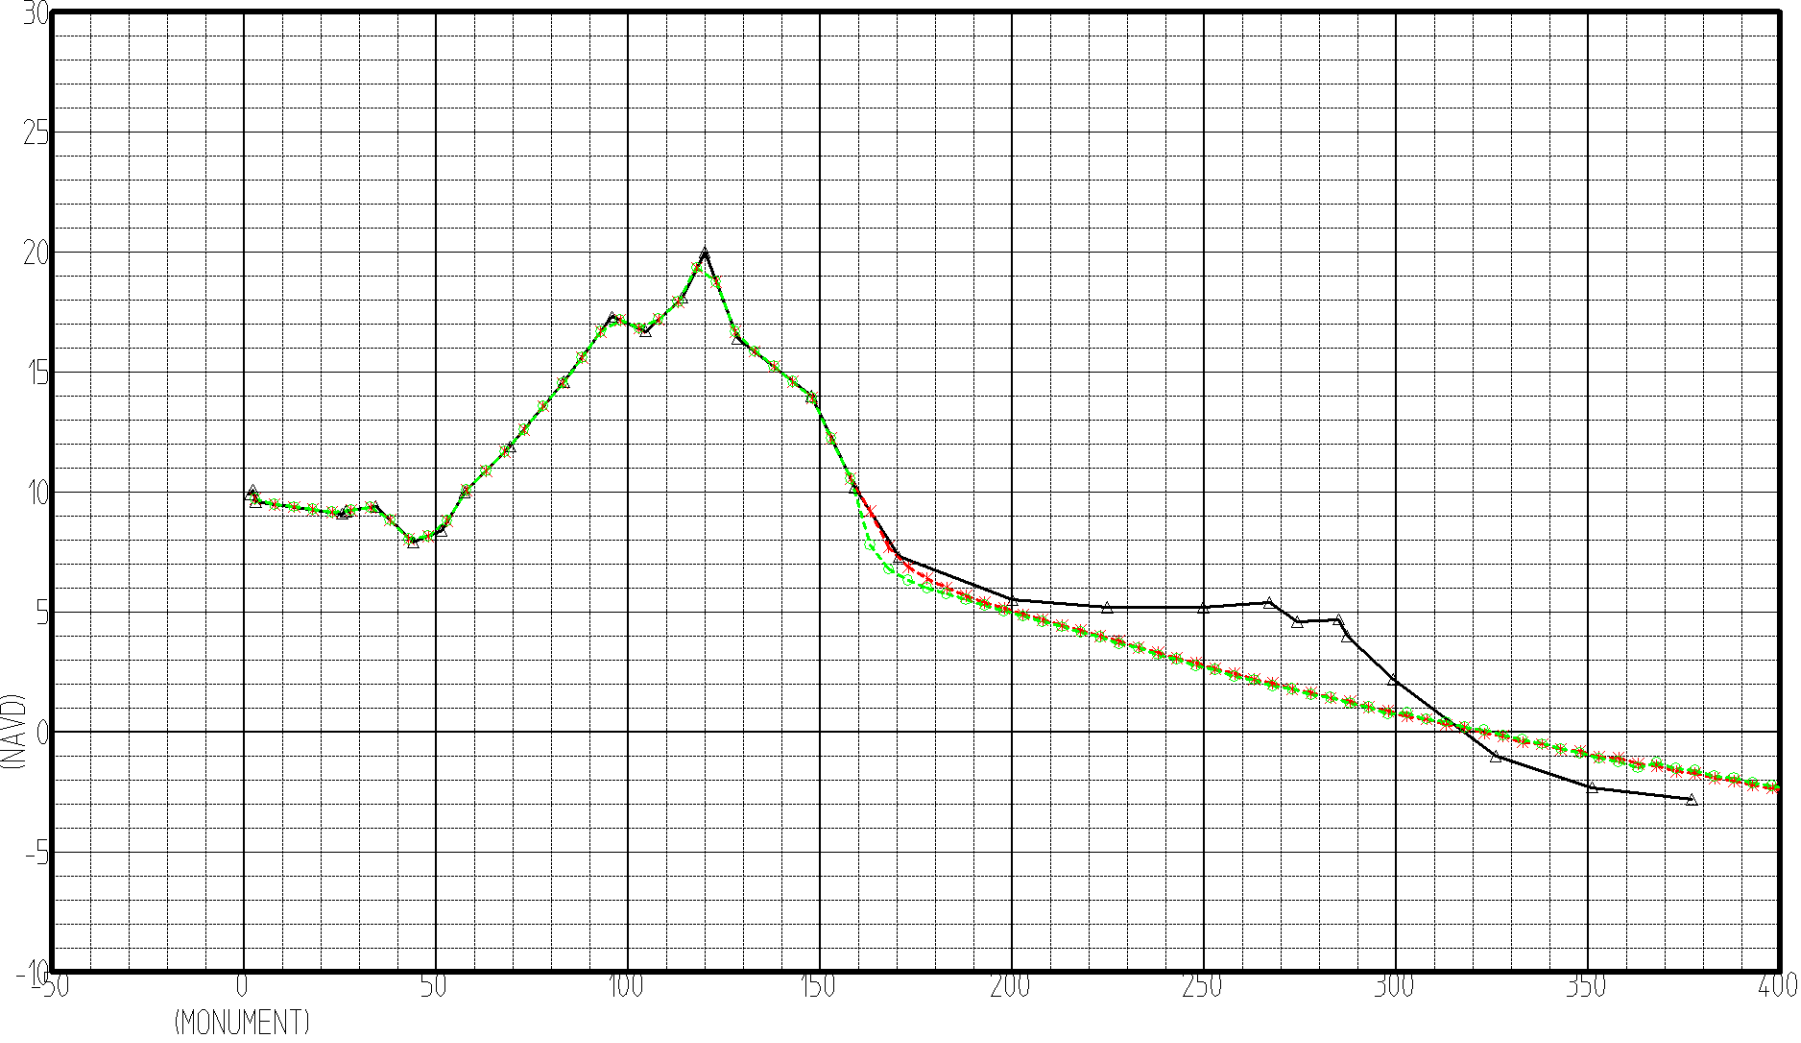
Range: R-41
 BEARING: 195.00
 1/2

BEACH PROFILE
 —△—△— WALTON JULY 2007 PRF
 - - * - - SBEACH 15-YR ERODED PRF
 - - o - - SBEACH 25-YR ERODED PRF

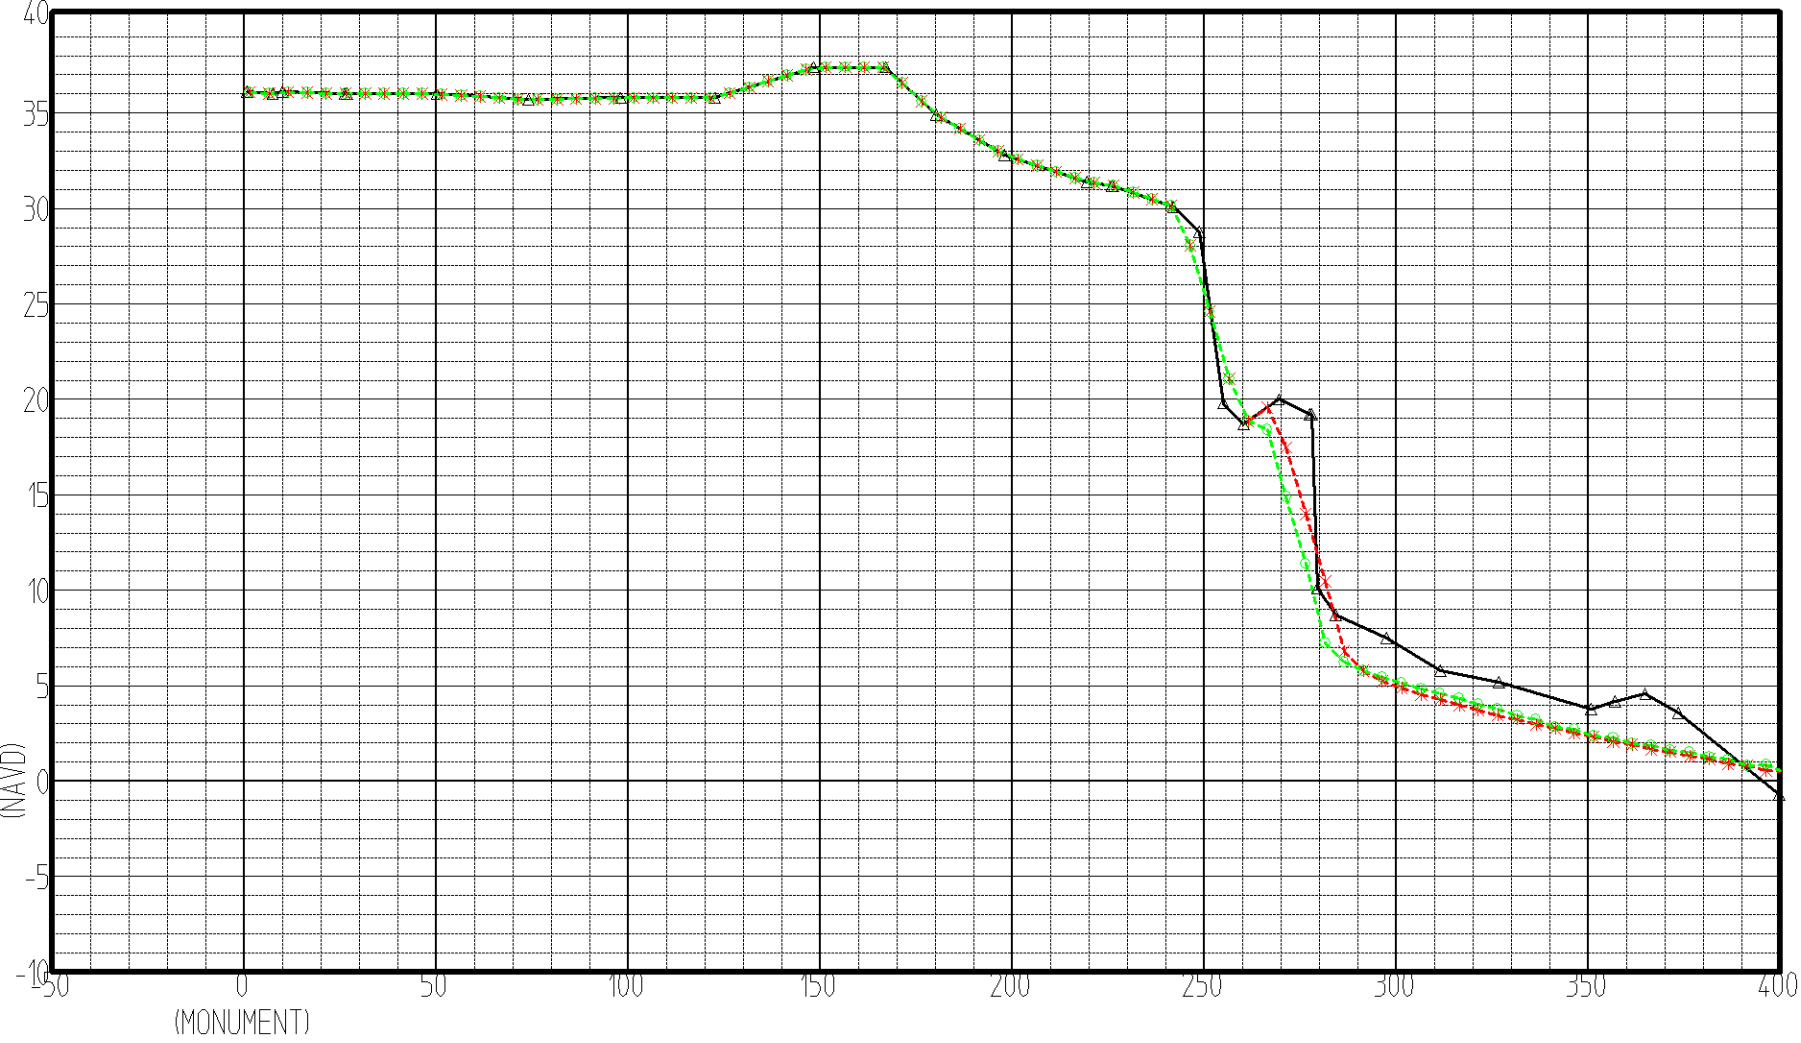
Range: R-42
 BEARING: 195.00
 1/2

BEACH PROFILE
 —△—△— WALTON JULY 2007 PRF
 - - * - - * - - SBEACH 15-YR ERODED PRF
 - - o - - o - - SBEACH 25-YR ERODED PRF

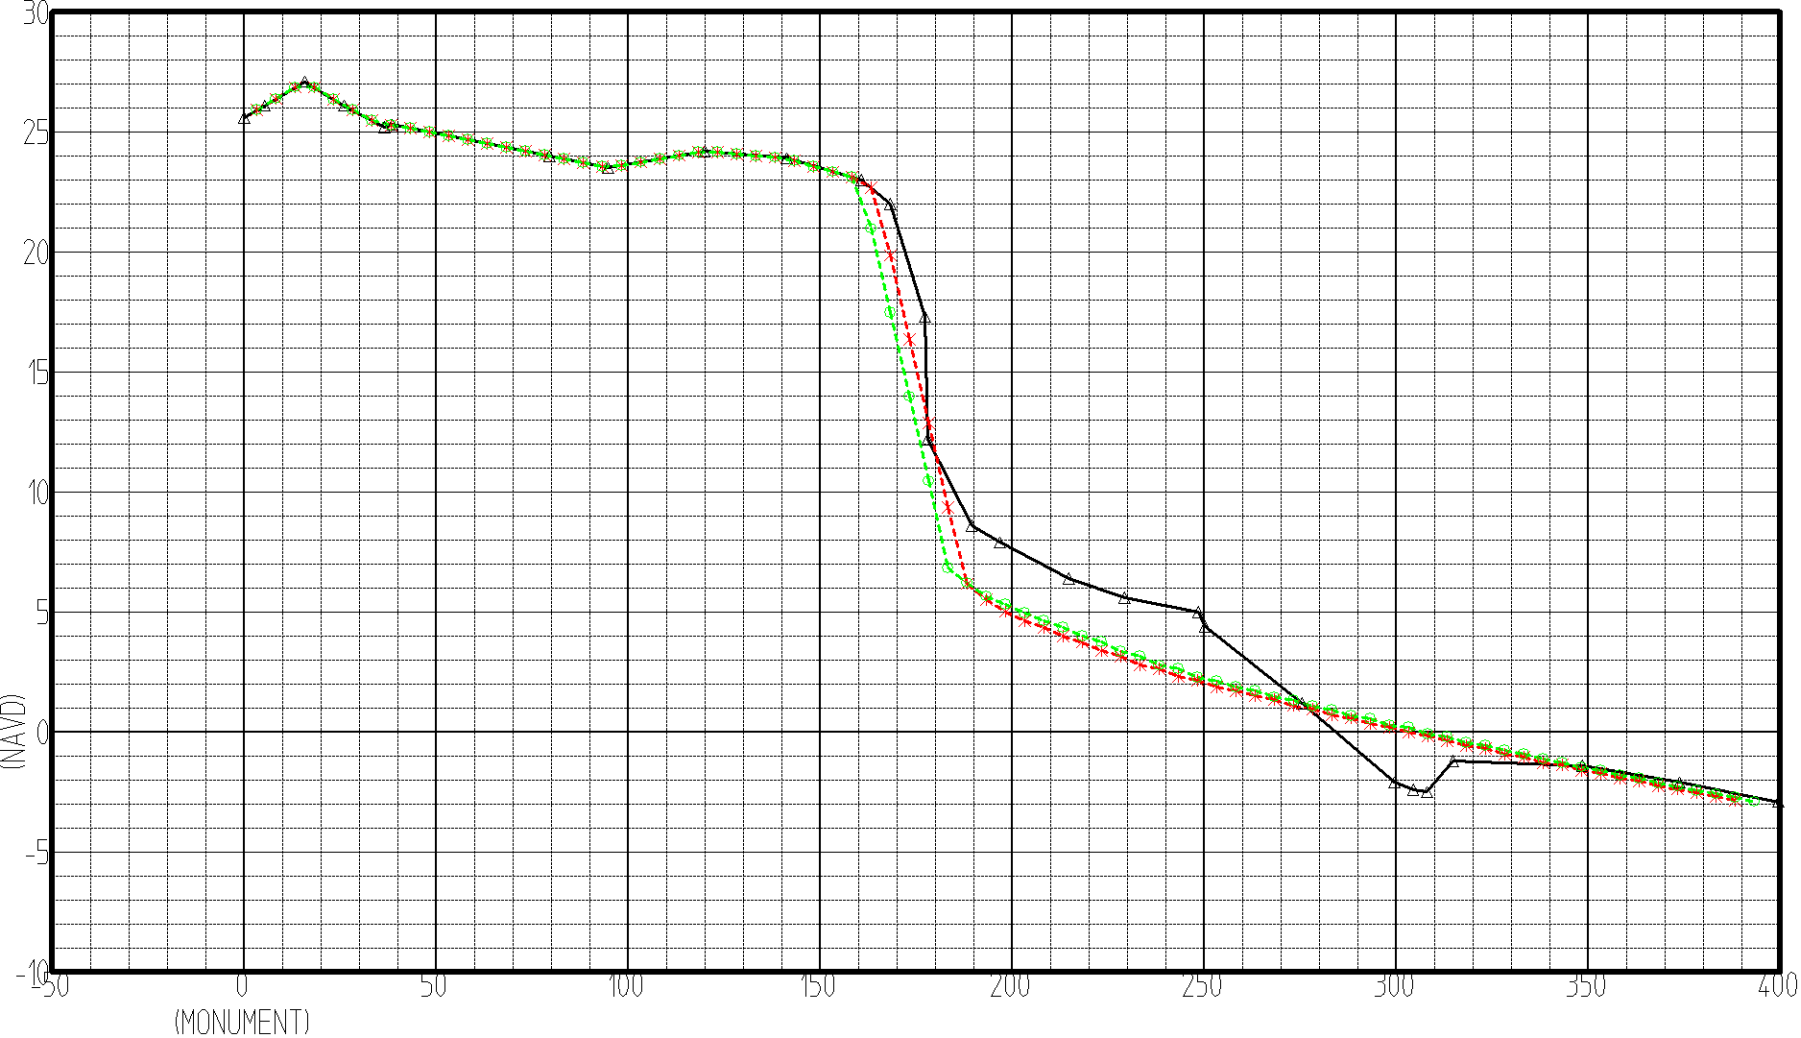
Range: R-42 2/2
 BEARING: 195.00

BEACH PROFILE
 —△—△— WALTON JULY 2007 PRF
 - - * - - SBEACH 15-YR ERODED PRF
 - - o - - SBEACH 25-YR ERODED PRF

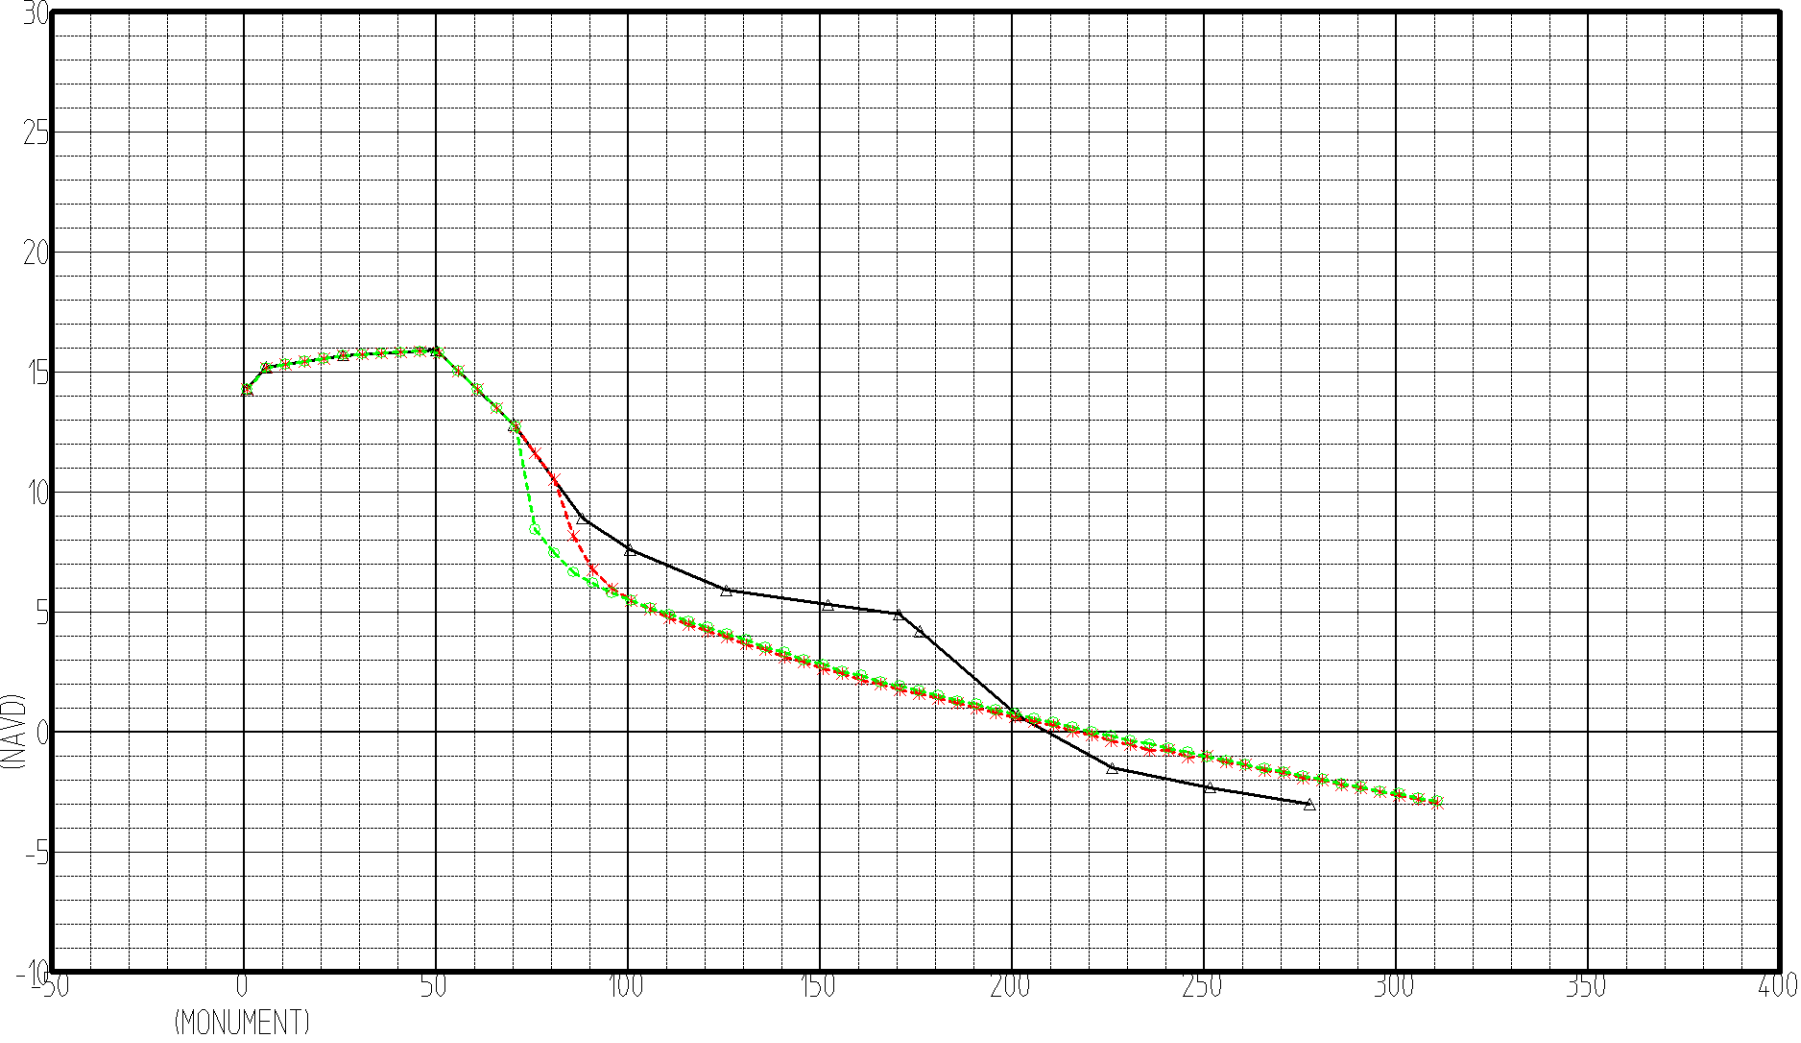
Range: R-44
 BEARING: 195.00
 1/1

BEACH PROFILE
 —△—△— WALTON JULY 2007 PRF
 - - * - - SBEACH 15-YR ERODED PRF
 - - o - - SBEACH 25-YR ERODED PRF

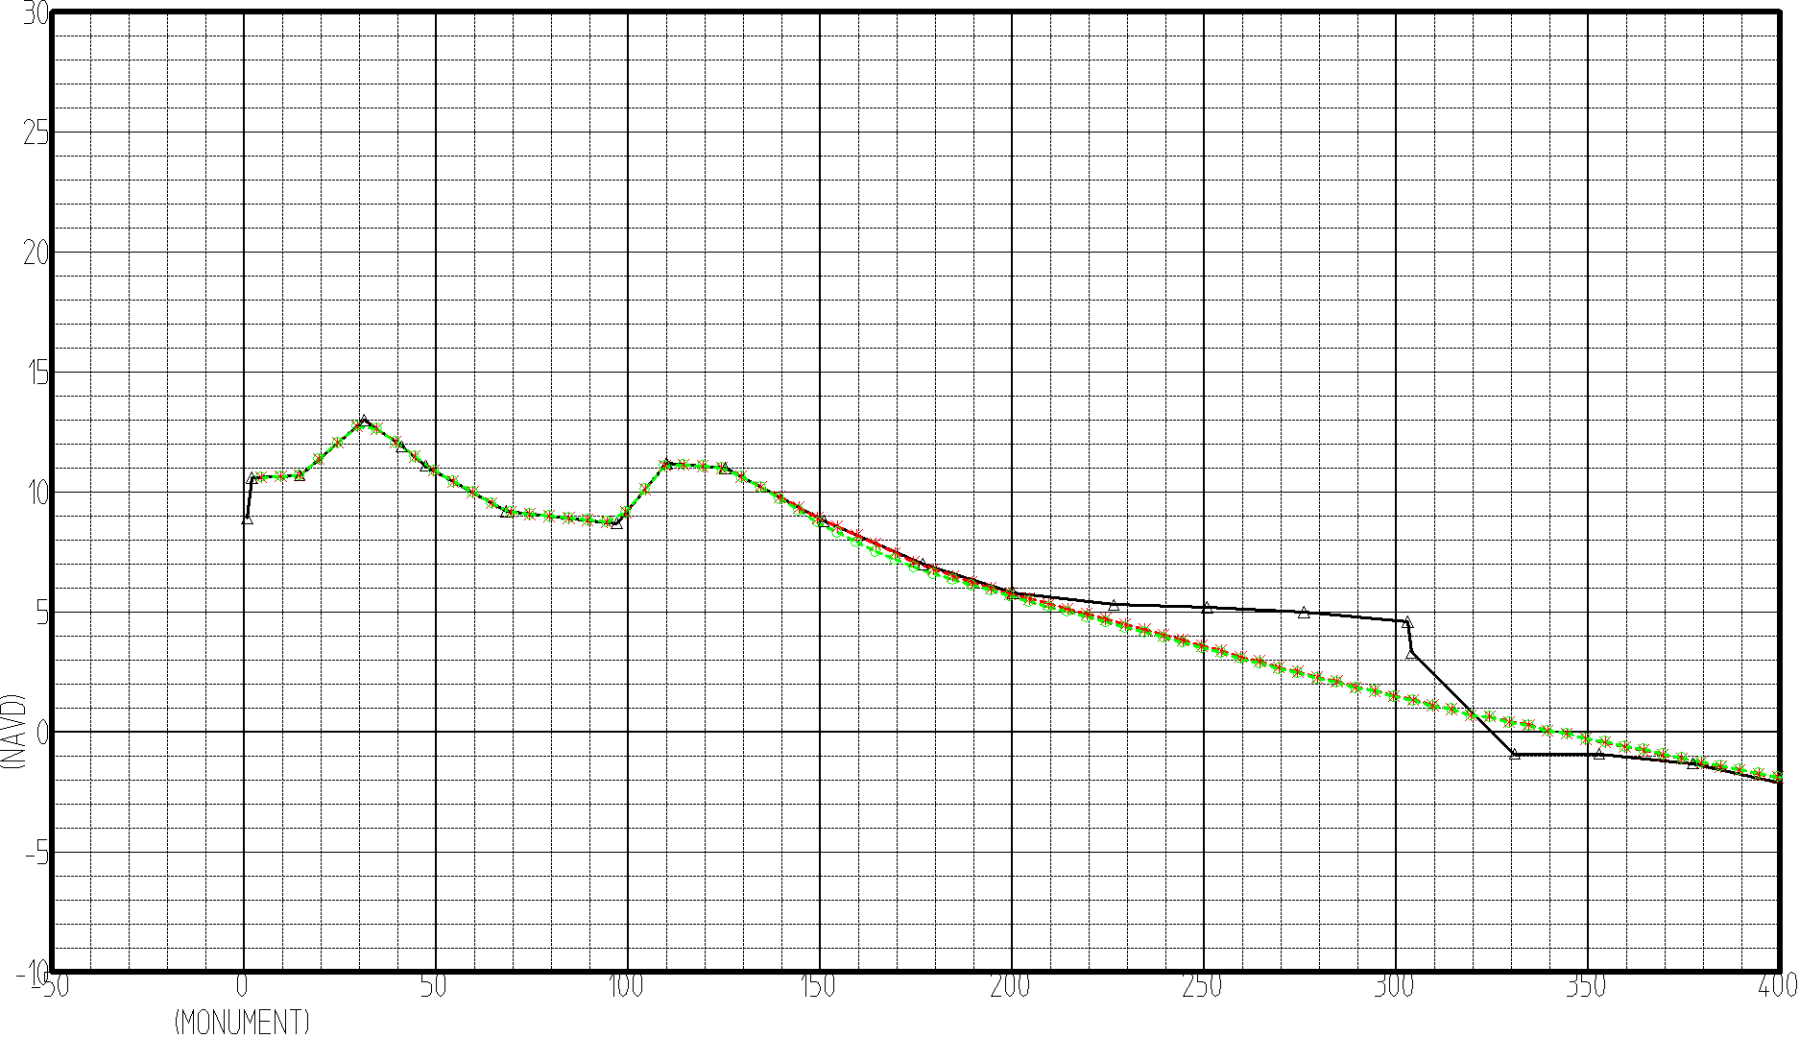
Range: R-46
 BEARING: 195.00
 1/2

BEACH PROFILE
 —△—△— WALTON JULY 2007 PRF
 - - * - - * - - SBEACH 15-YR ERODED PRF
 - - o - - o - - SBEACH 25-YR ERODED PRF

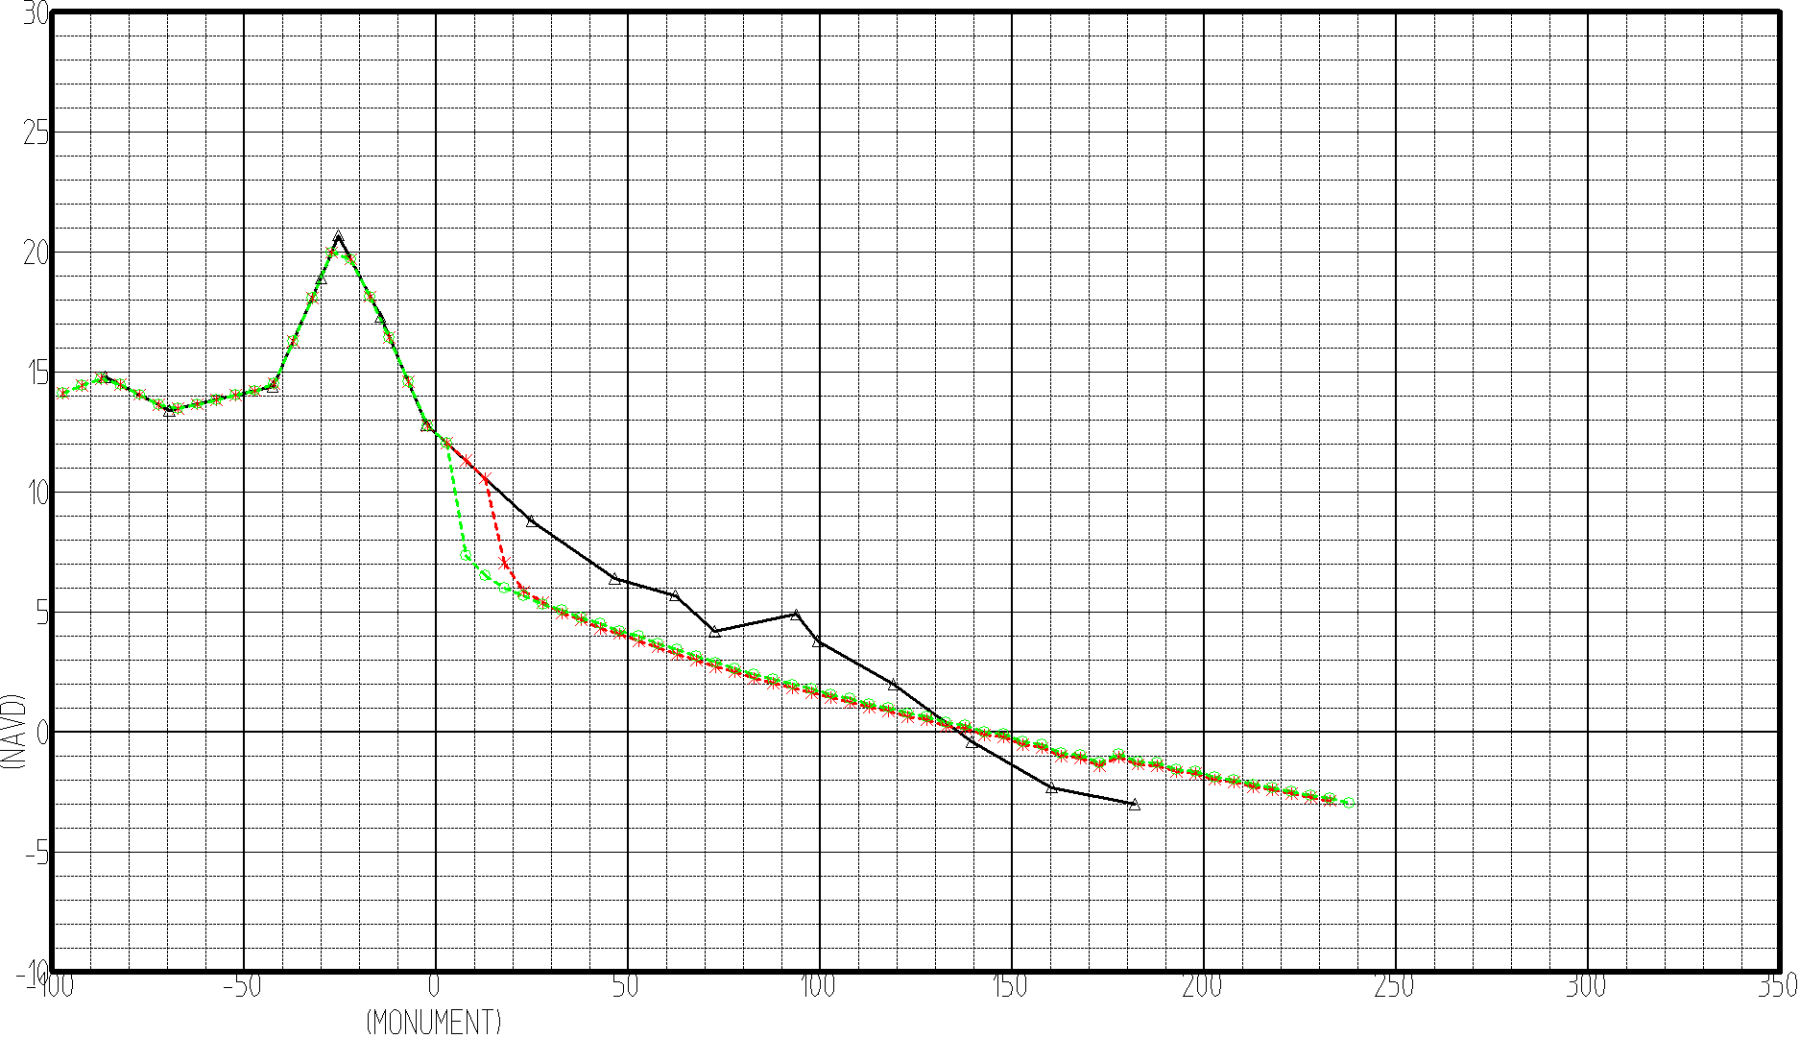
Range: R-47
 BEARING: 195.00
 1/1

BEACH PROFILE
 —△—△— WALTON JULY 2007 PRF
 - - * - - * - - SBEACH 15-YR ERODED PRF
 - - o - - o - - SBEACH 25-YR ERODED PRF

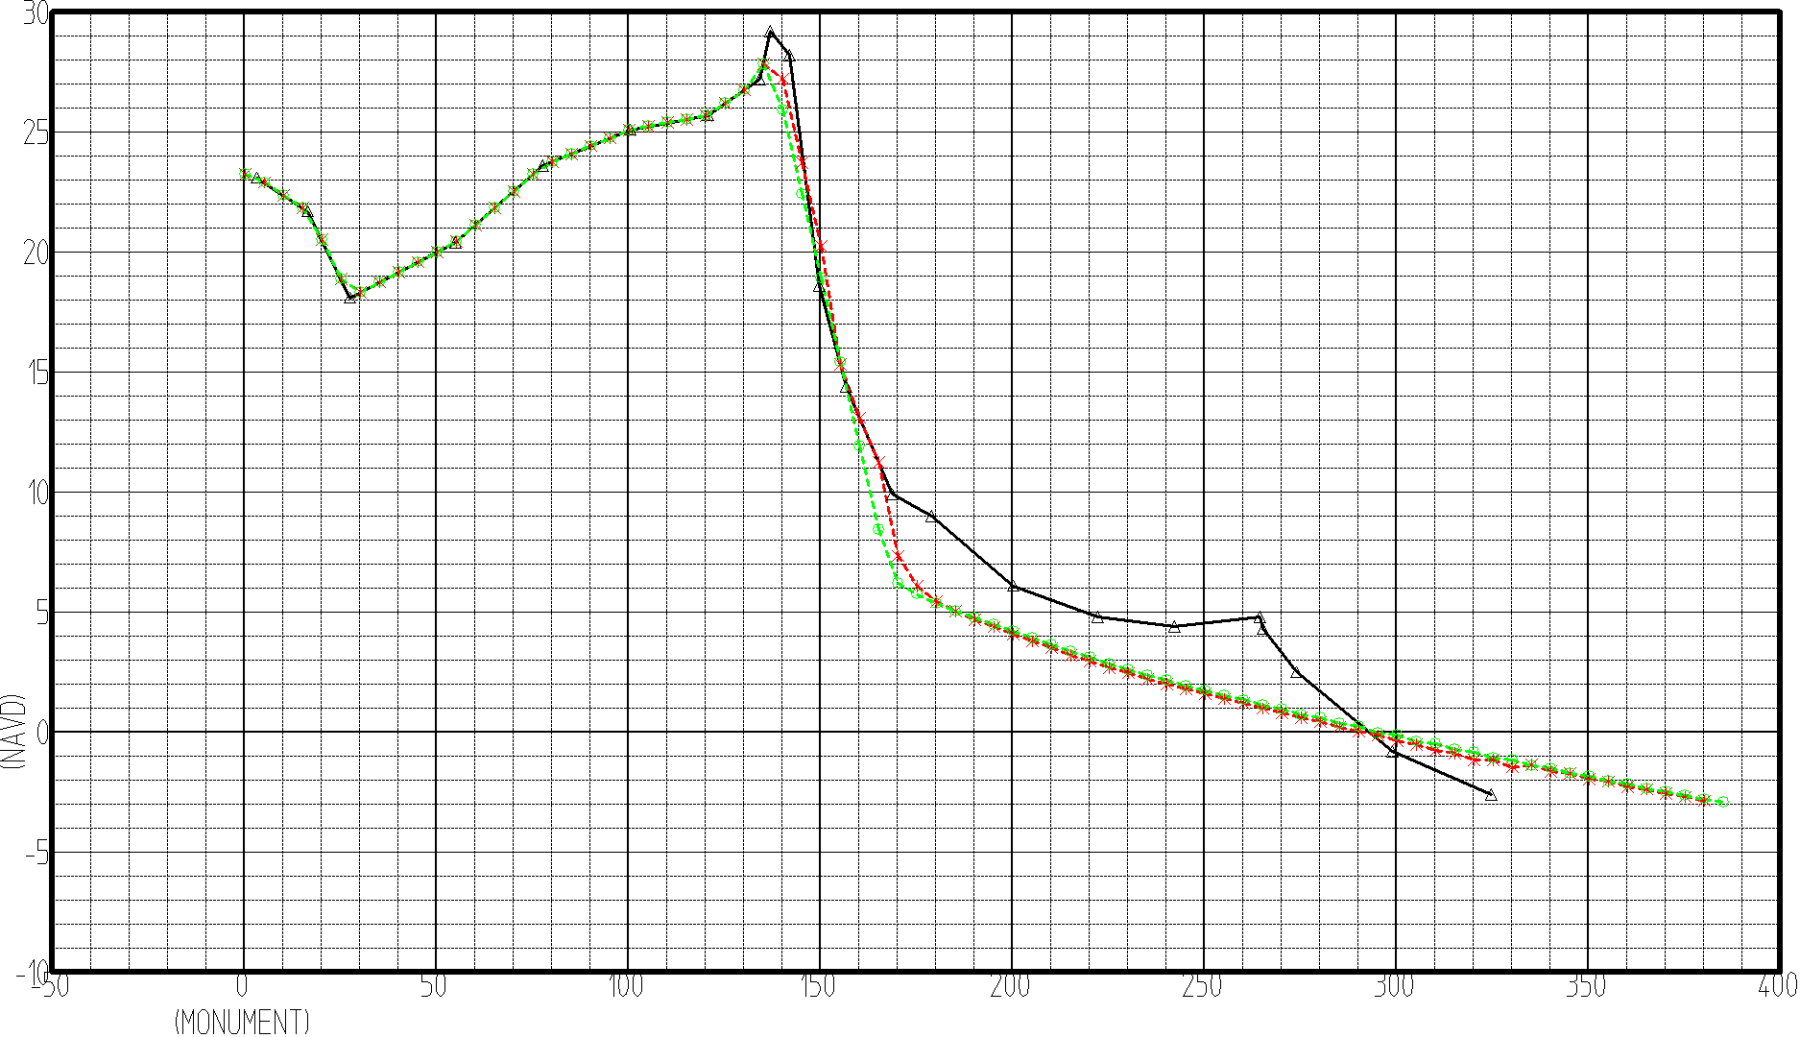
Range: R-48
 BEARING: 195.00
 1/1

BEACH PROFILE
 —△—△— WALTON JULY 2007 PRF
 - - * - - SBEACH 15-YR ERODED PRF
 - - o - - SBEACH 25-YR ERODED PRF

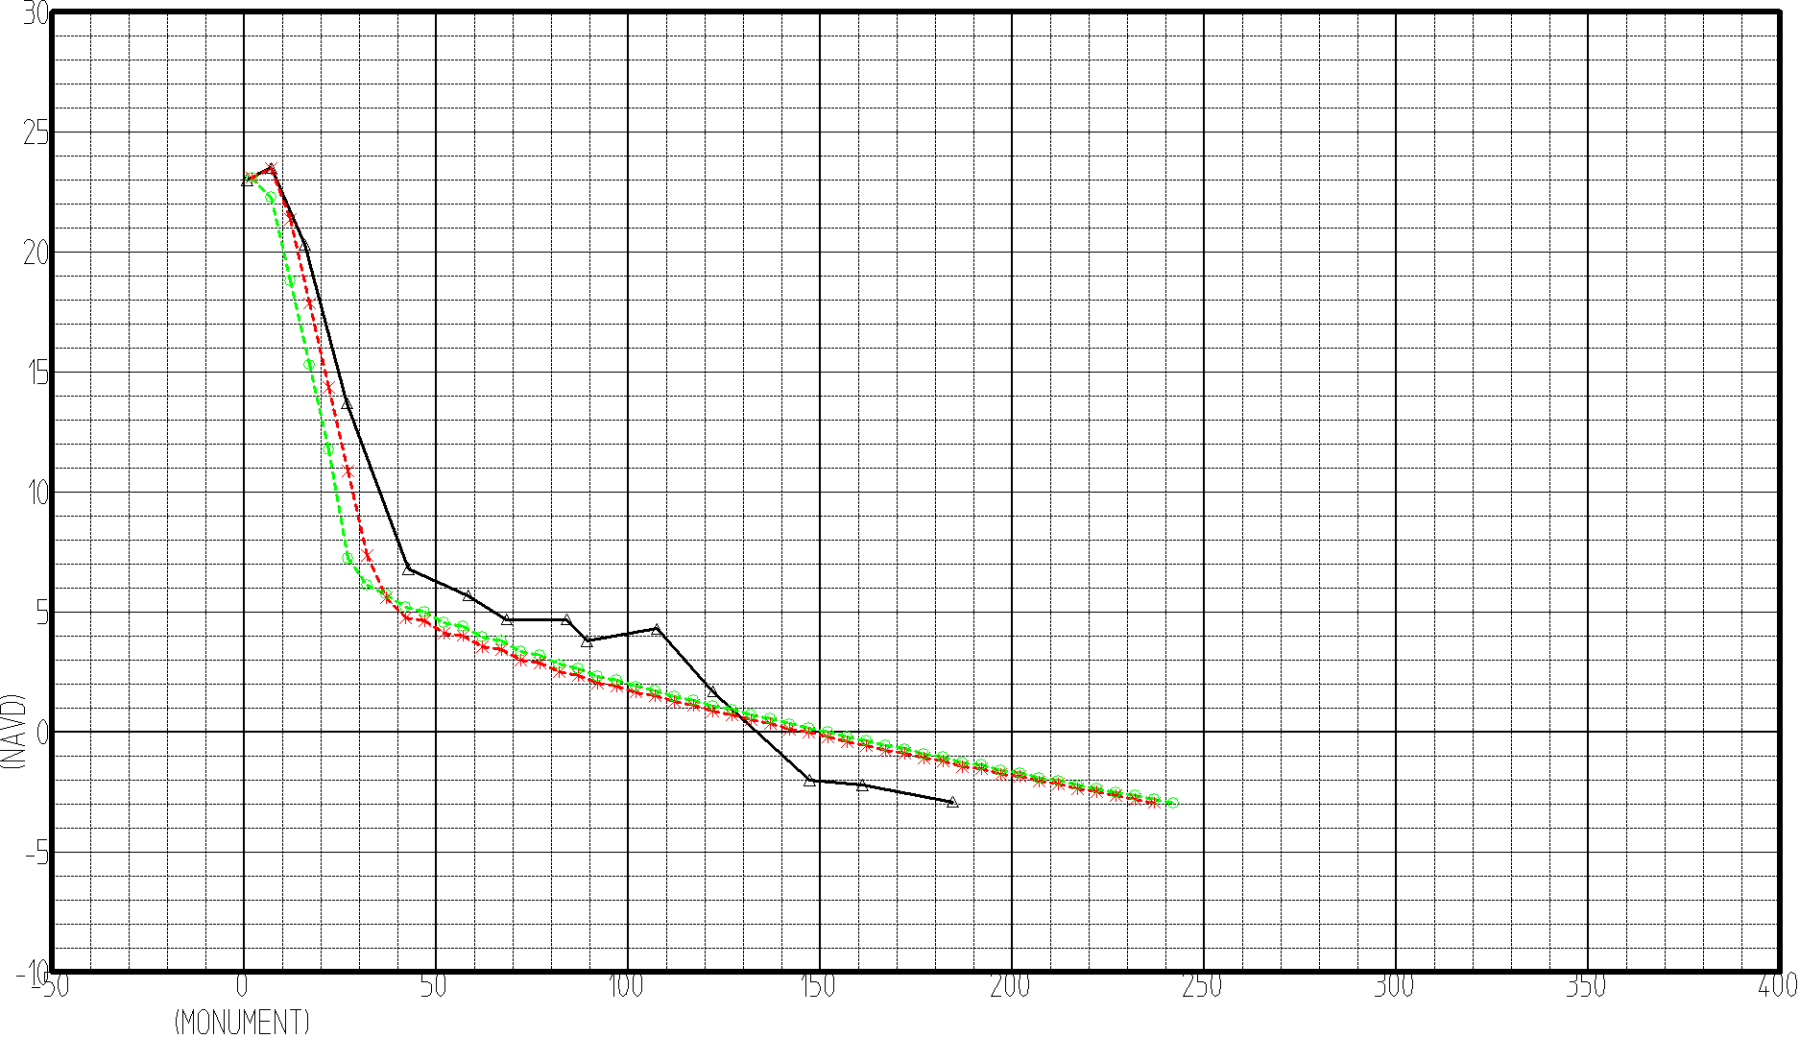
Range: R-49
 BEARING: 195.00
 1/1

BEACH PROFILE
 —△—△— WALTON JULY 2007 PRF
 - - * - - SBEACH 15-YR ERODED PRF
 - - o - - SBEACH 25-YR ERODED PRF

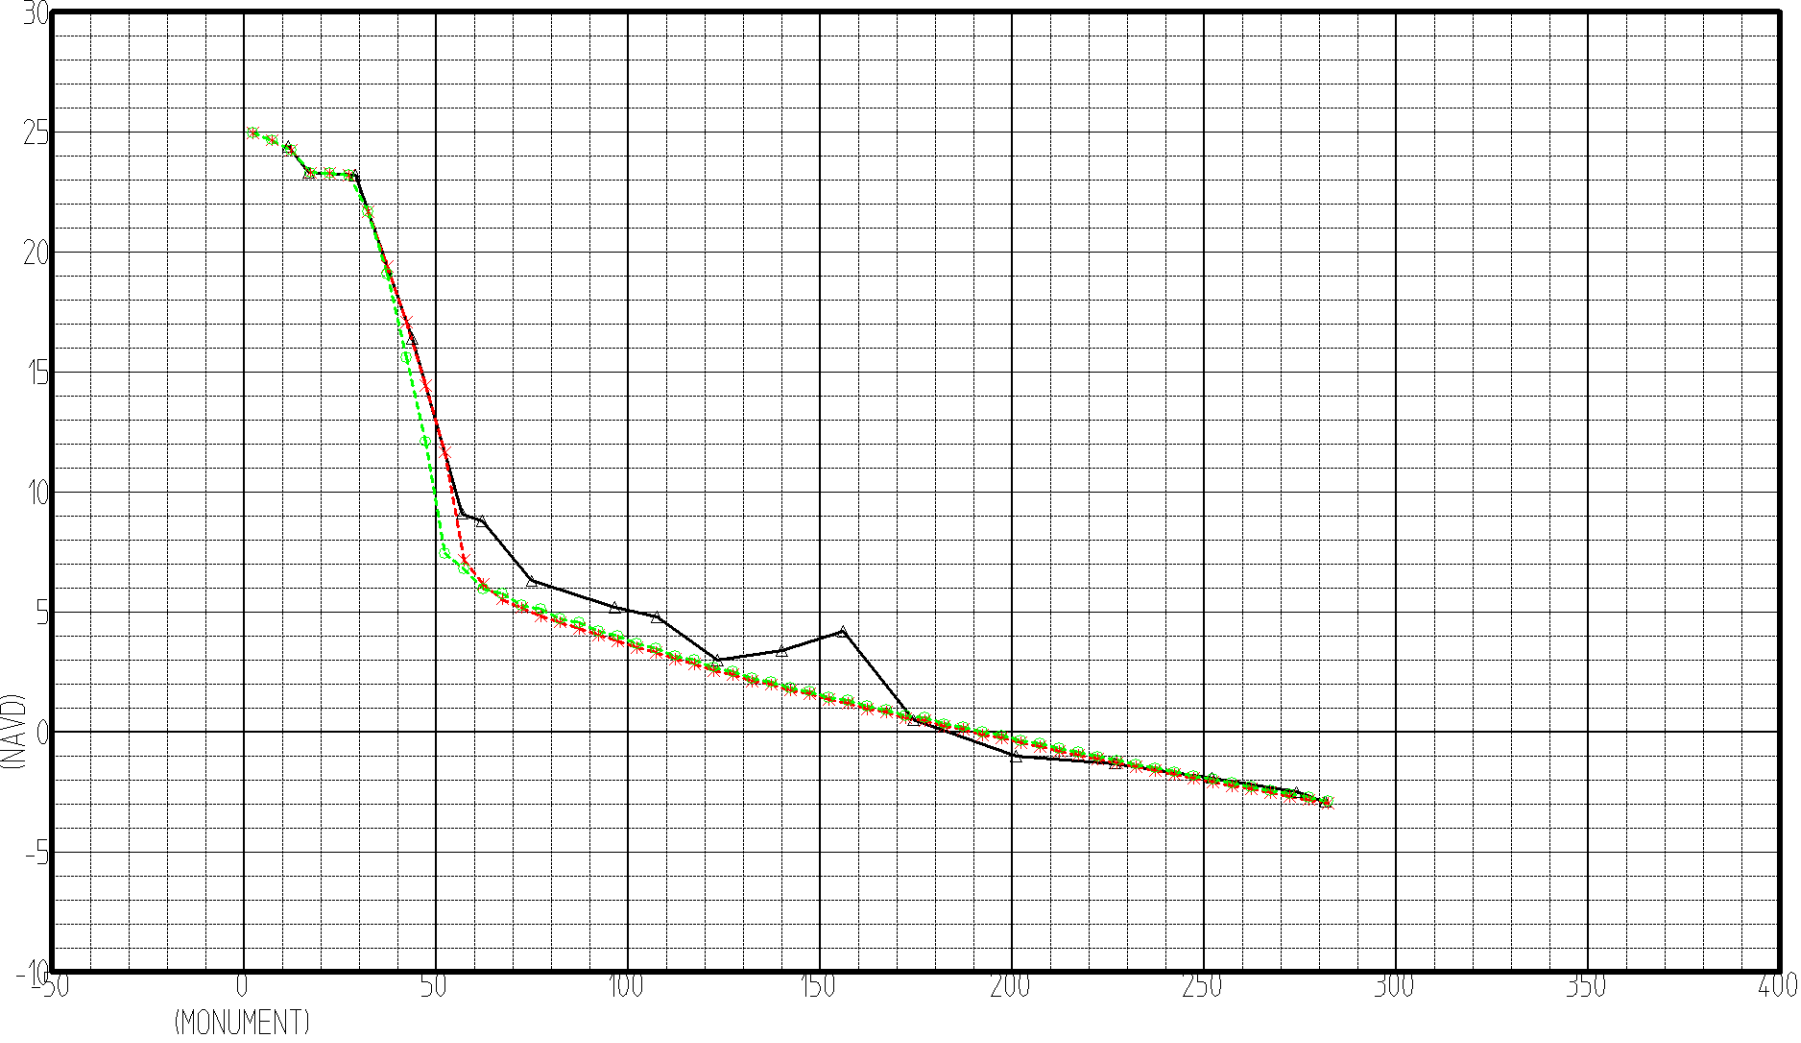
Range: R-51 1/1

BEACH PROFILE

—△—△— WALTON JULY 2007 PRF
 - - * - - * - - SBEACH 15-YR ERODED PRF
 - - o - - o - - SBEACH 25-YR ERODED PRF

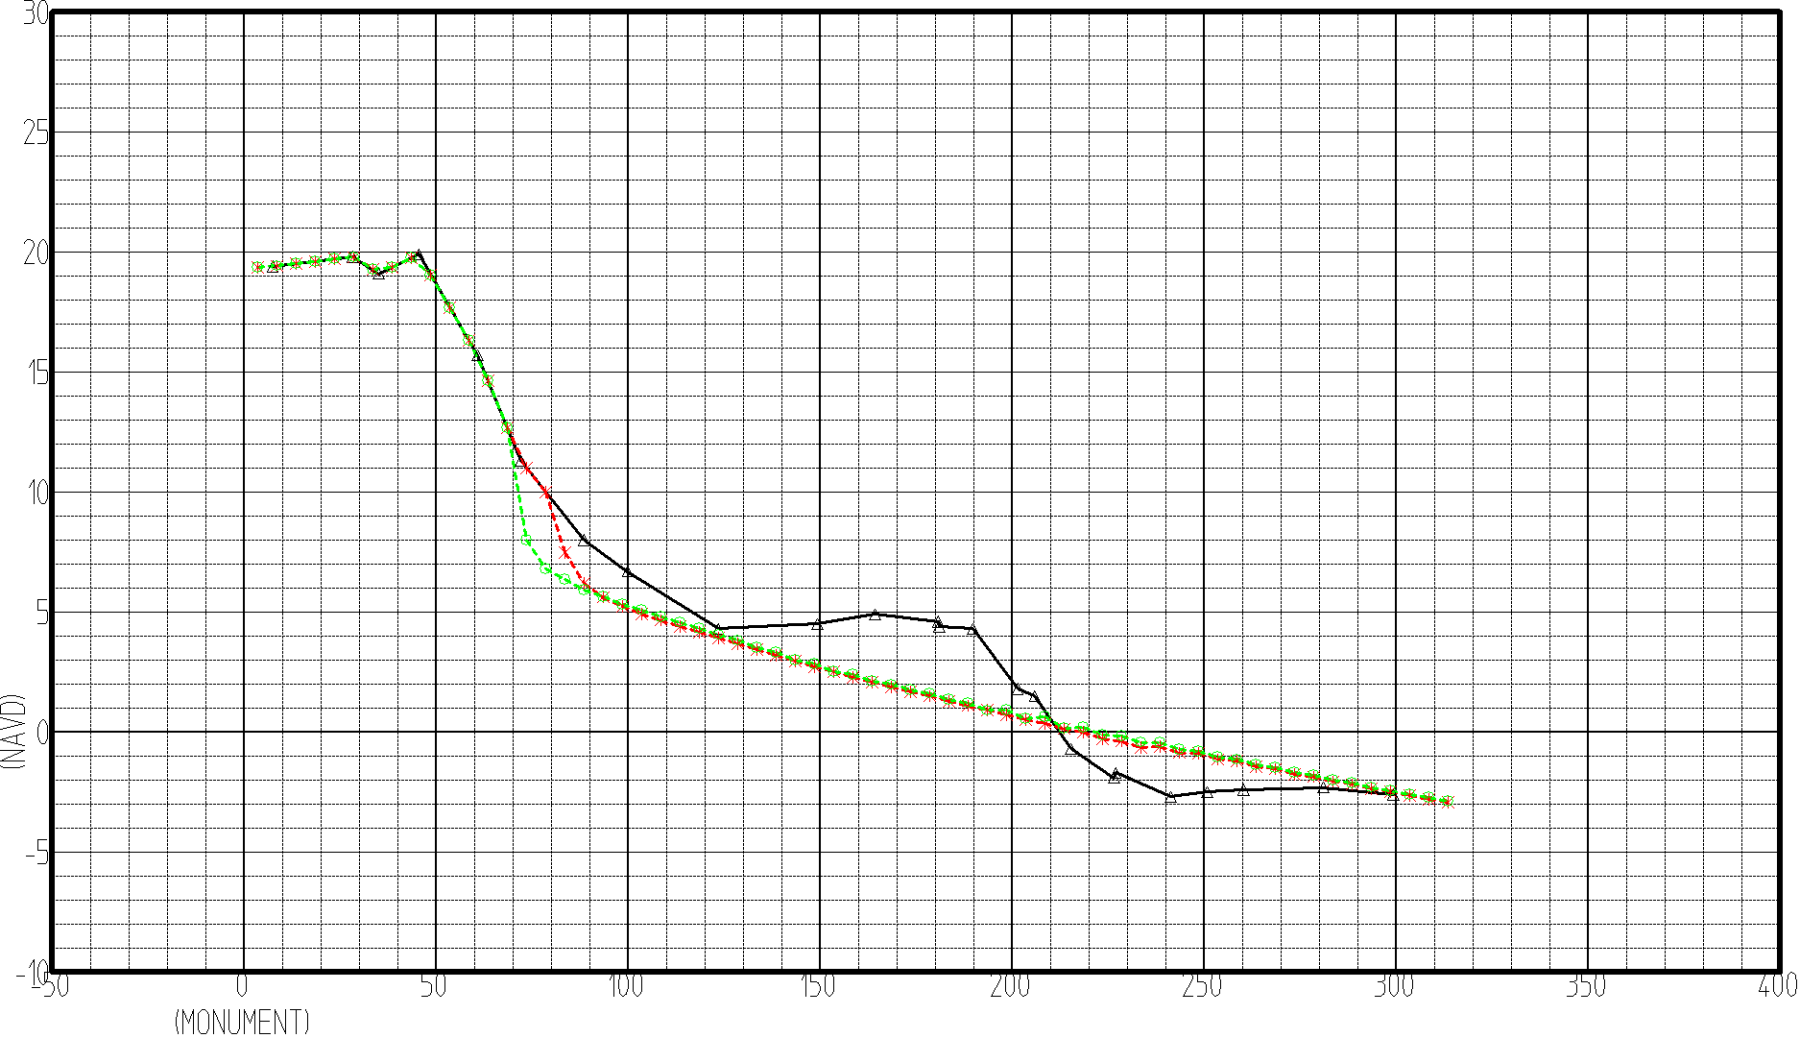
Range: R-52
 BEARING: 200.00
 1/1

BEACH PROFILE
 —△—△— WALTON JULY 2007 PRF
 - - * - - SBEACH 15-YR ERODED PRF
 - - o - - SBEACH 25-YR ERODED PRF

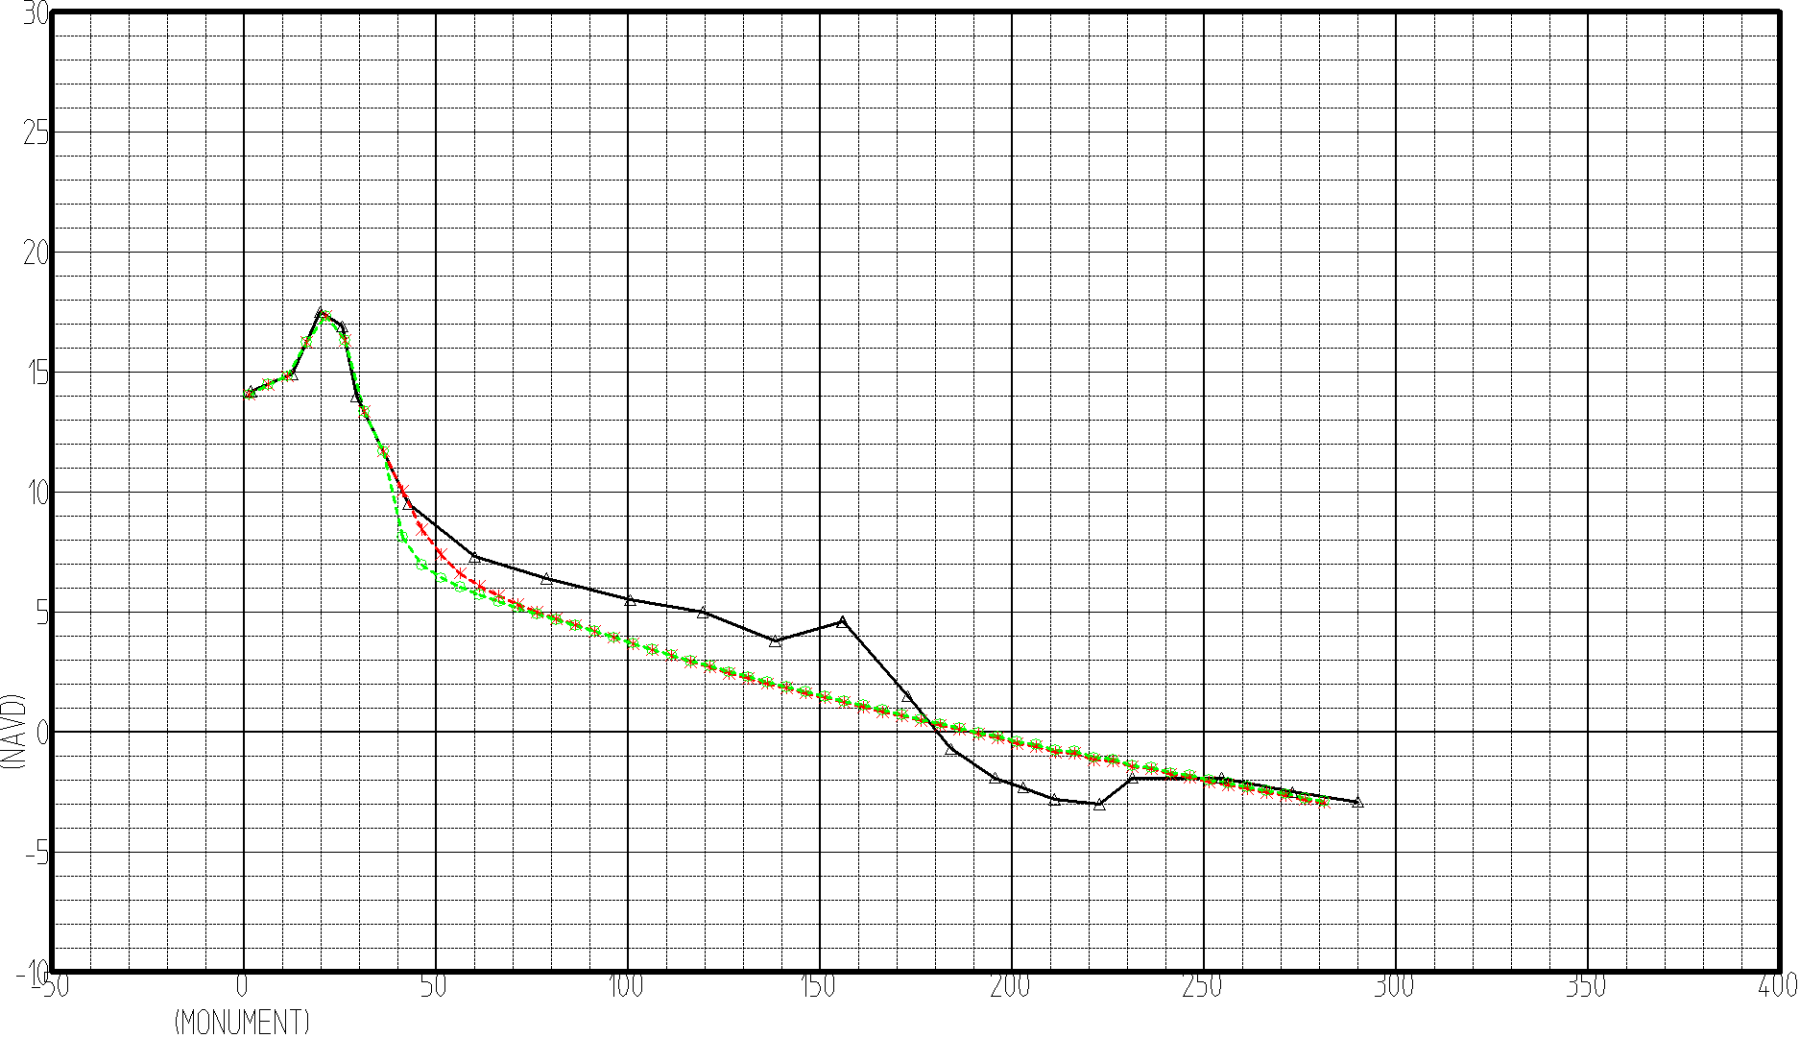
Range: R-53
 BEARING: 200.00
 1/1

BEACH PROFILE
 —△—△— WALTON JULY 2007 PRF
 - - * - - SBEACH 15-YR ERODED PRF
 - - o - - SBEACH 25-YR ERODED PRF
