Appendix II

SBEACH Model Erosion Profile Plots

Walton County

15-year and 25-year Storm Events

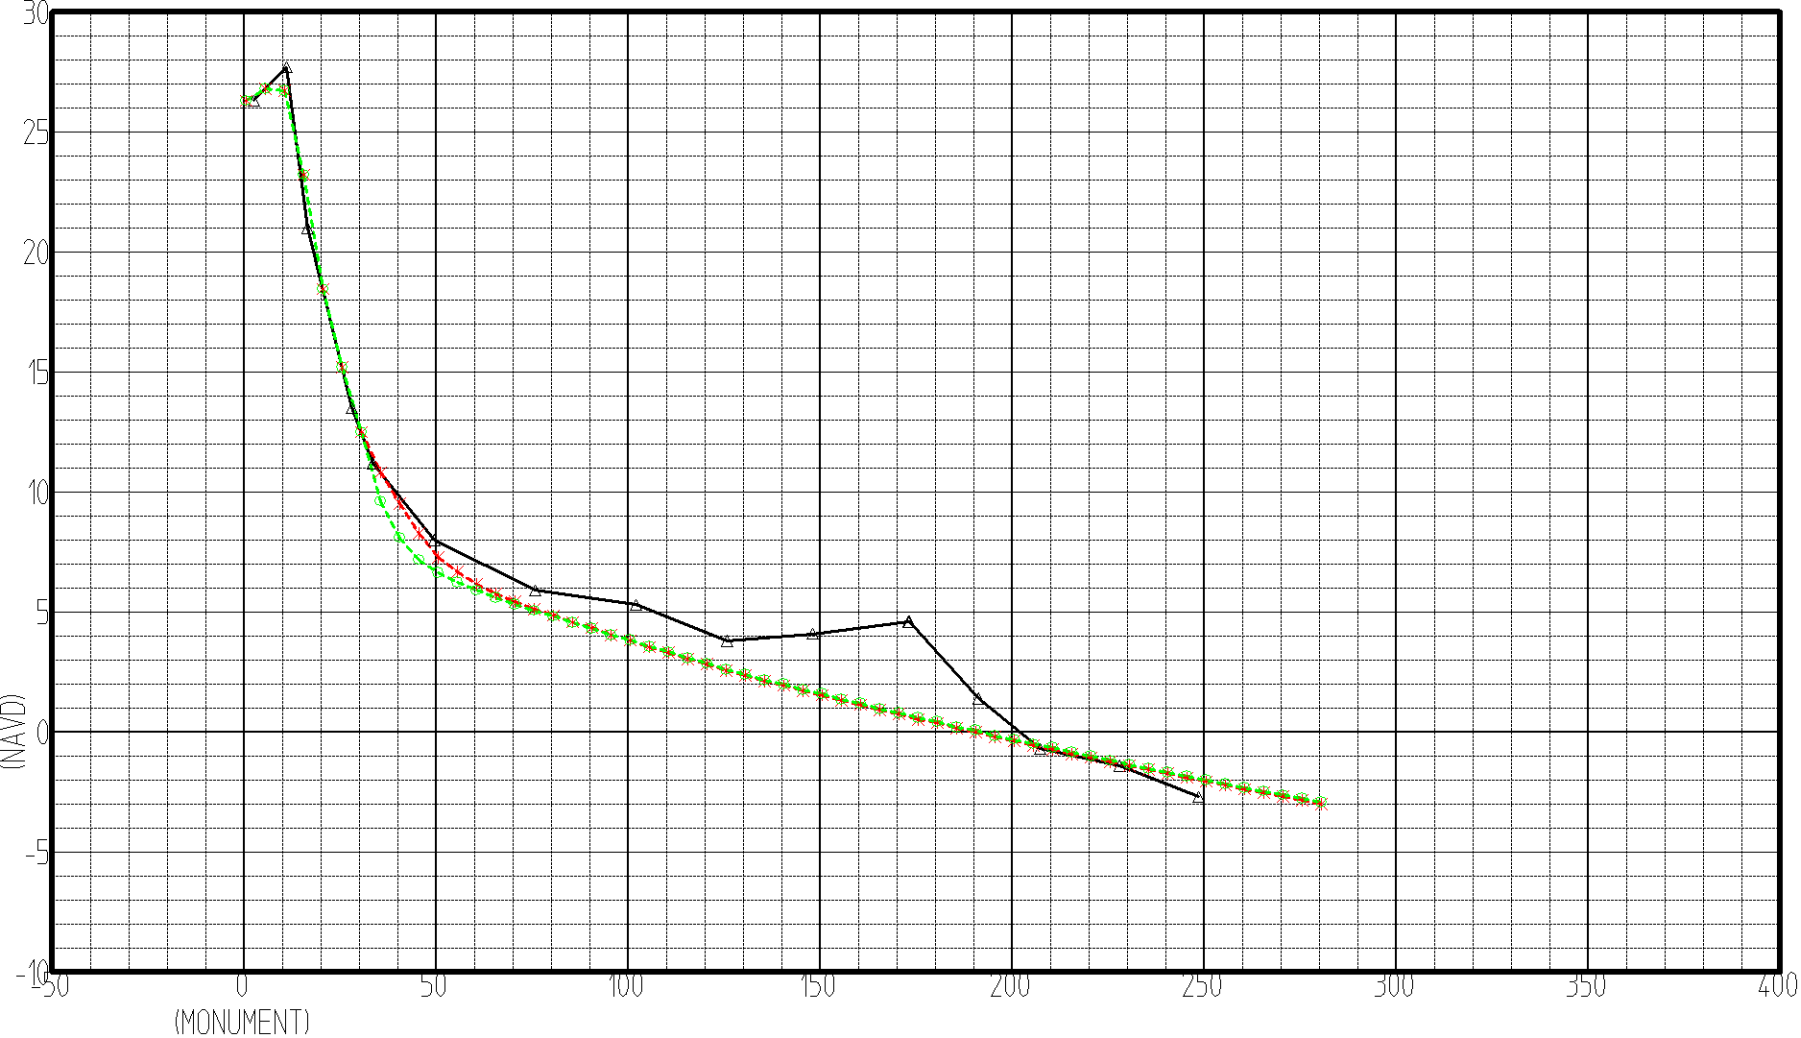
Range: R-54 1/1

BEACH PROFILE

- △—△— WALTON JULY 2007 PRF
- - - * - - - SBEACH 15-YR ERODED PRF
- - - o - - - SBEACH 25-YR ERODED PRF

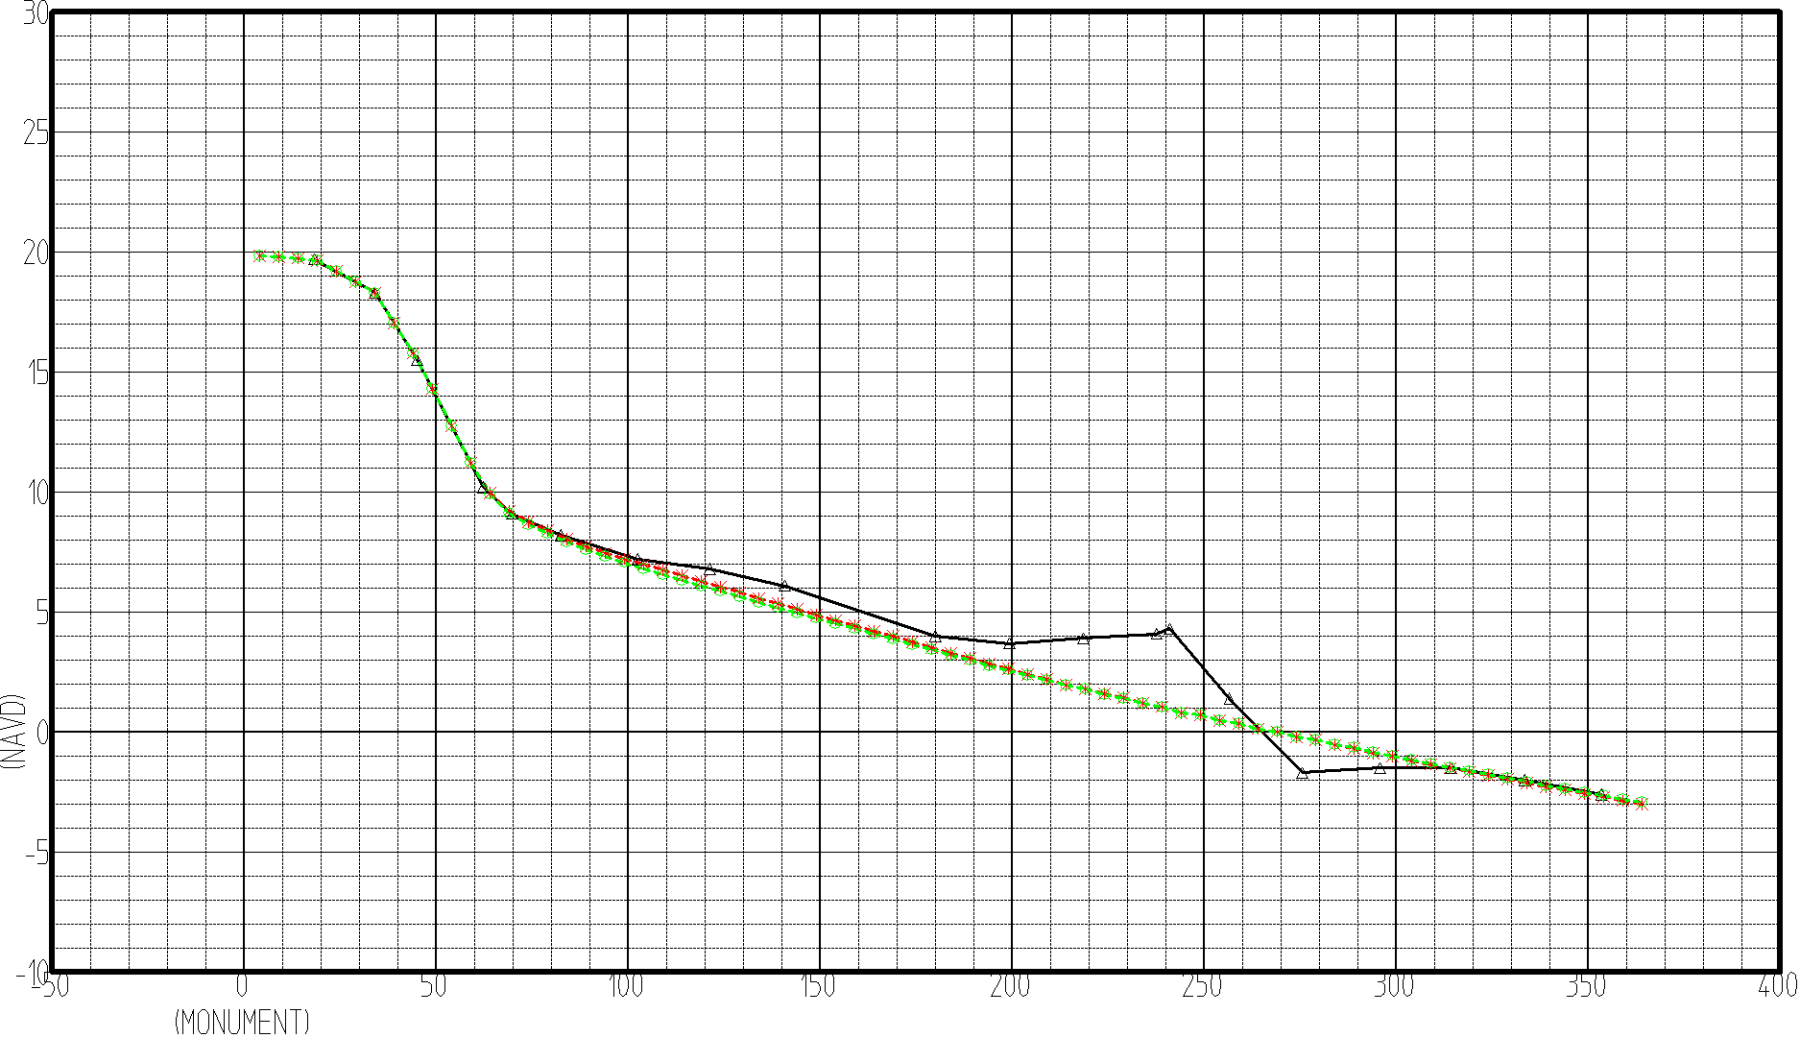
Range: R-55
 BEARING: 200.00
 1/1

BEACH PROFILE
 —△—△— WALTON JULY 2007 PRF
 - - * - - SBEACH 15-YR ERODED PRF
 - - o - - SBEACH 25-YR ERODED PRF

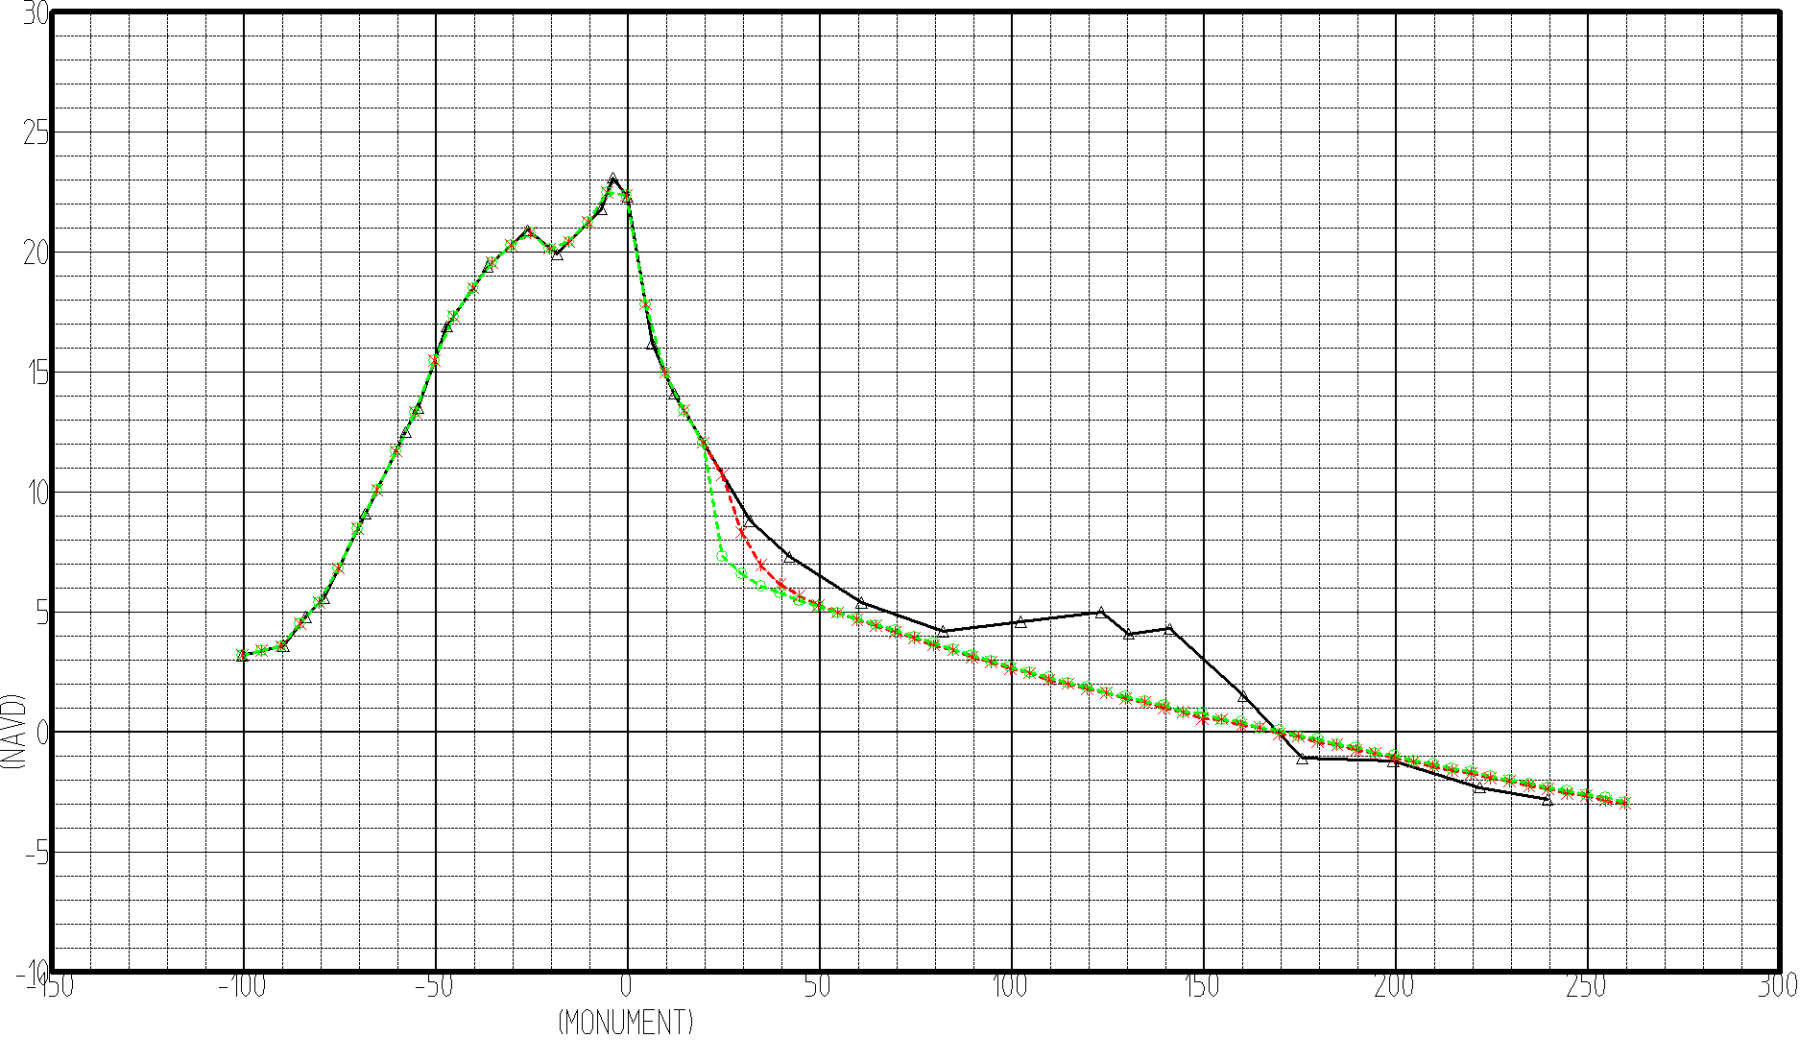
Range: R-56
 BEARING: 200.00
 1/1

BEACH PROFILE
 —△—△— WALTON JULY 2007 PRF
 - - * - - SBEACH 15-YR ERODED PRF
 - - o - - SBEACH 25-YR ERODED PRF

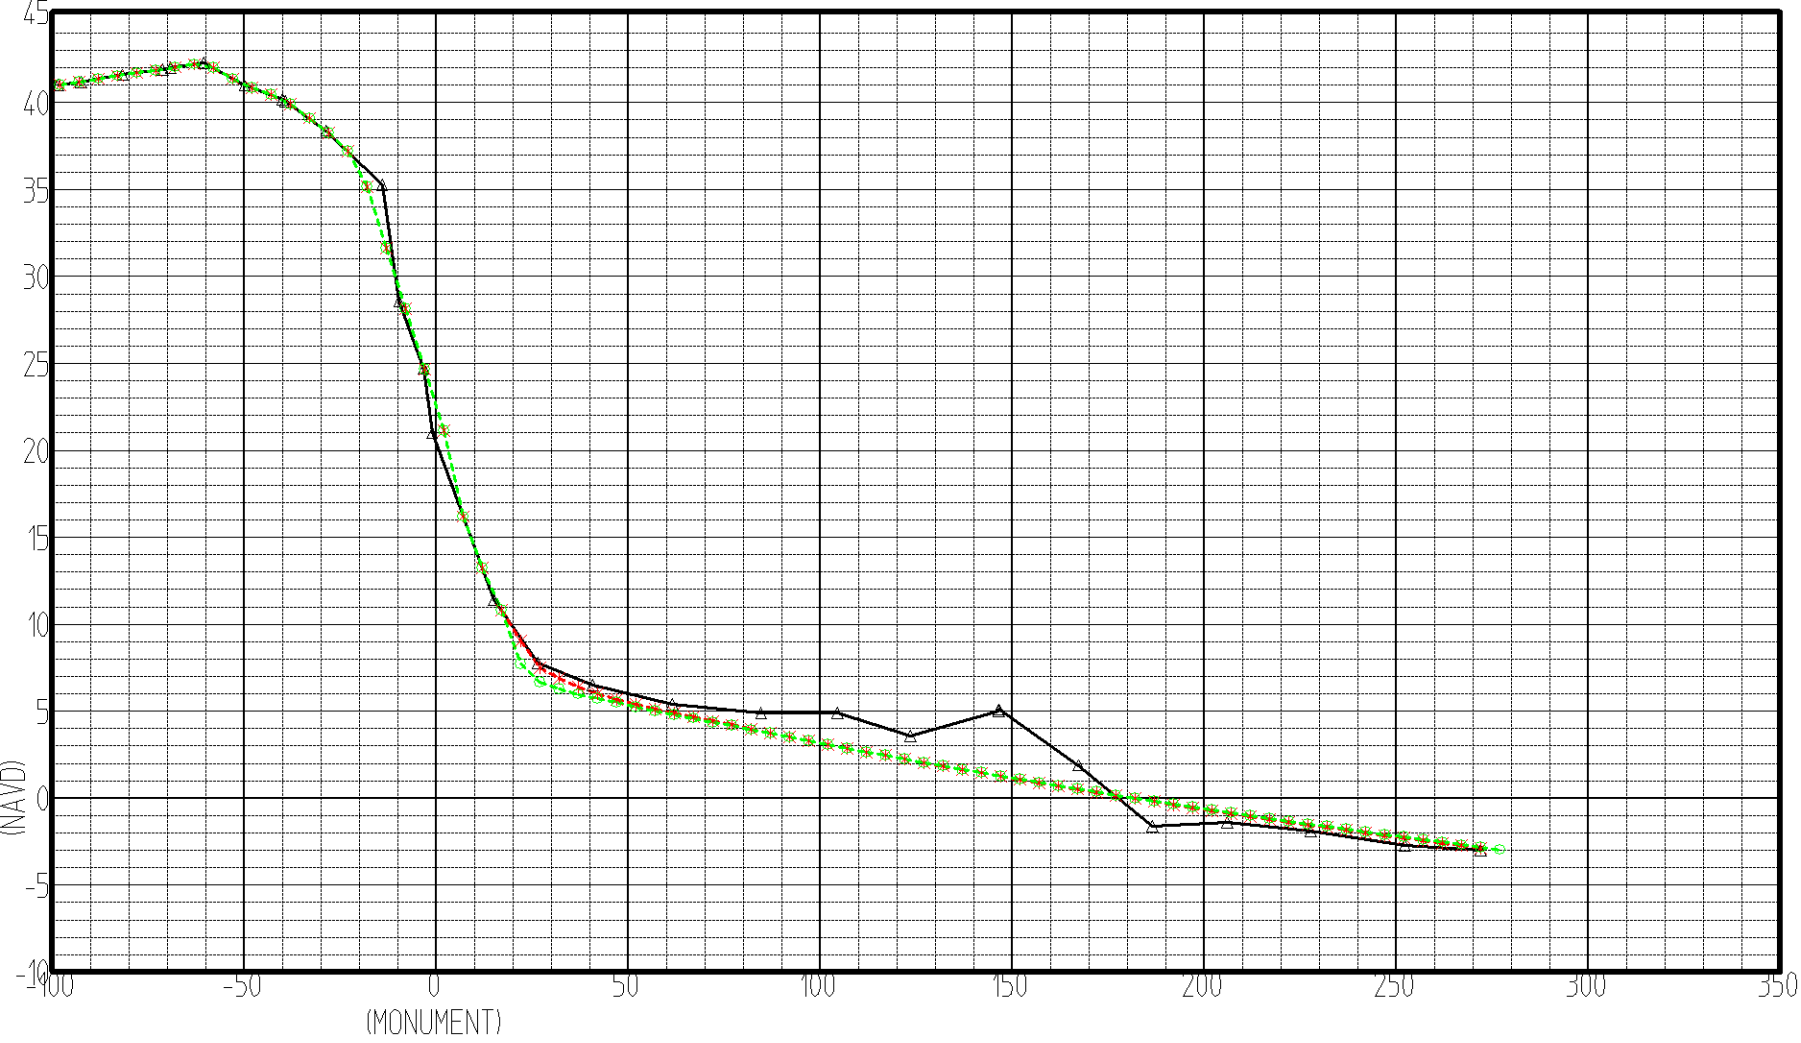
Range: R-57

BEACH PROFILE

—△—△— WALTON JULY 2007 PRF

- - - * - - - SBEACH 15-YR ERODED PRF

- - - o - - - SBEACH 25-YR ERODED PRF

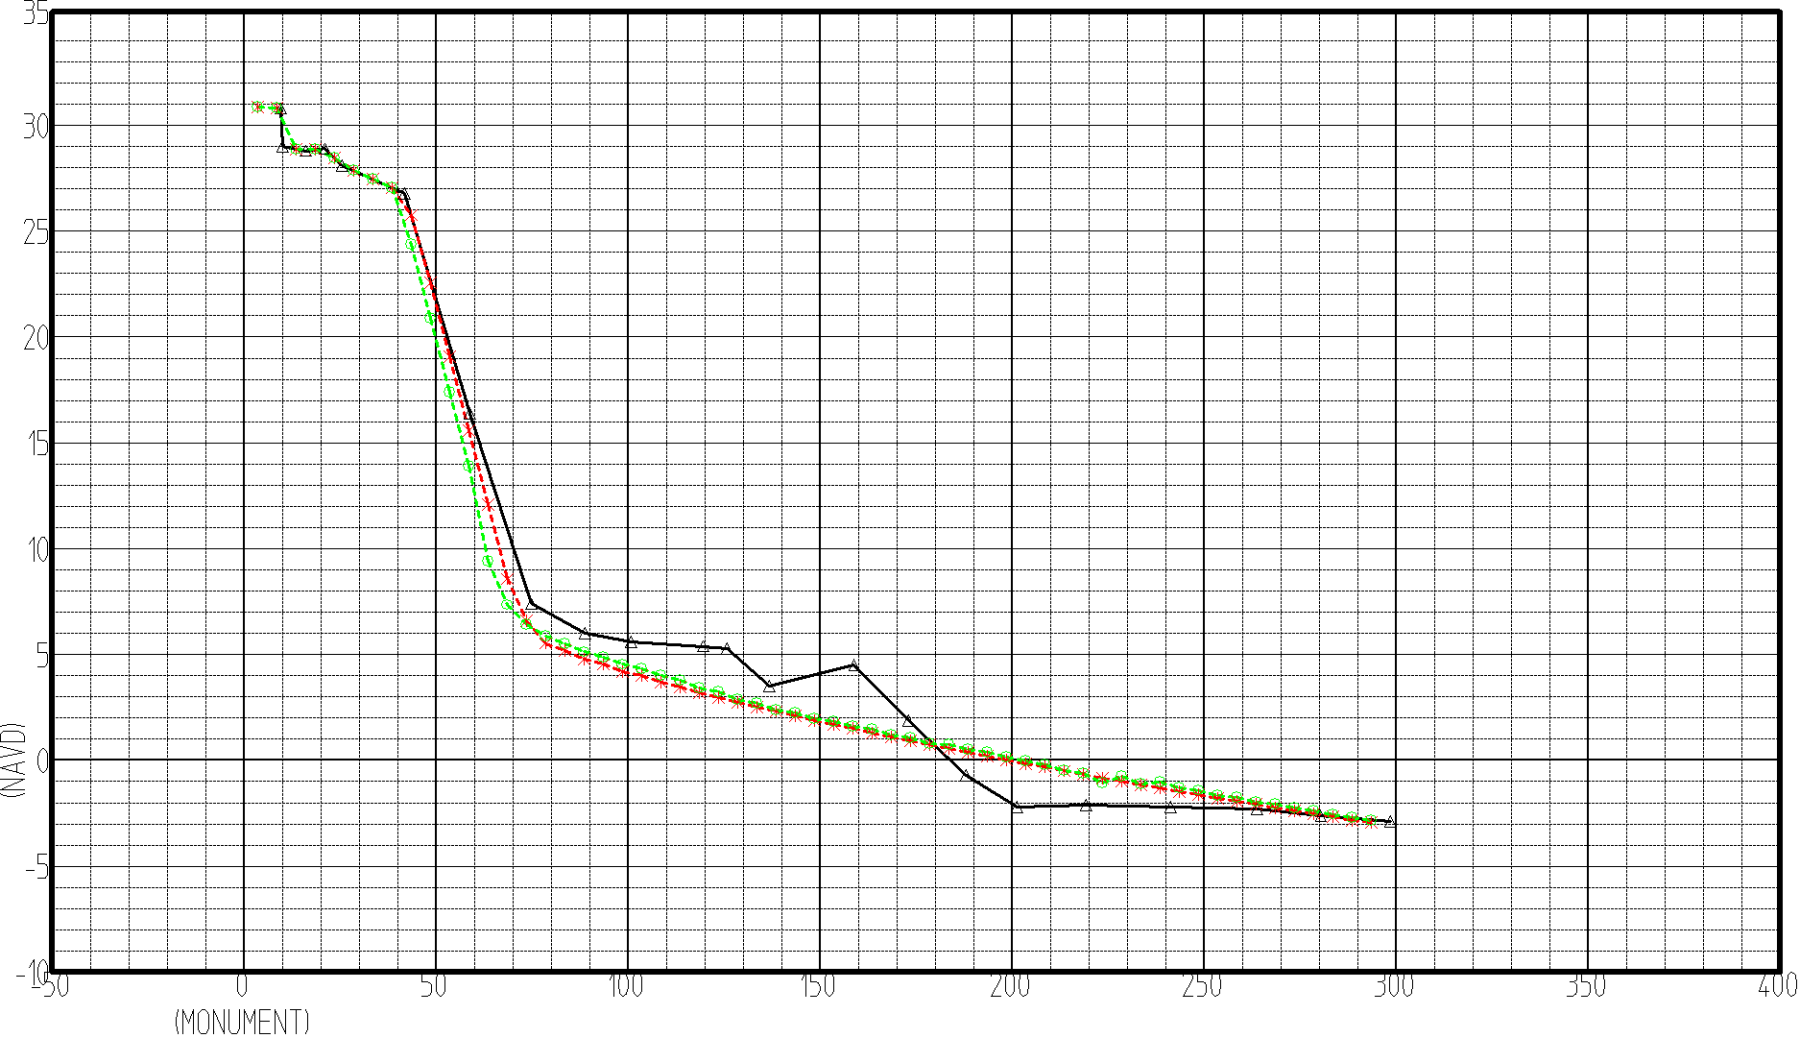
Range: R-58
 BEARING: 200.00
 1/1

BEACH PROFILE
 —△—△— WALTON JULY 2007 PRF
 - - * - - SBEACH 15-YR ERODED PRF
 - - o - - SBEACH 25-YR ERODED PRF

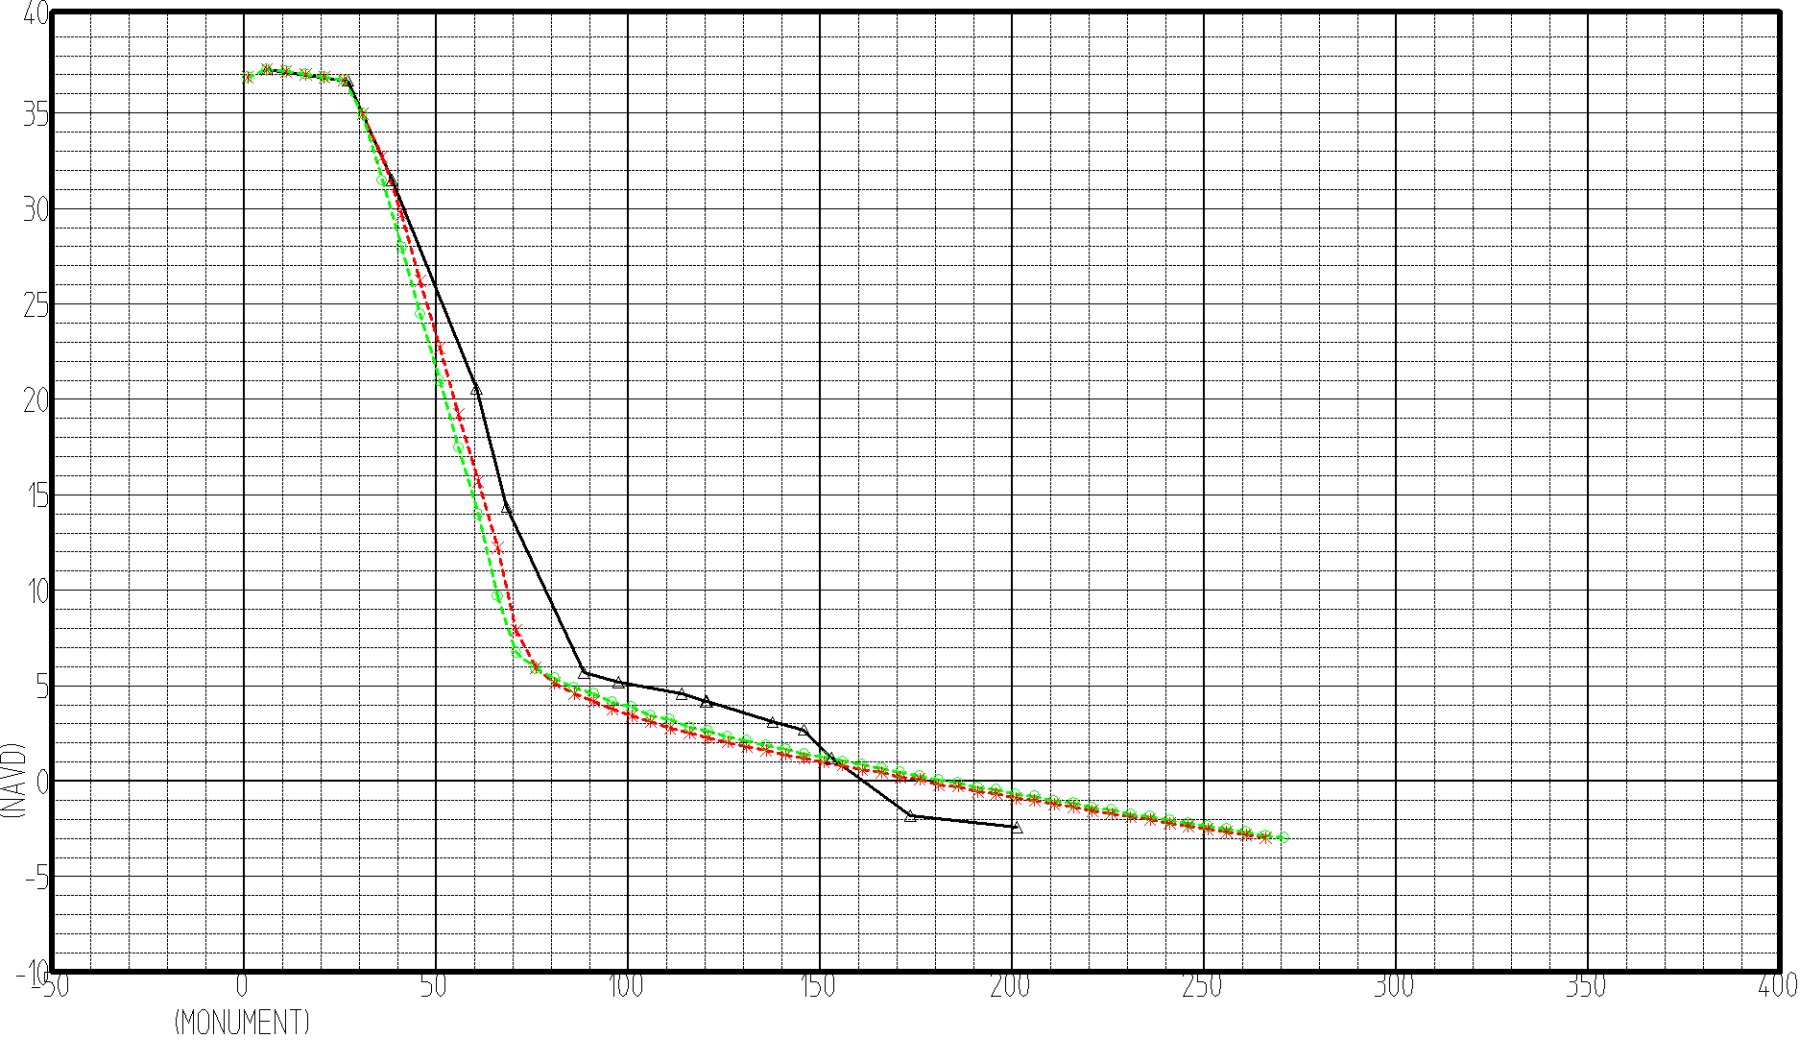
Range: R-59
 BEARING: 200.00
 1/1

BEACH PROFILE
 —△—△— WALTON JULY 2007 PRF
 - - * - - * - - SBEACH 15-YR ERODED PRF
 - - o - - o - - SBEACH 25-YR ERODED PRF

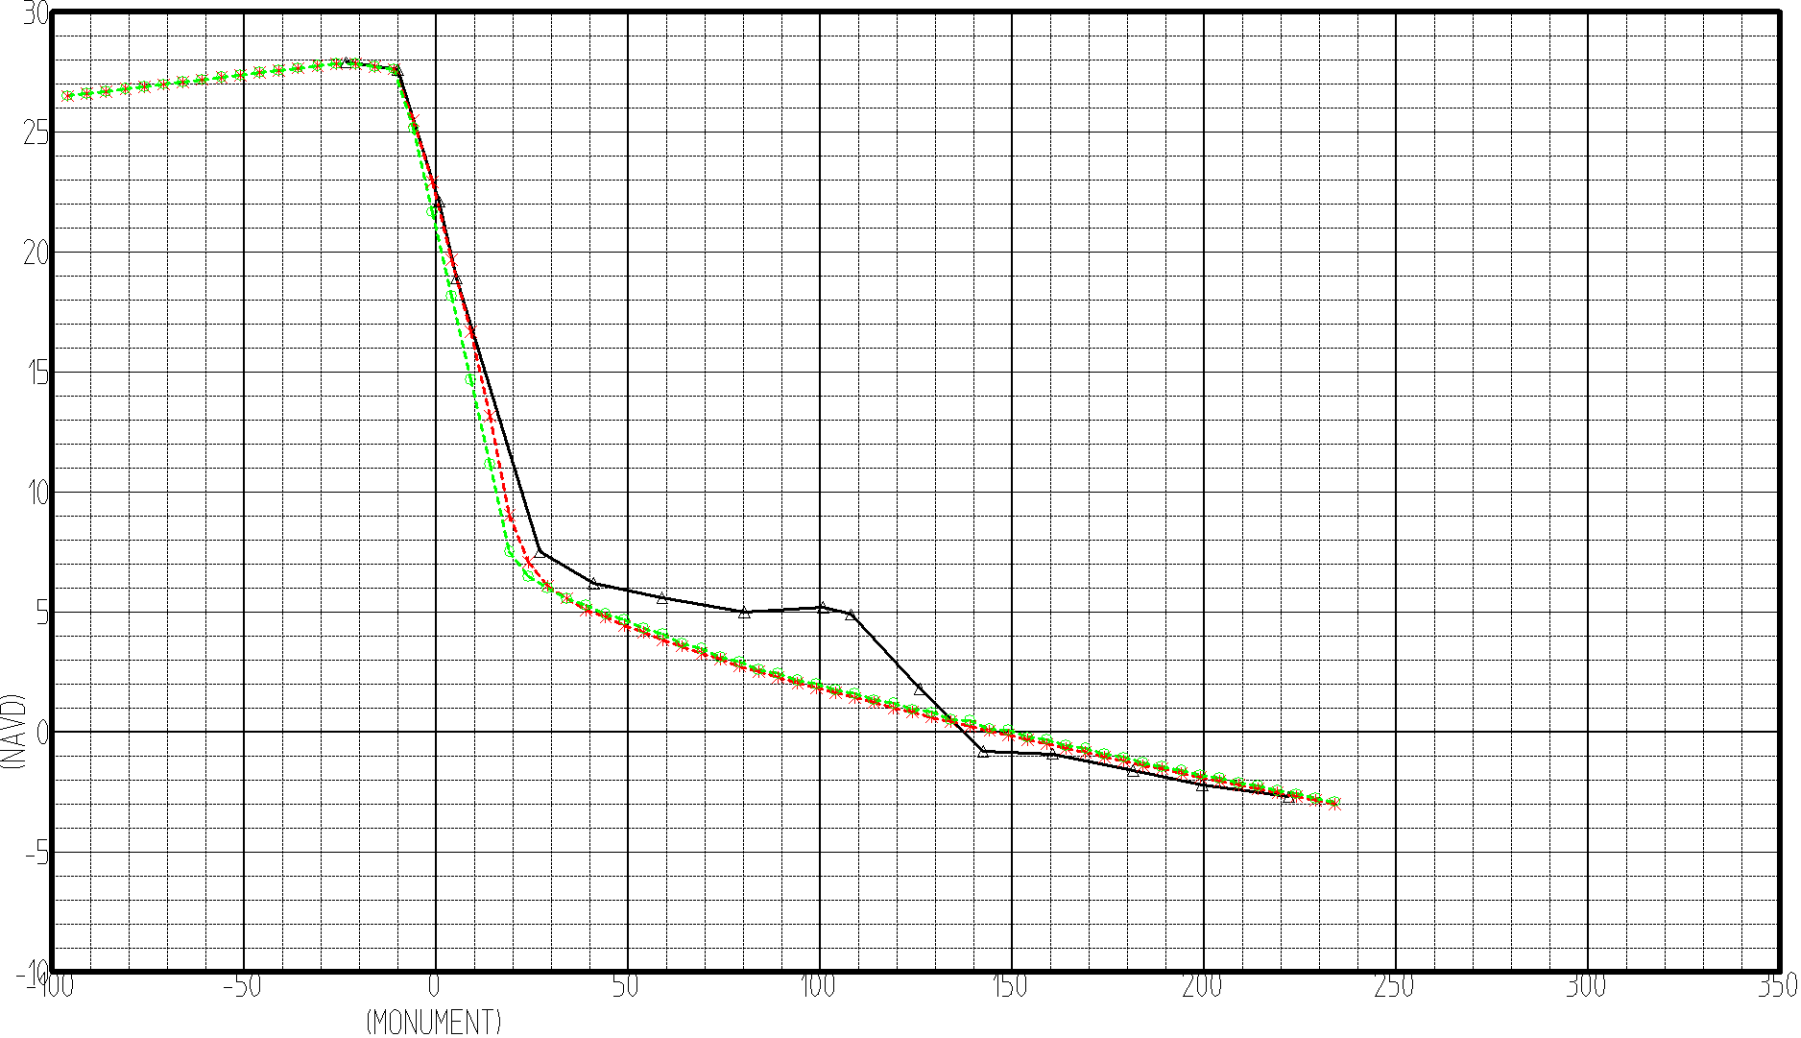
Range: R-60
 BEARING: 200.00
 1/1

BEACH PROFILE
 —△—△— WALTON JULY 2007 PRF
 - - * - - SBEACH 15-YR ERODED PRF
 - - o - - SBEACH 25-YR ERODED PRF

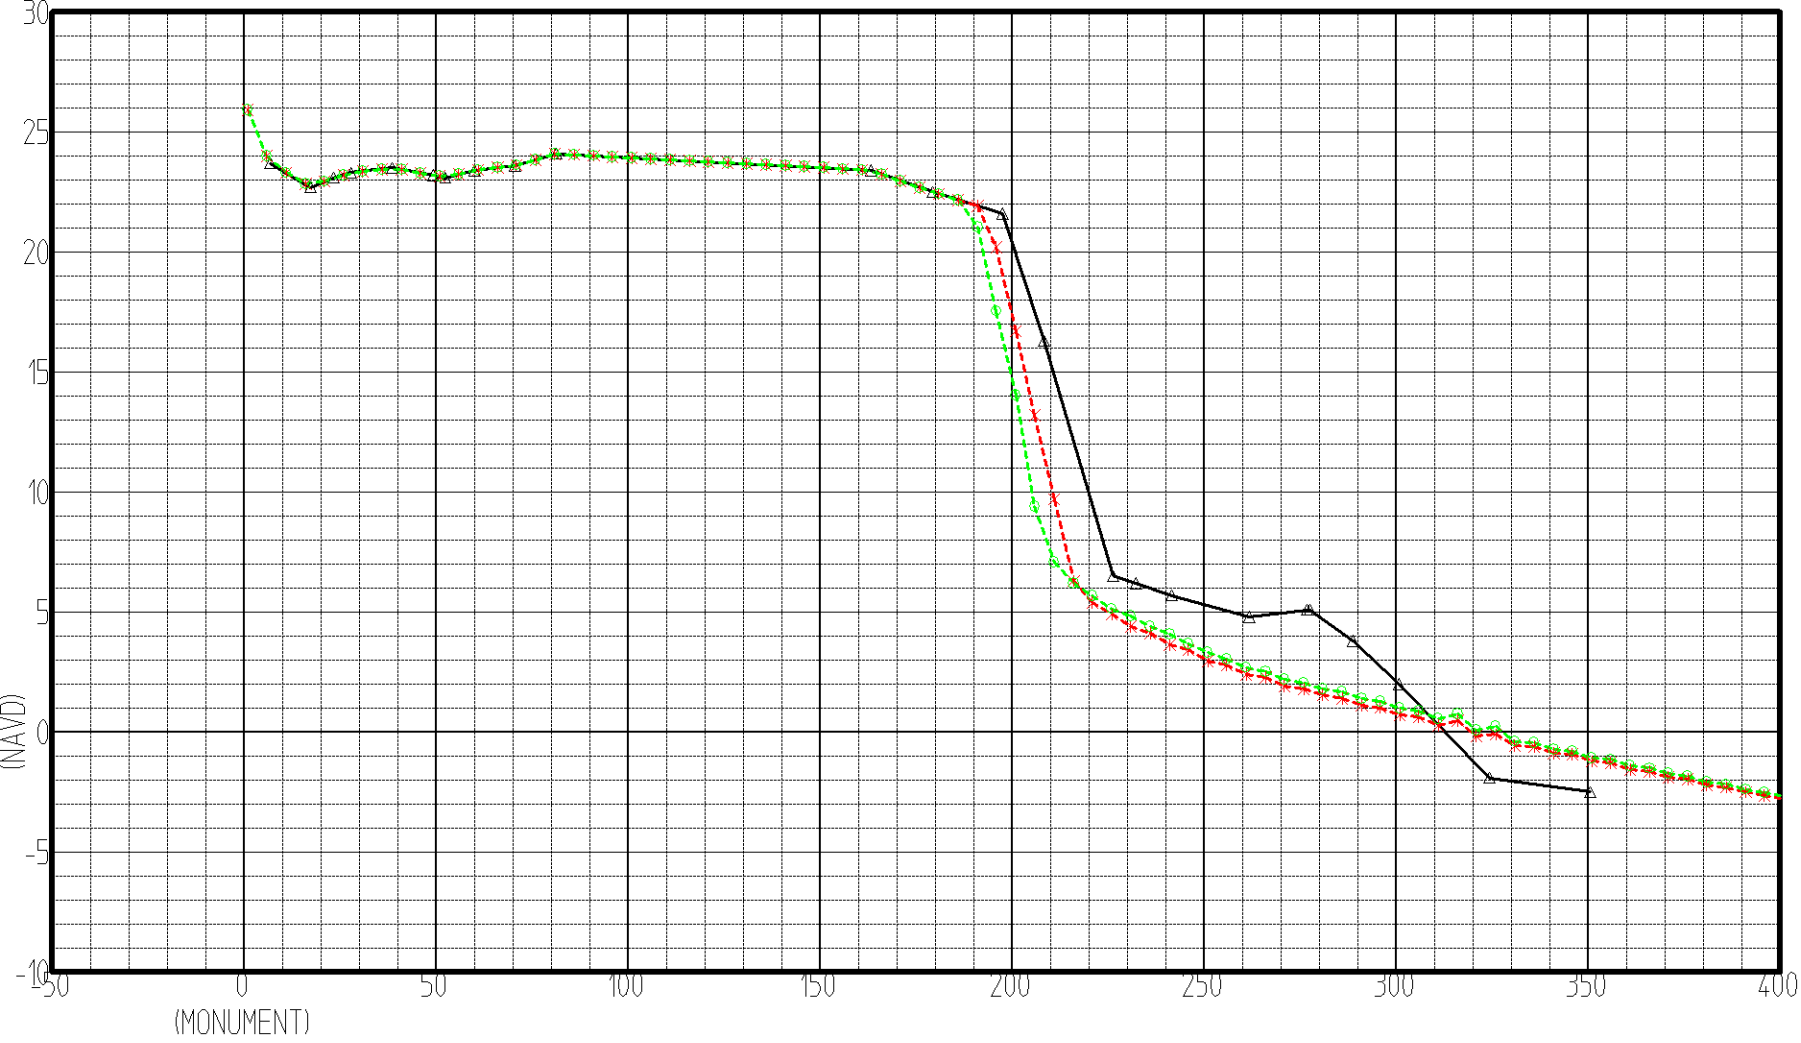
Range: R-61 1/2

BEACH PROFILE

—△—△— WALTON JULY 2007 PRF
 - - * - - * - - SBEACH 15-YR ERODED PRF
 - - o - - o - - SBEACH 25-YR ERODED PRF

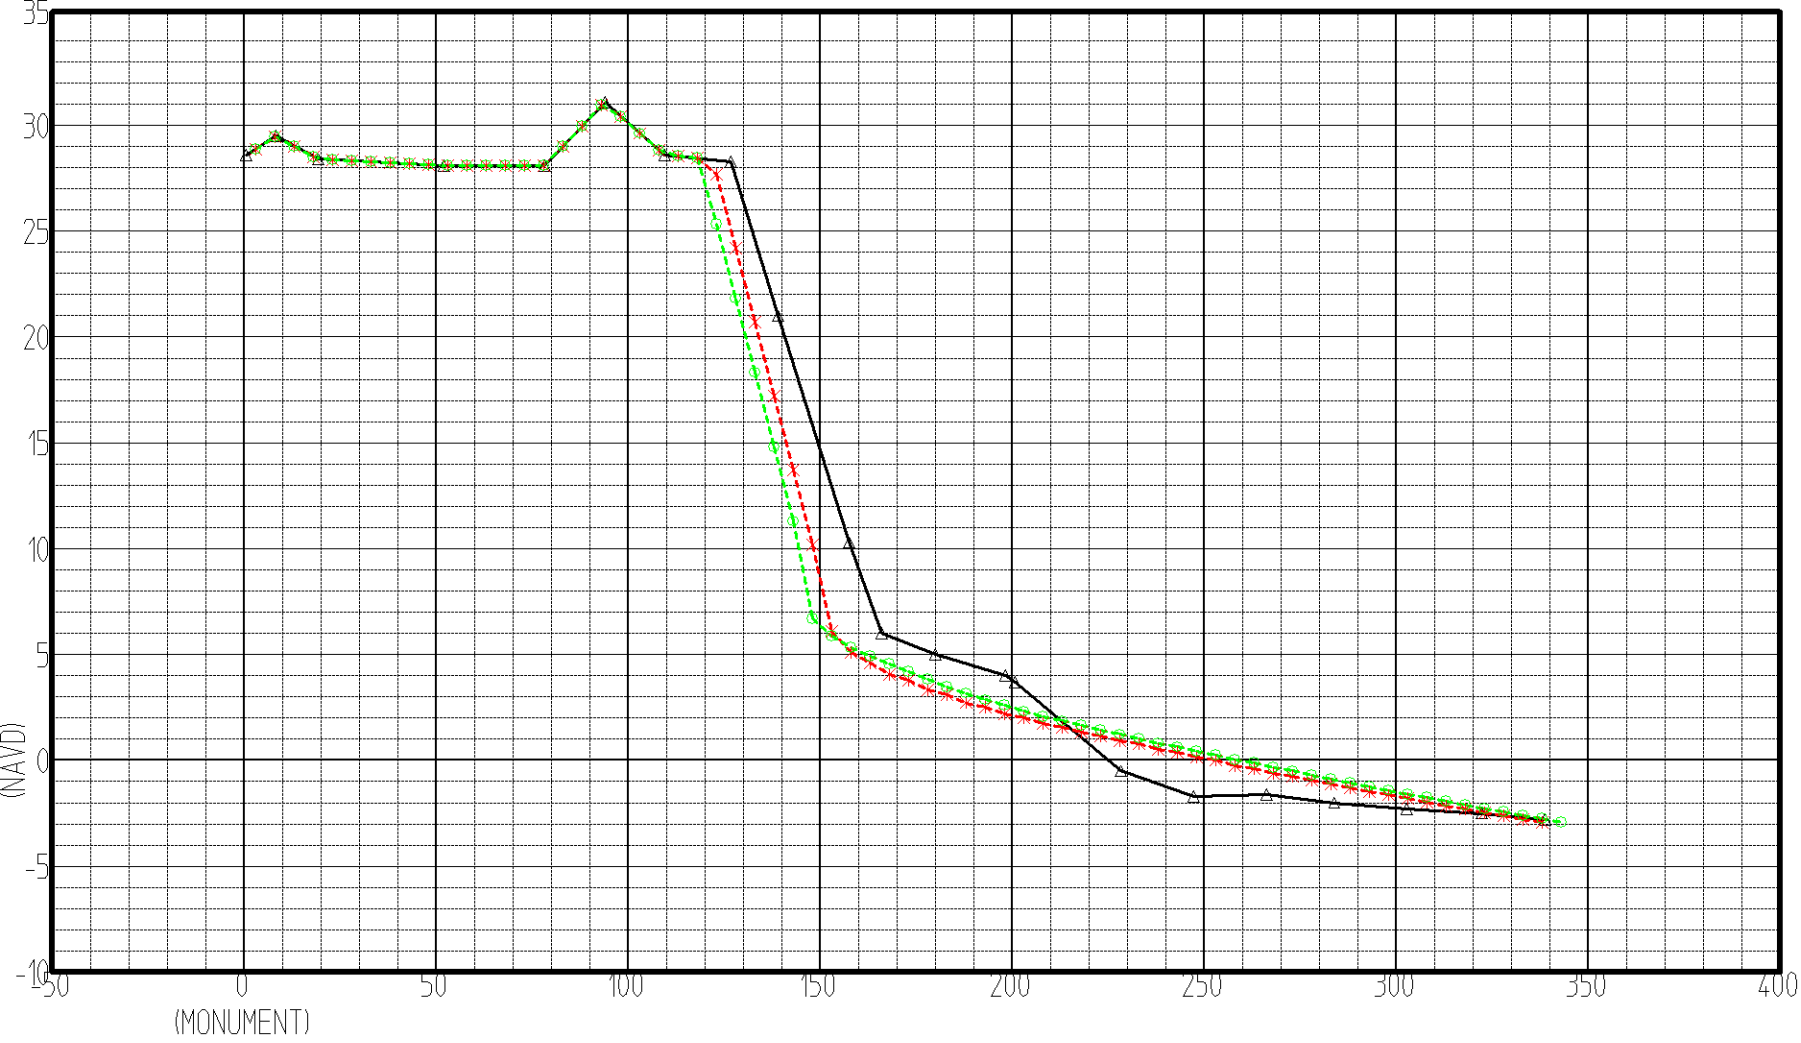
Range: R-62
 BEARING: 200.00
 1/1

BEACH PROFILE
 —△—△— WALTON JULY 2007 PRF
 - - * - - * - - SBEACH 15-YR ERODED PRF
 - - o - - o - - SBEACH 25-YR ERODED PRF

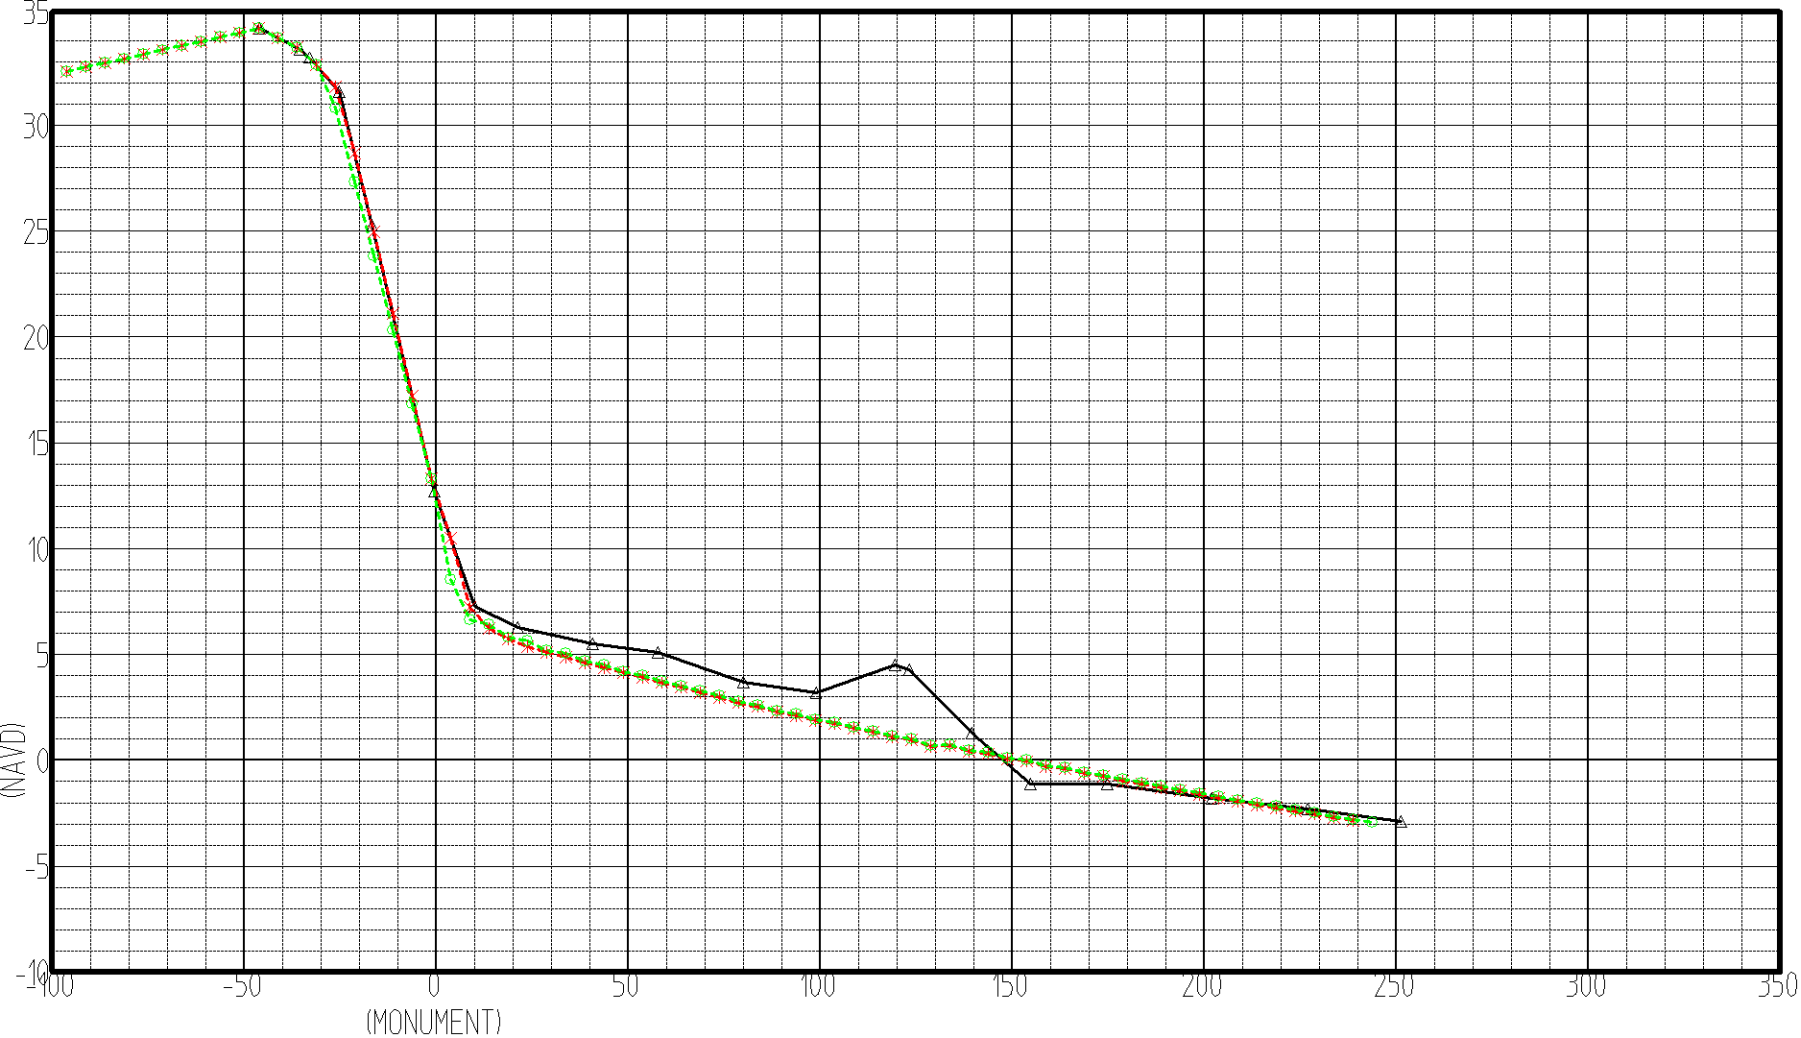
Range: R-63
 BEARING: 195.00
 1/1

BEACH PROFILE
 —△—△— WALTON JULY 2007 PRF
 - - * - - SBEACH 15-YR ERODED PRF
 - - o - - SBEACH 25-YR ERODED PRF

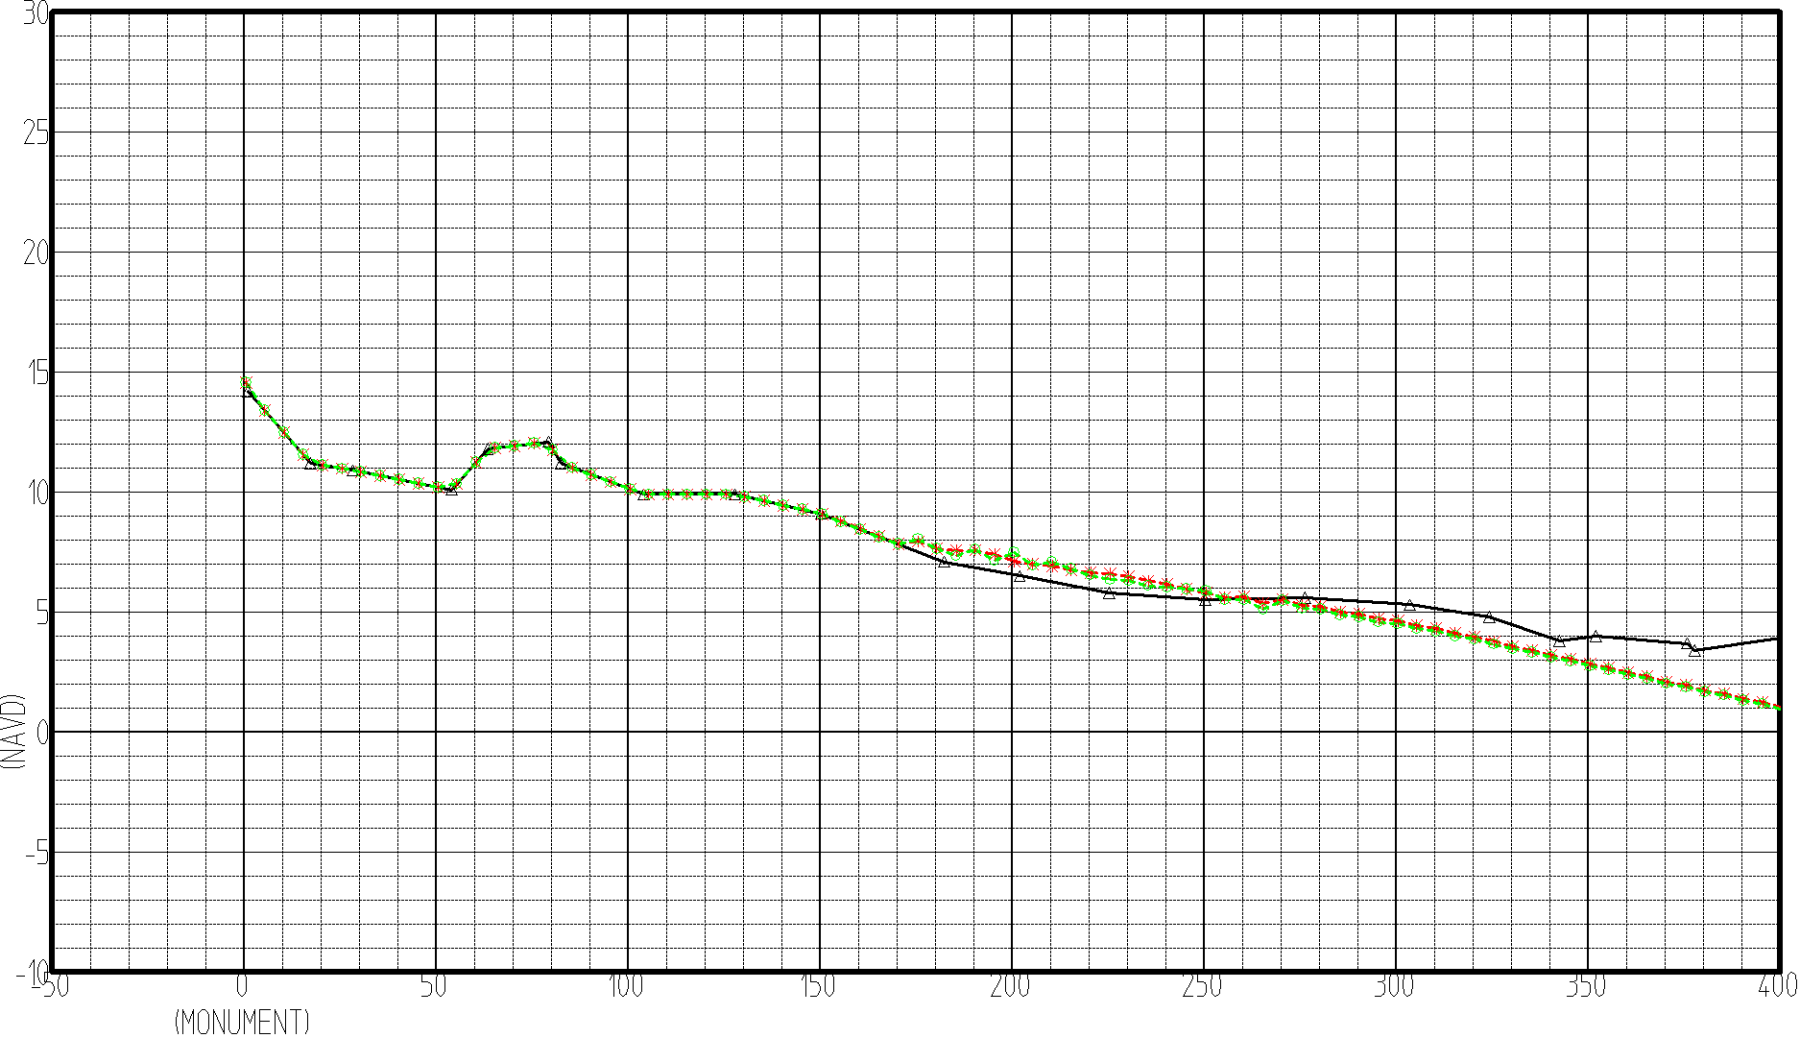
Range: R-64
 BEARING: 200.00
 1/2

BEACH PROFILE
 —△—△— WALTON JULY 2007 PRF
 - - * - - SBEACH 15-YR ERODED PRF
 - - o - - SBEACH 25-YR ERODED PRF

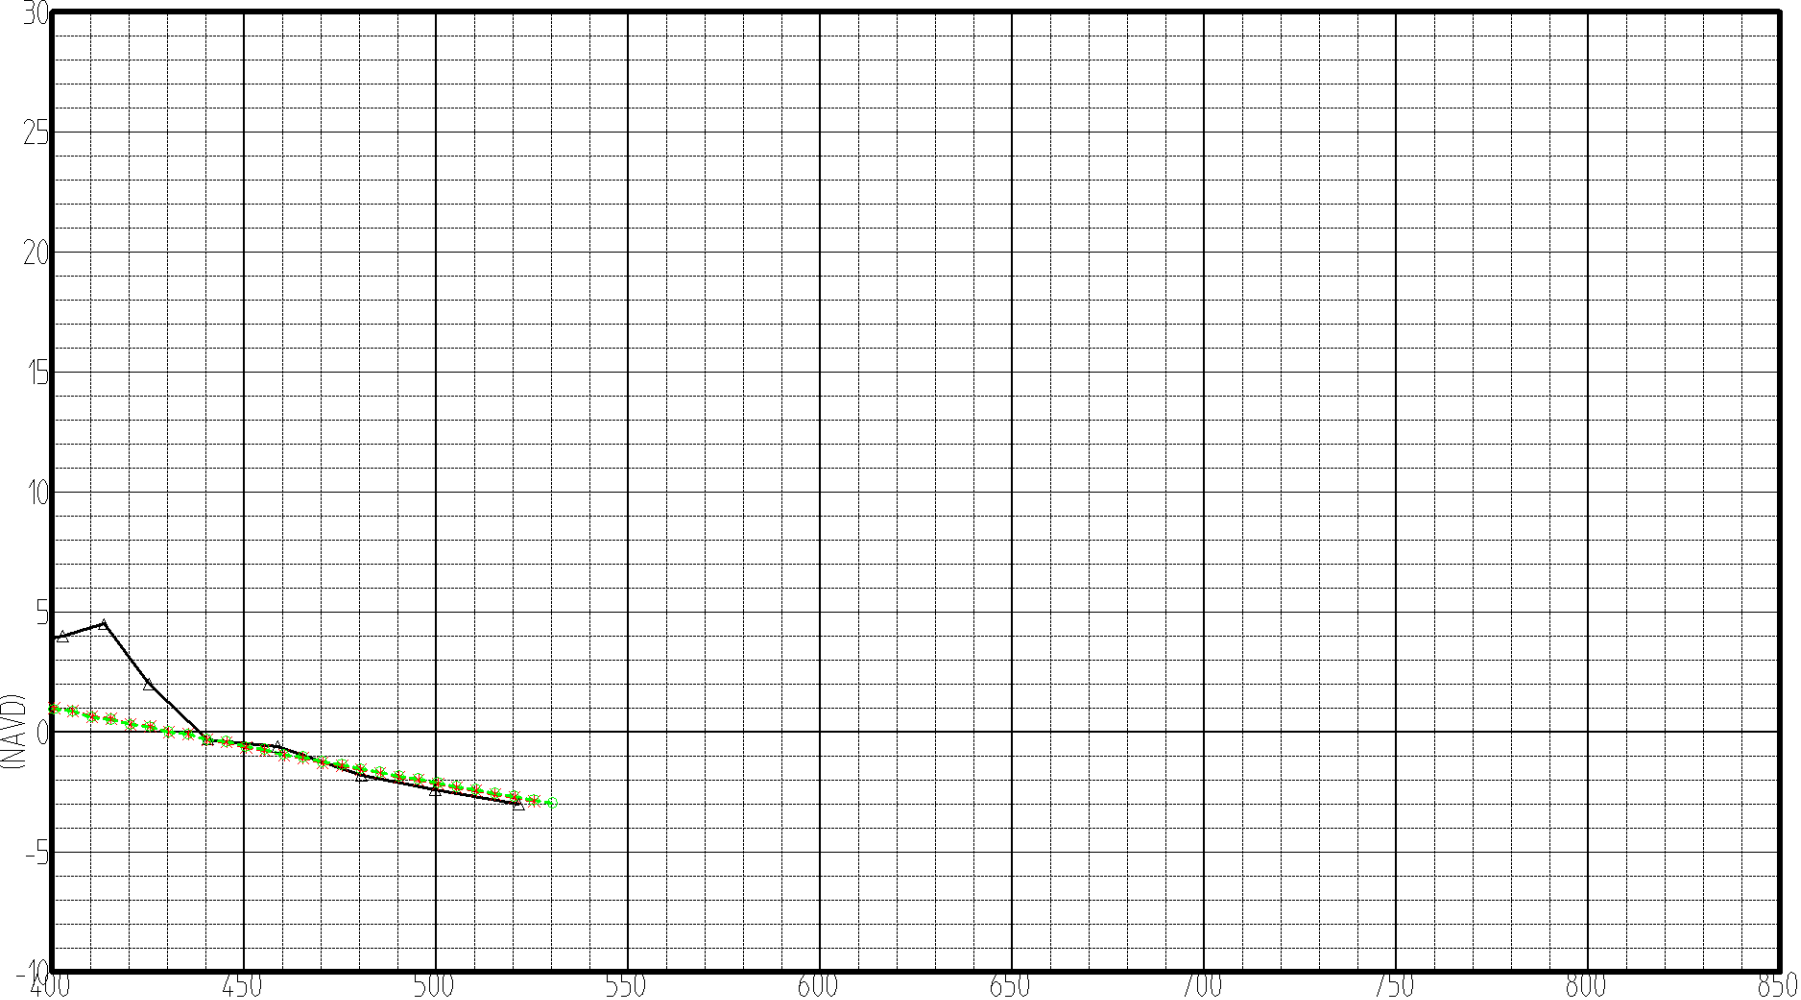
Range: R-64 2/2
 BEARING: 200.00

BEACH PROFILE
 —△—△— WALTON JULY 2007 PRF
 - - * - - SBEACH 15-YR ERODED PRF
 - - o - - SBEACH 25-YR ERODED PRF
