Appendix II

SBEACH Model Erosion Profile Plots

Walton County

15-year and 25-year Storm Events

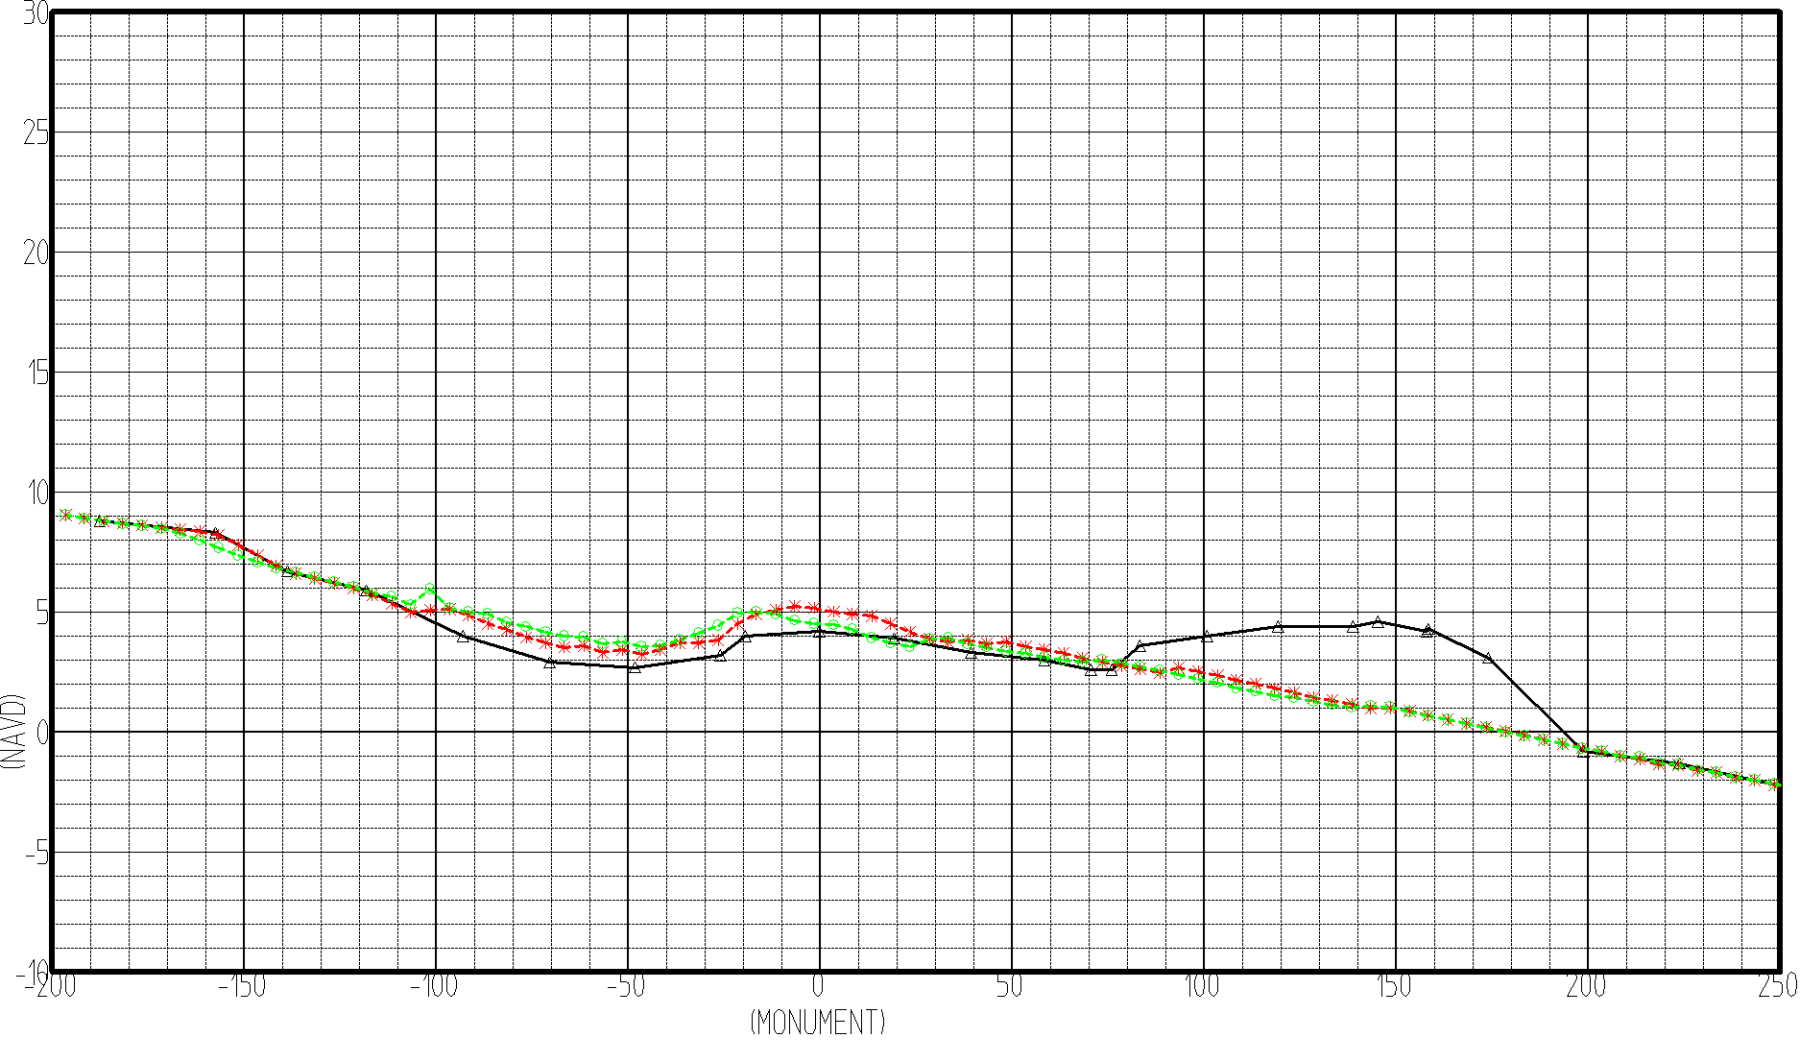
Range: R-65
 BEARING: 200.00
 1/2

BEACH PROFILE
 —△—△— WALTON JULY 2007 PRF
 - - * - - SBEACH 15-YR ERODED PRF
 - - o - - SBEACH 25-YR ERODED PRF

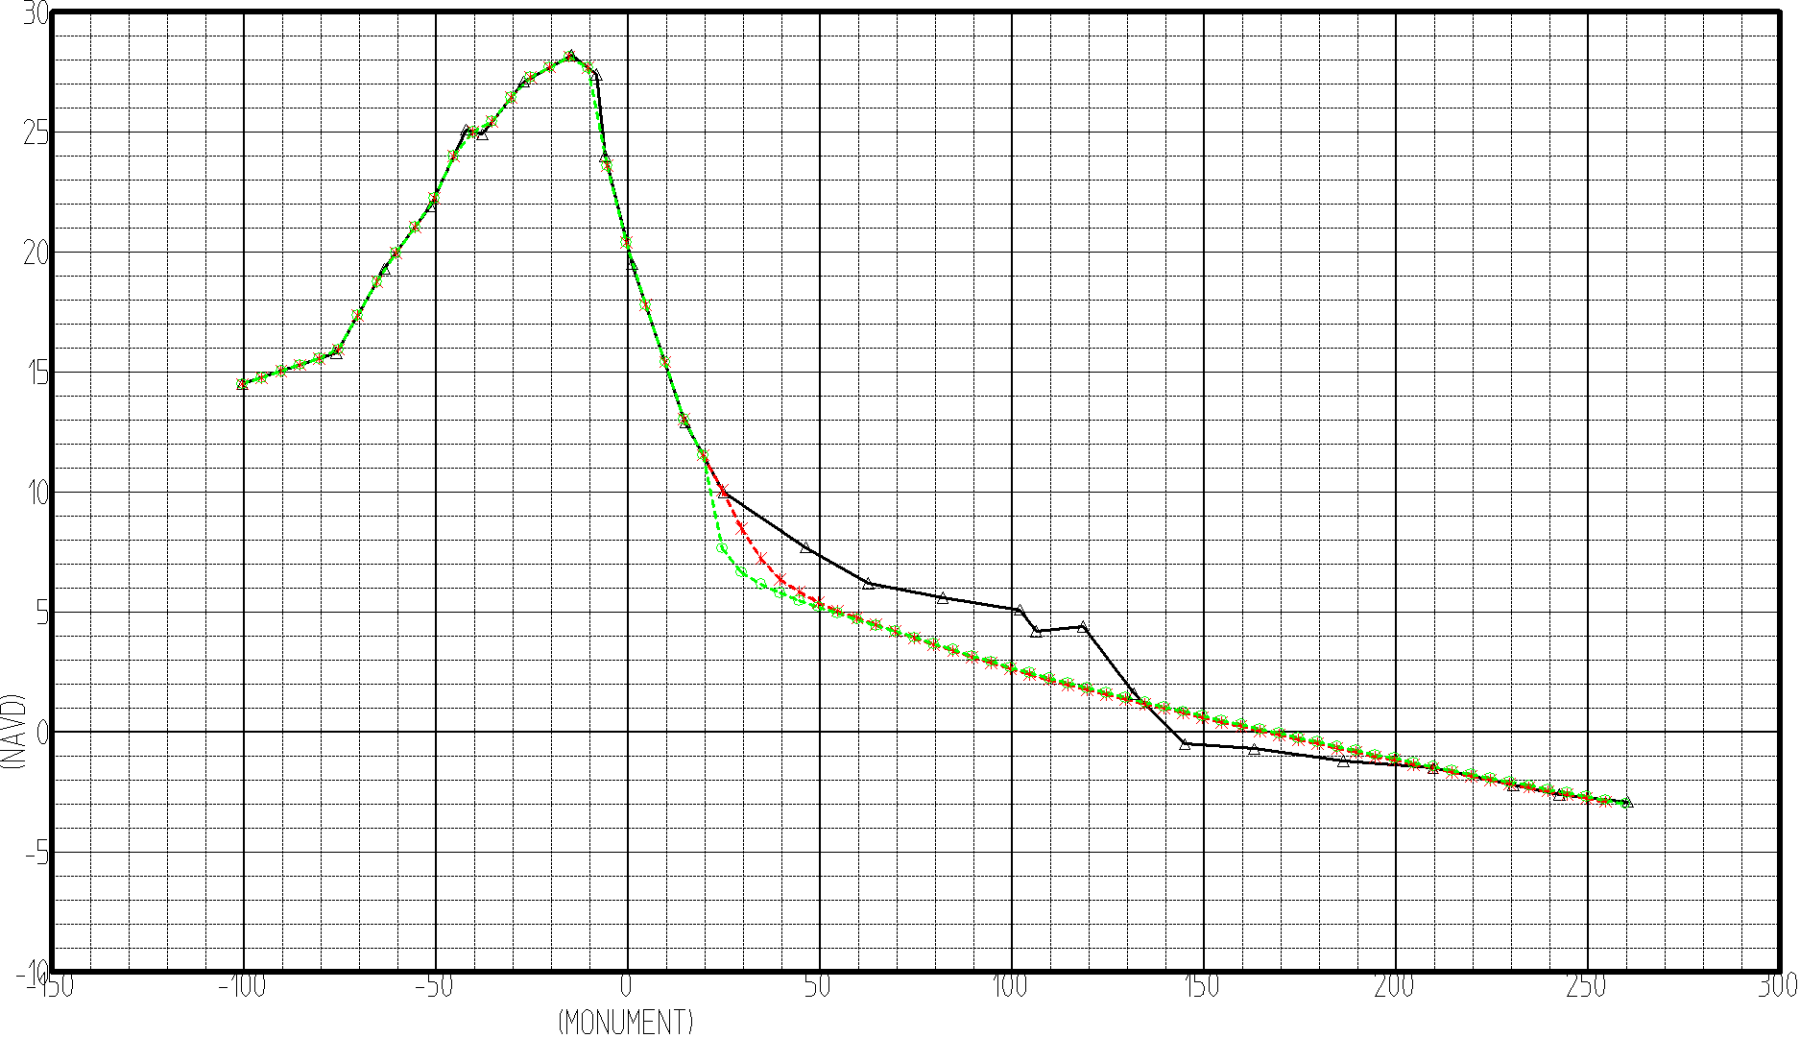
Range: R-66
 BEARING: 200.00
 1/1

BEACH PROFILE
 —△—△— WALTON JULY 2007 PRF
 - - * - - SBEACH 15-YR ERODED PRF
 - - o - - SBEACH 25-YR ERODED PRF

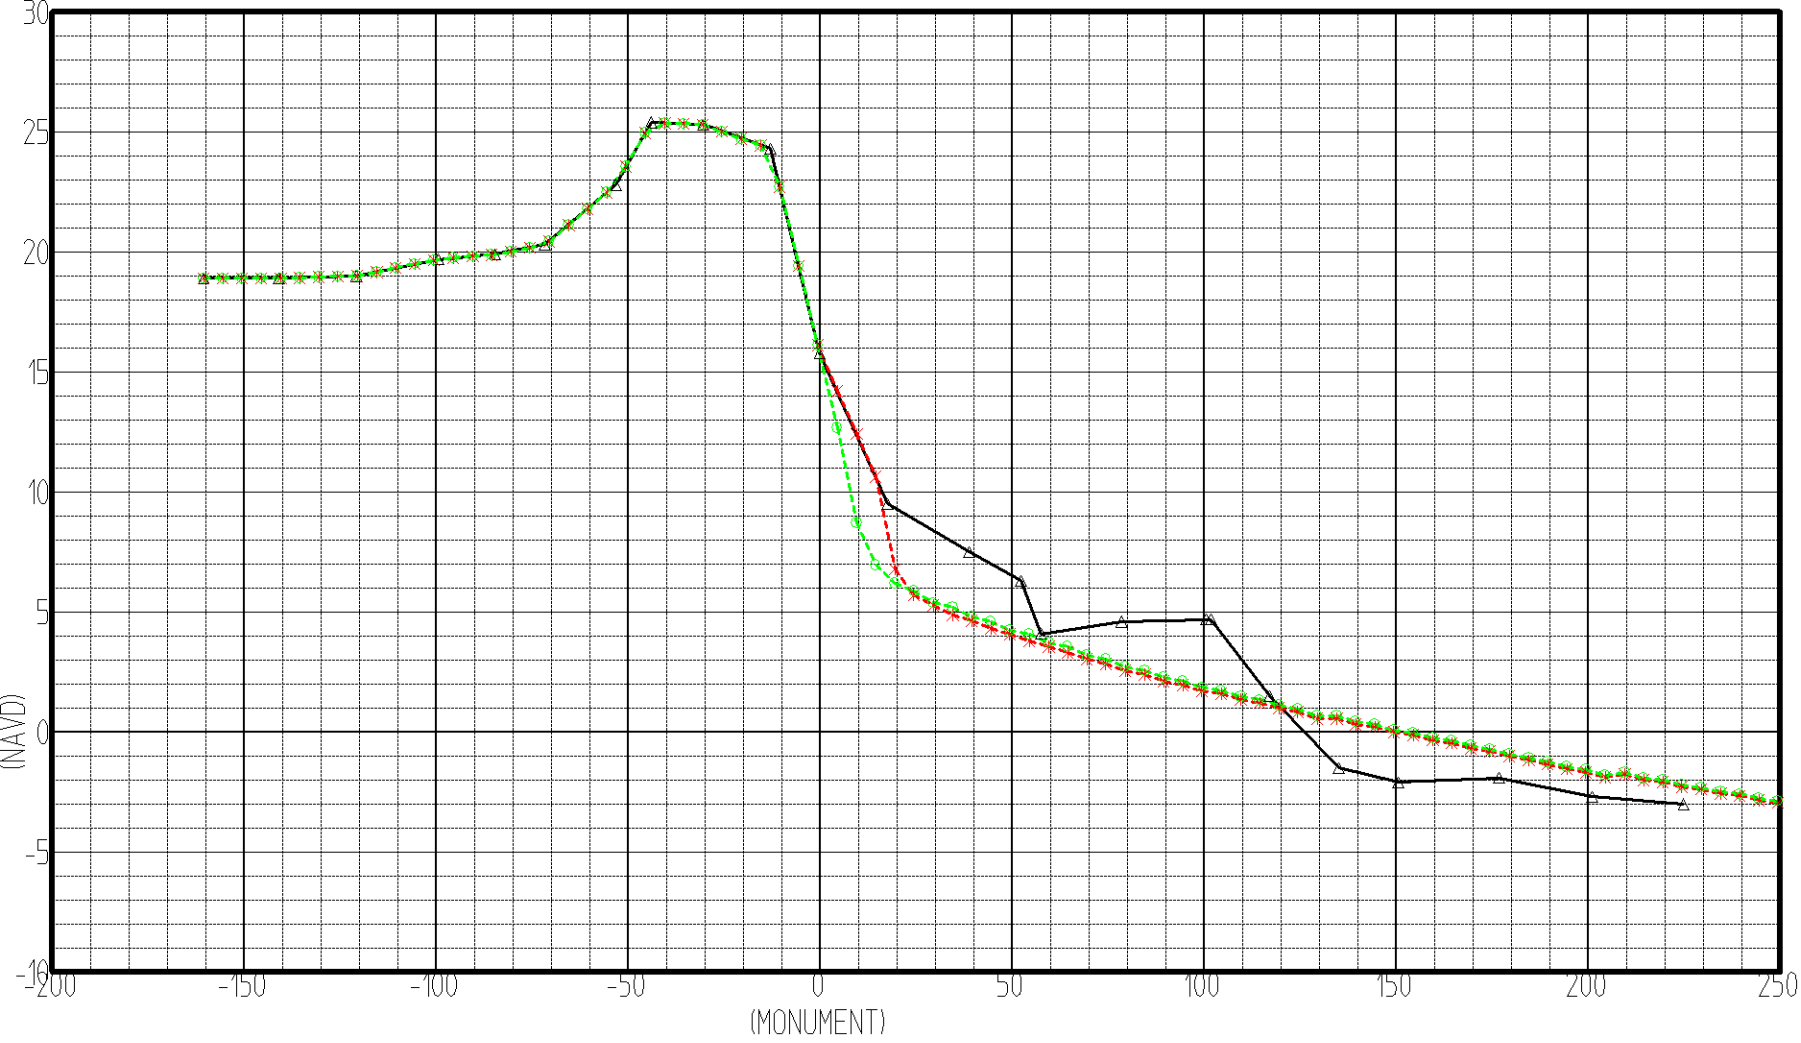
Range: R-67

BEACH PROFILE

—△—△— WALTON JULY 2007 PRF

- - * - - SBEACH 15-YR ERODED PRF

- - o - - SBEACH 25-YR ERODED PRF

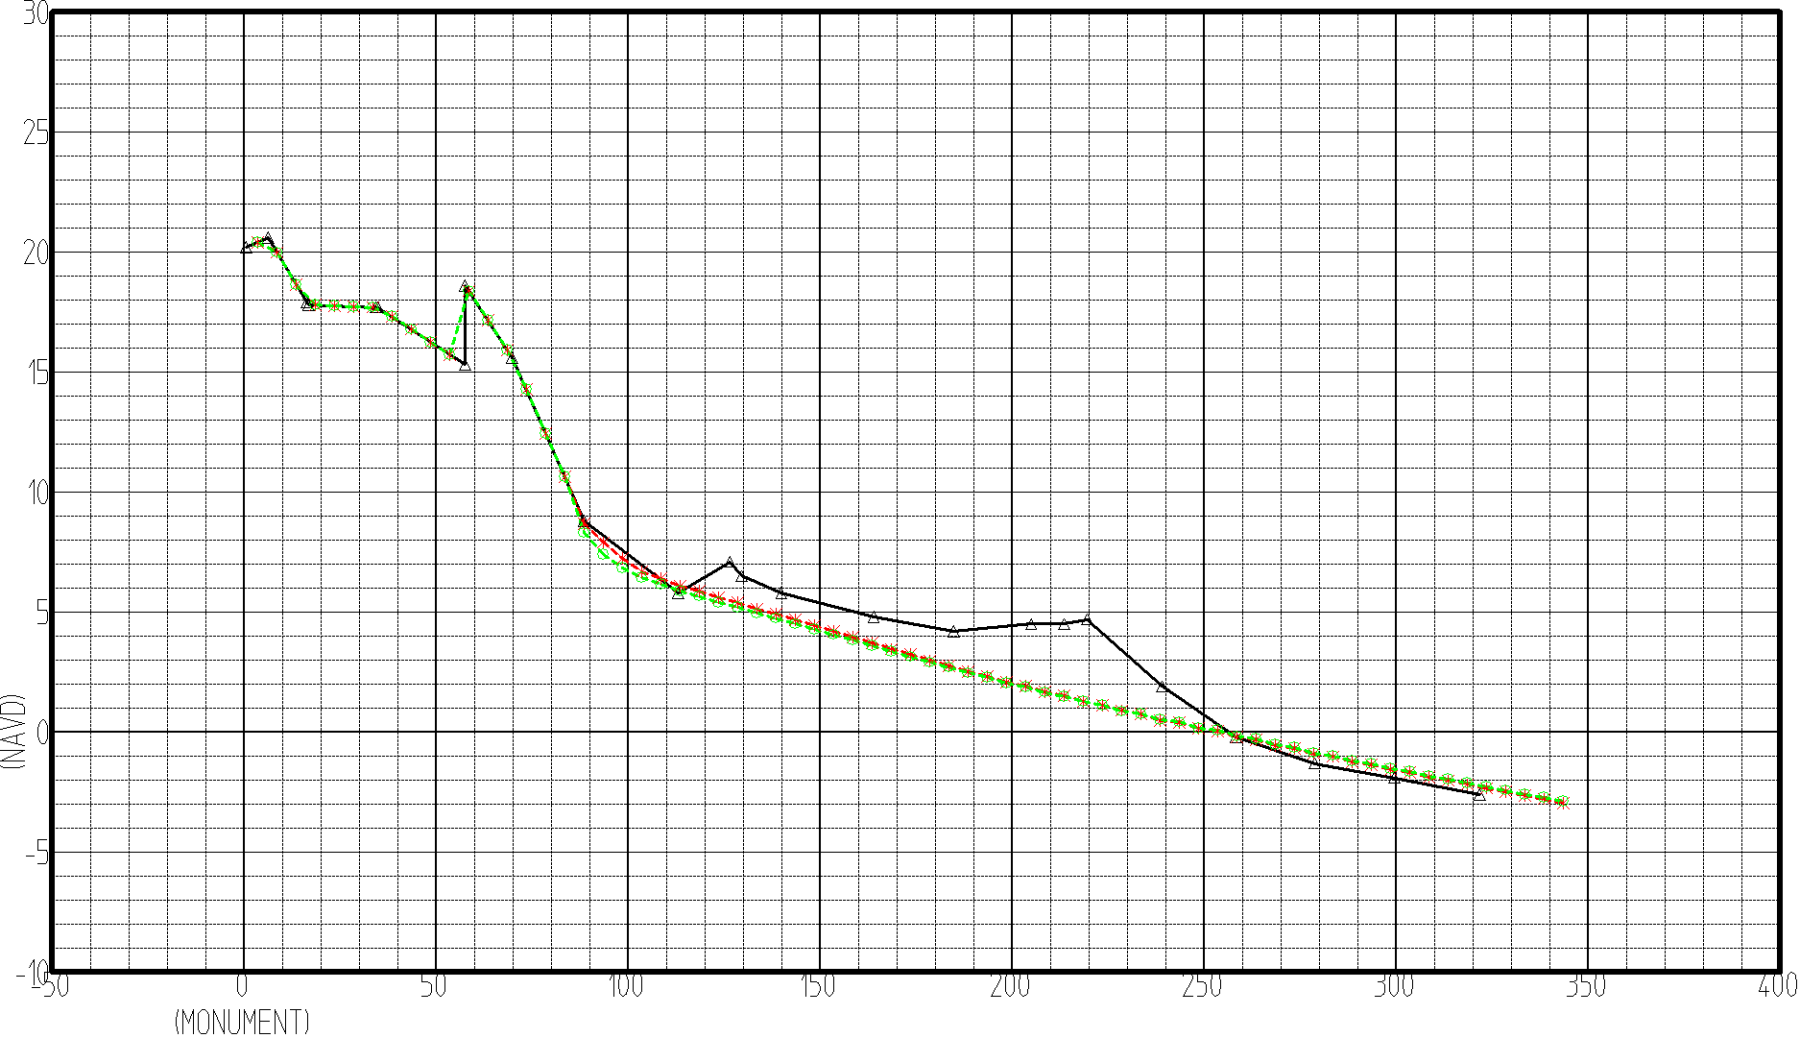
Range: R-68
 BEARING: 200.00
 1/1

BEACH PROFILE
 —△—△— WALTON JULY 2007 PRF
 - - * - - SBEACH 15-YR ERODED PRF
 - - o - - SBEACH 25-YR ERODED PRF

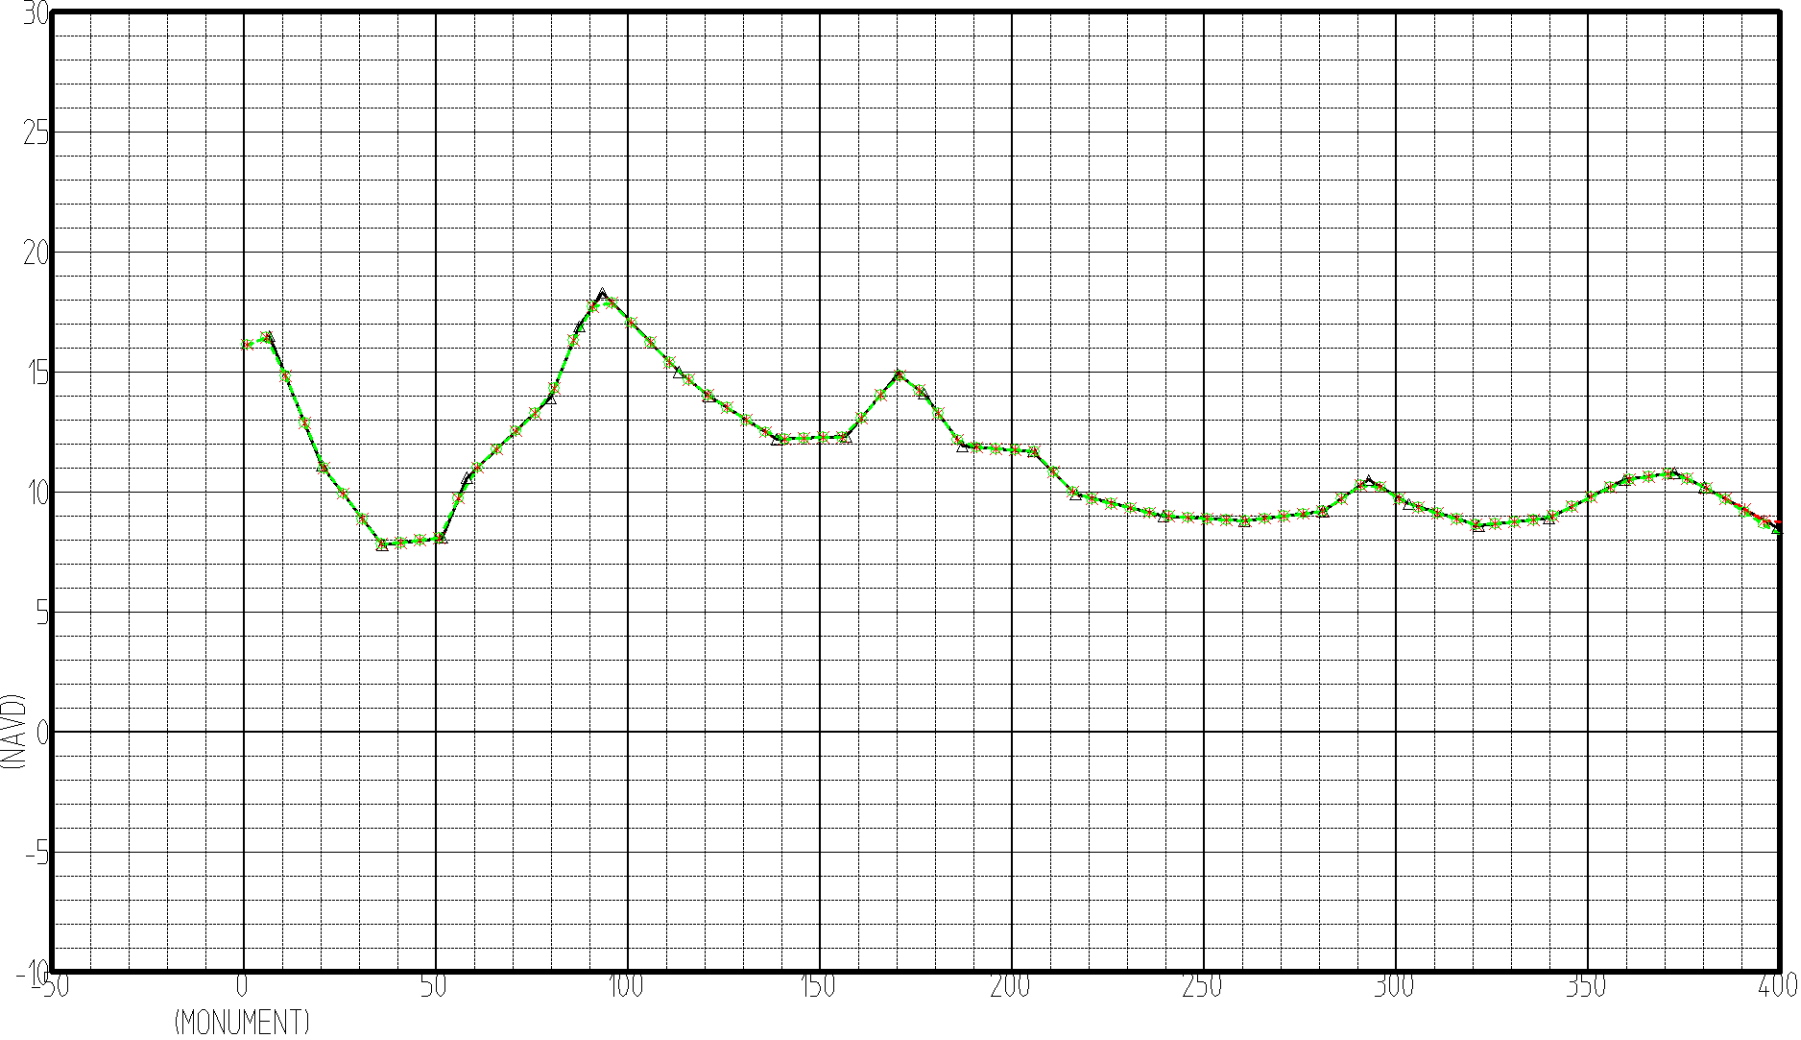
Range: R-69
 BEARING: 200.00
 1/2

BEACH PROFILE
 —△—△— WALTON JULY 2007 PRF
 - - * - - * - - SBEACH 15-YR ERODED PRF
 - - o - - o - - SBEACH 25-YR ERODED PRF

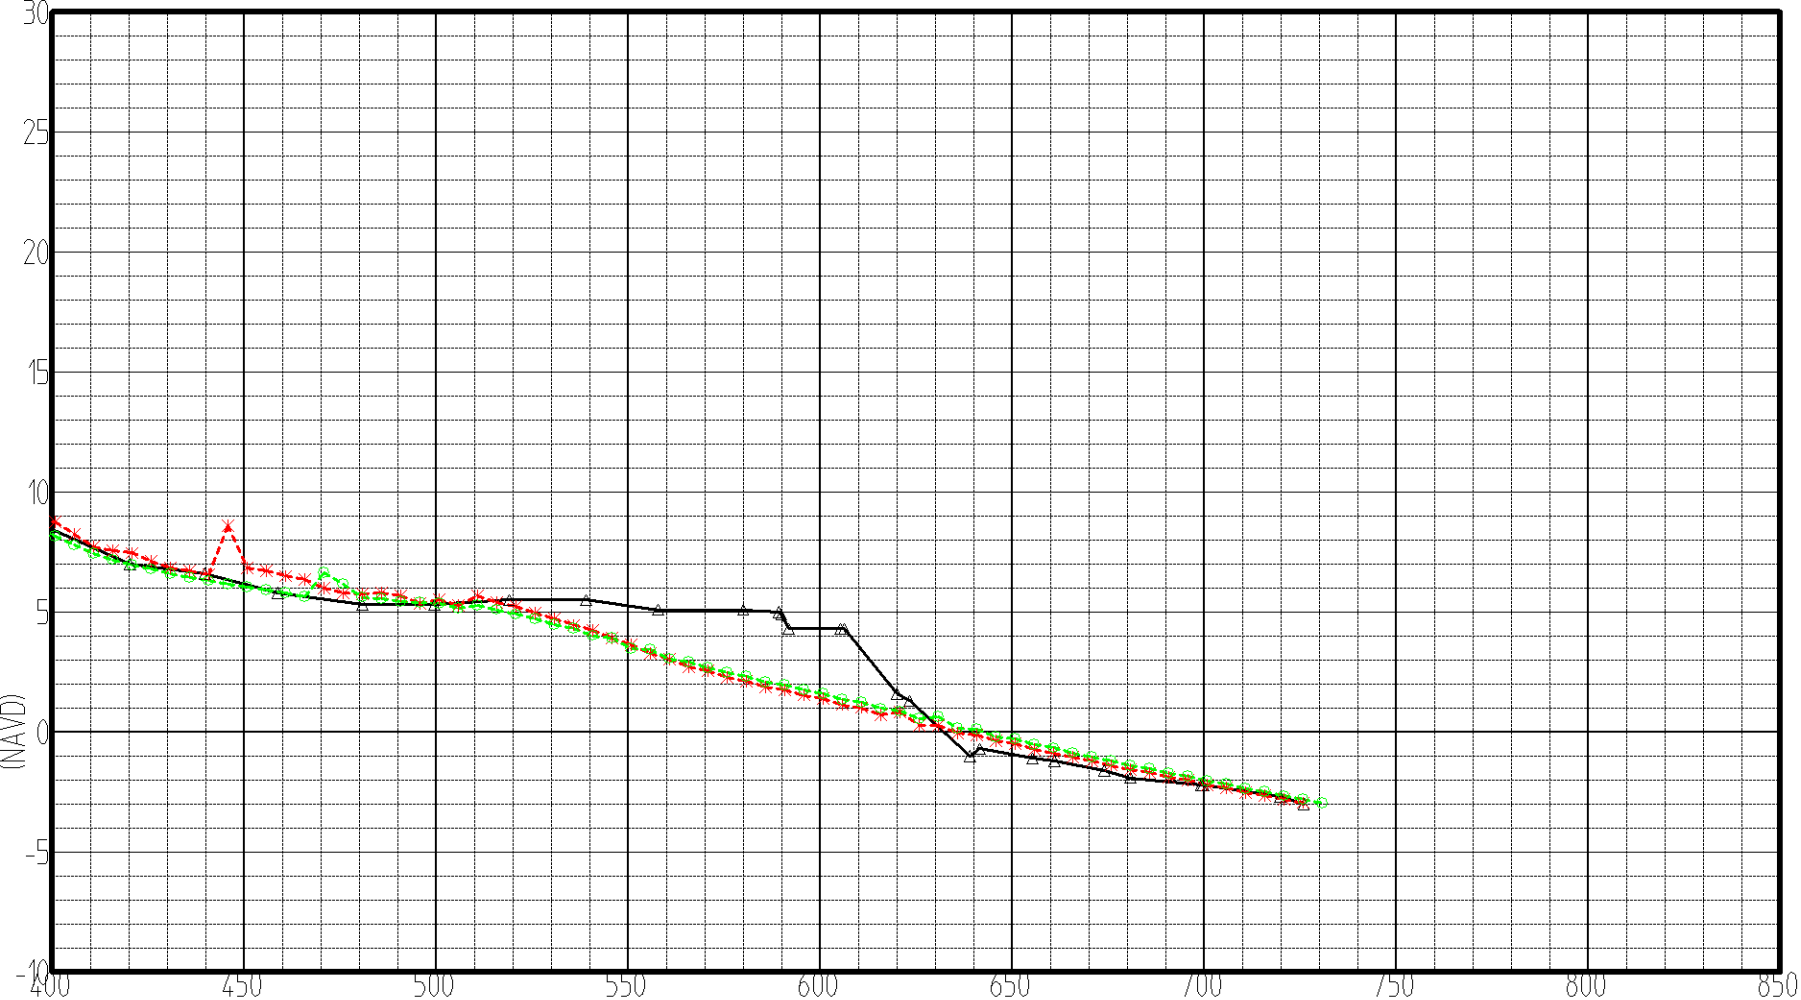
Range: R-69 2/2
 BEARING: 200.00

BEACH PROFILE
 —△—△— WALTON JULY 2007 PRF
 - - * - - SBEACH 15-YR ERODED PRF
 - - o - - SBEACH 25-YR ERODED PRF

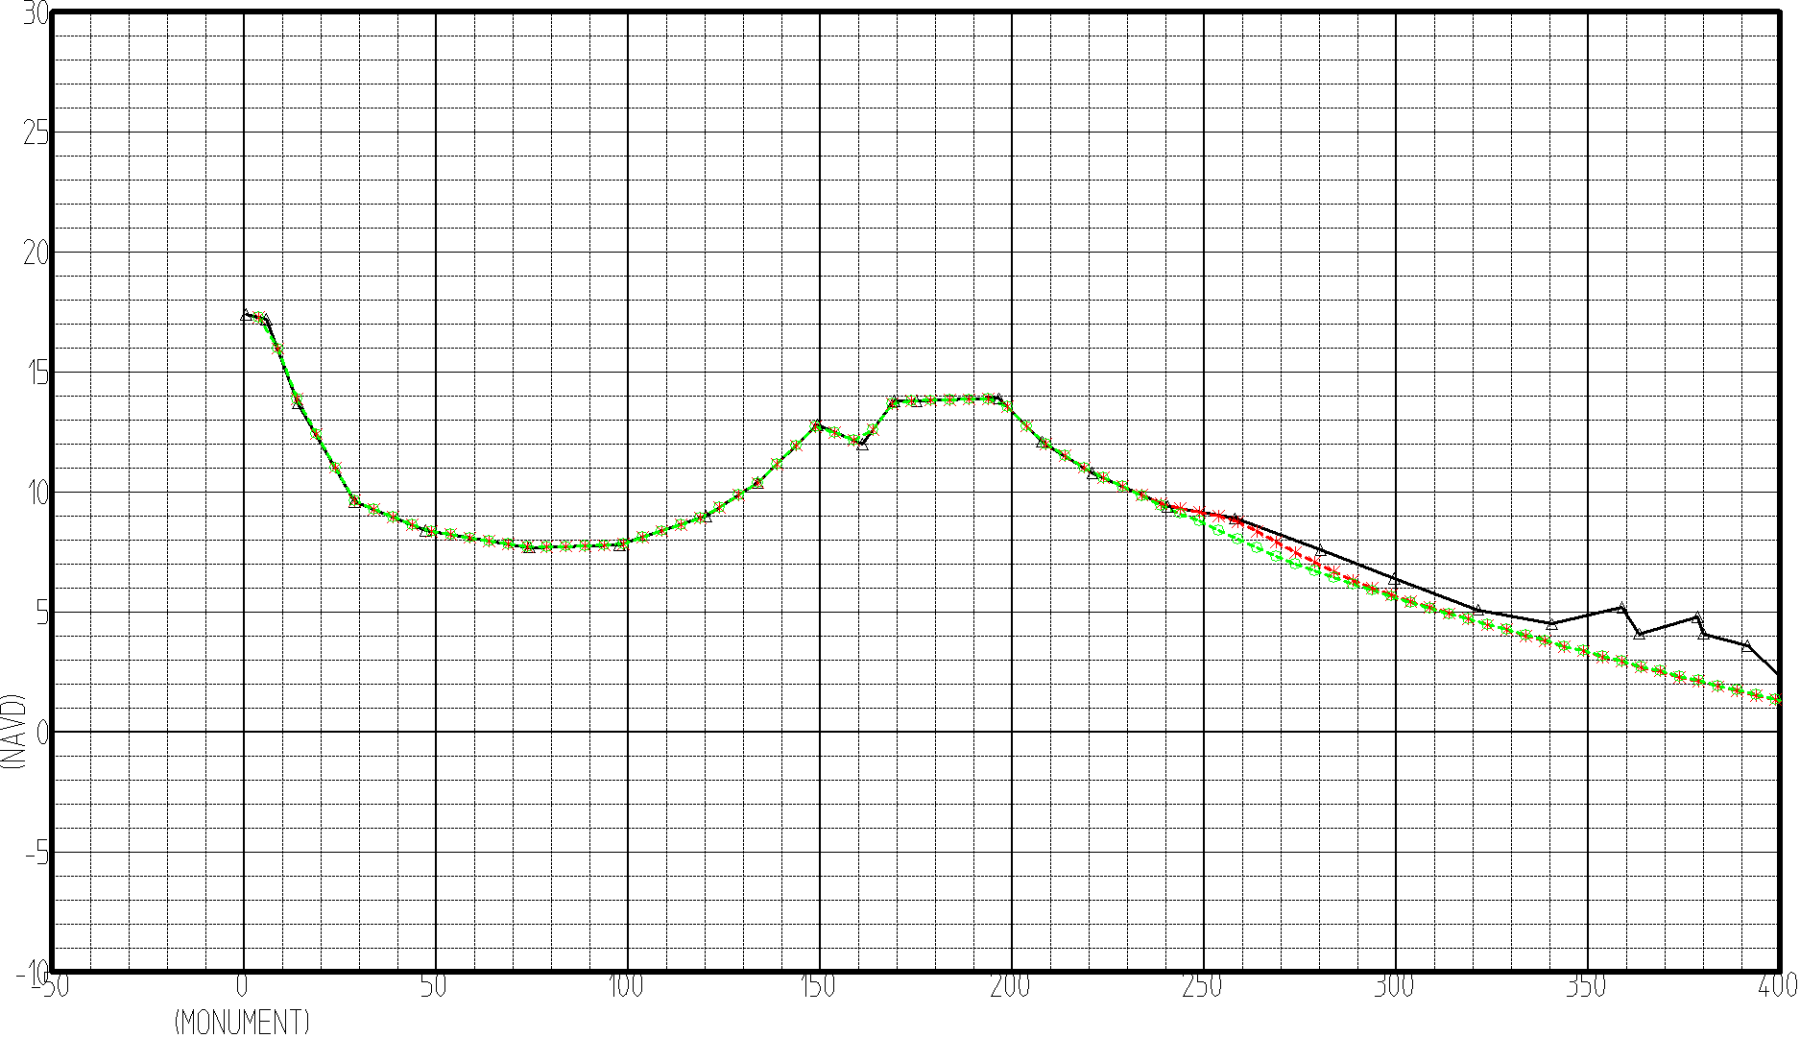
Range: R-70
 BEARING: 200.00
 1/2

BEACH PROFILE
 —△—△— WALTON JULY 2007 PRF
 - - * - - * - - SBEACH 15-YR ERODED PRF
 - - o - - o - - SBEACH 25-YR ERODED PRF

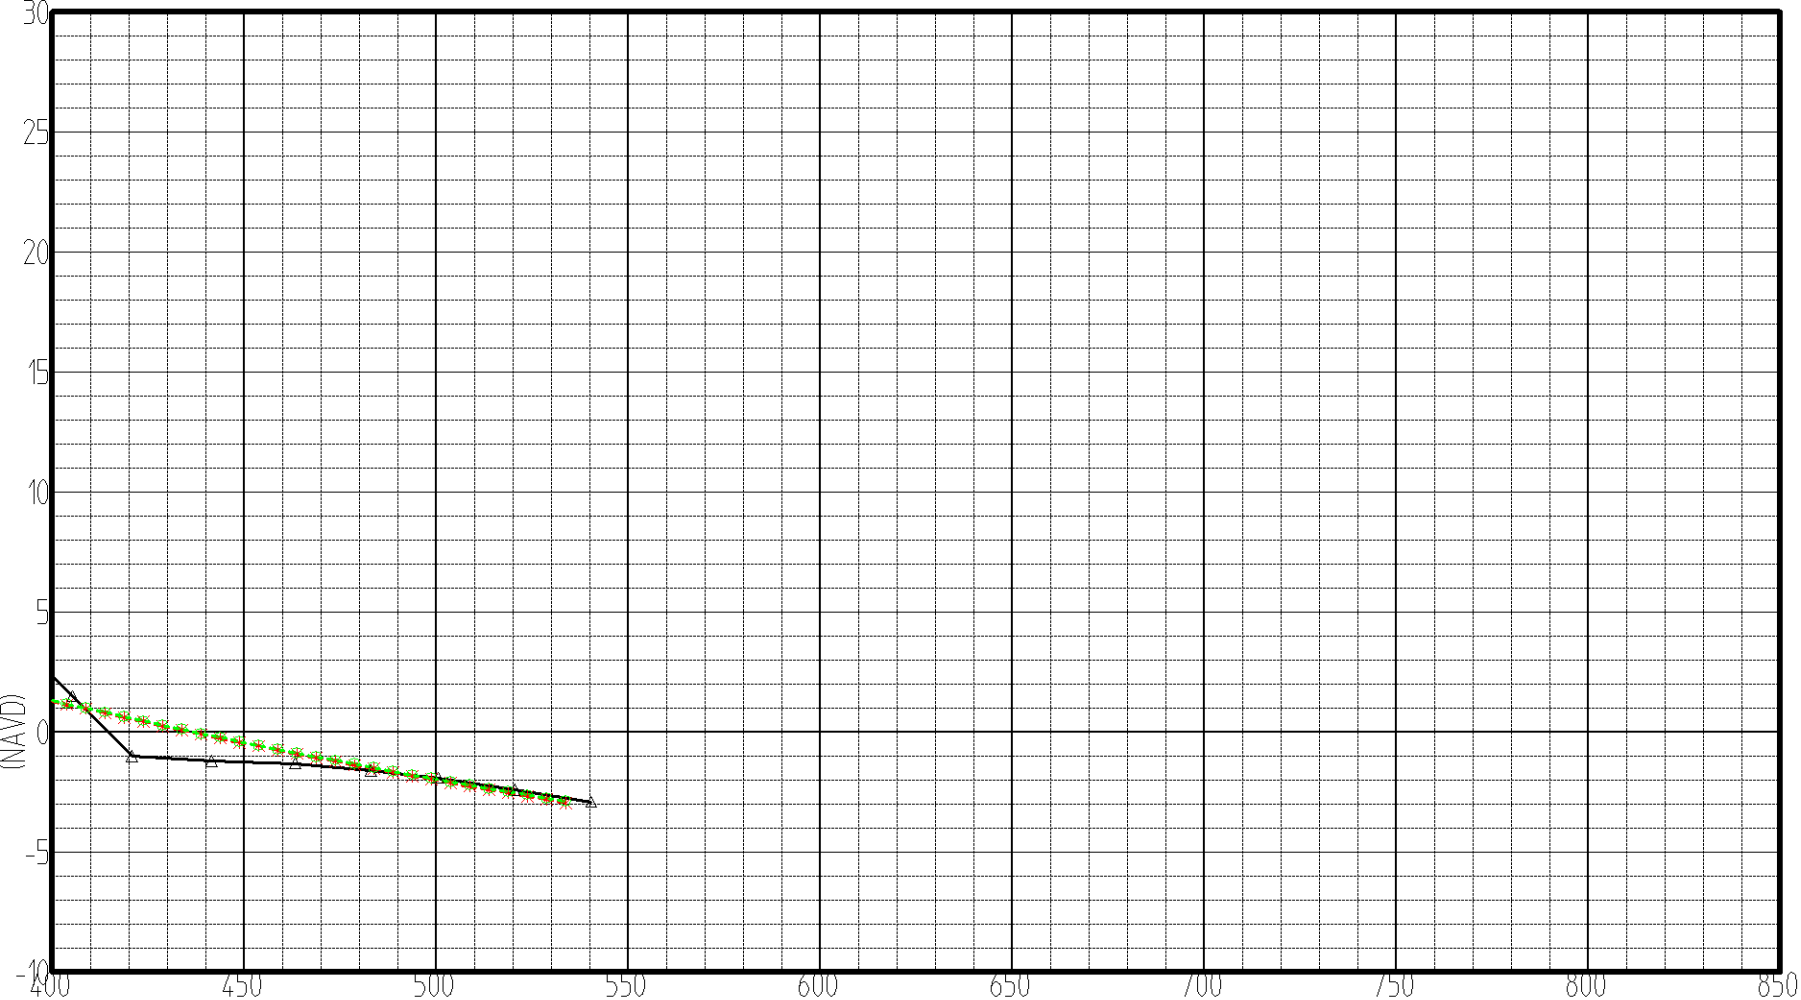
Range: R-70 2/2
 BEARING: 200.00

BEACH PROFILE
 —△—△— WALTON JULY 2007 PRF
 - - * - - SBEACH 15-YR ERODED PRF
 - - o - - SBEACH 25-YR ERODED PRF

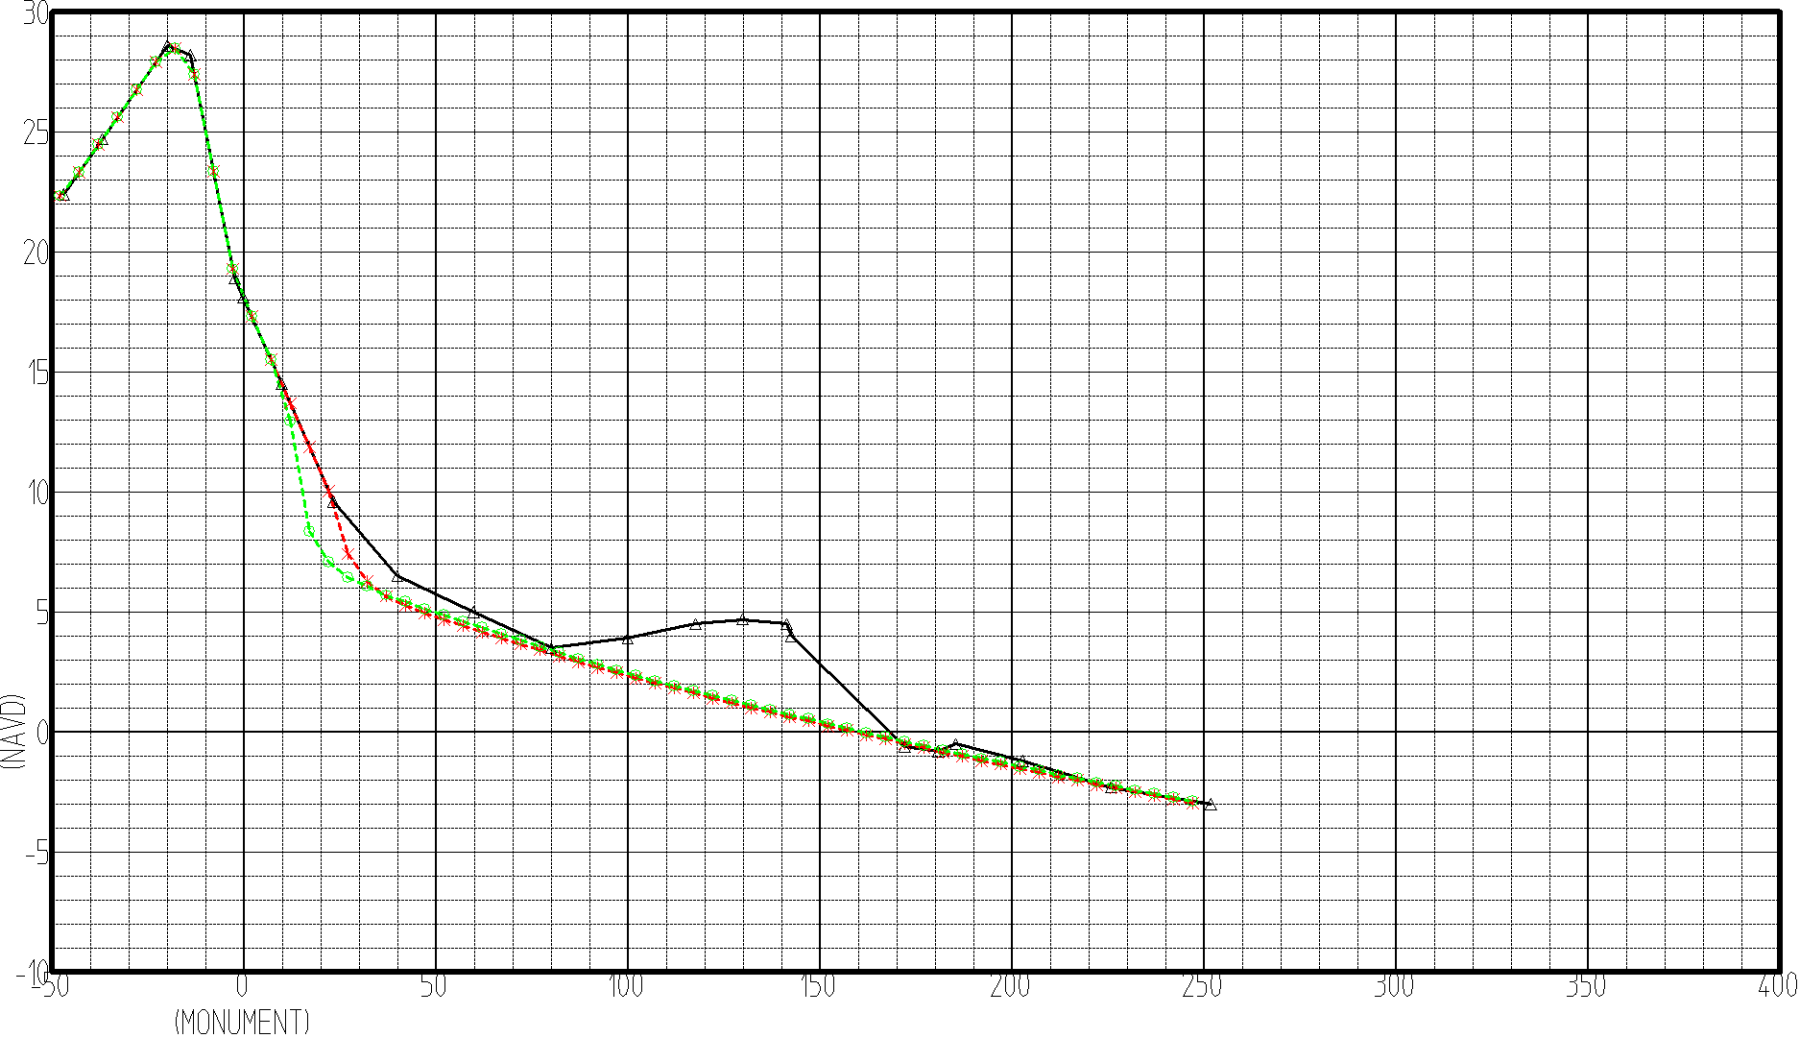
Range: R-71
 BEARING: 200.00
 1/1

BEACH PROFILE
 —△—△— WALTON JULY 2007 PRF
 - - * - - SBEACH 15-YR ERODED PRF
 - - o - - SBEACH 25-YR ERODED PRF

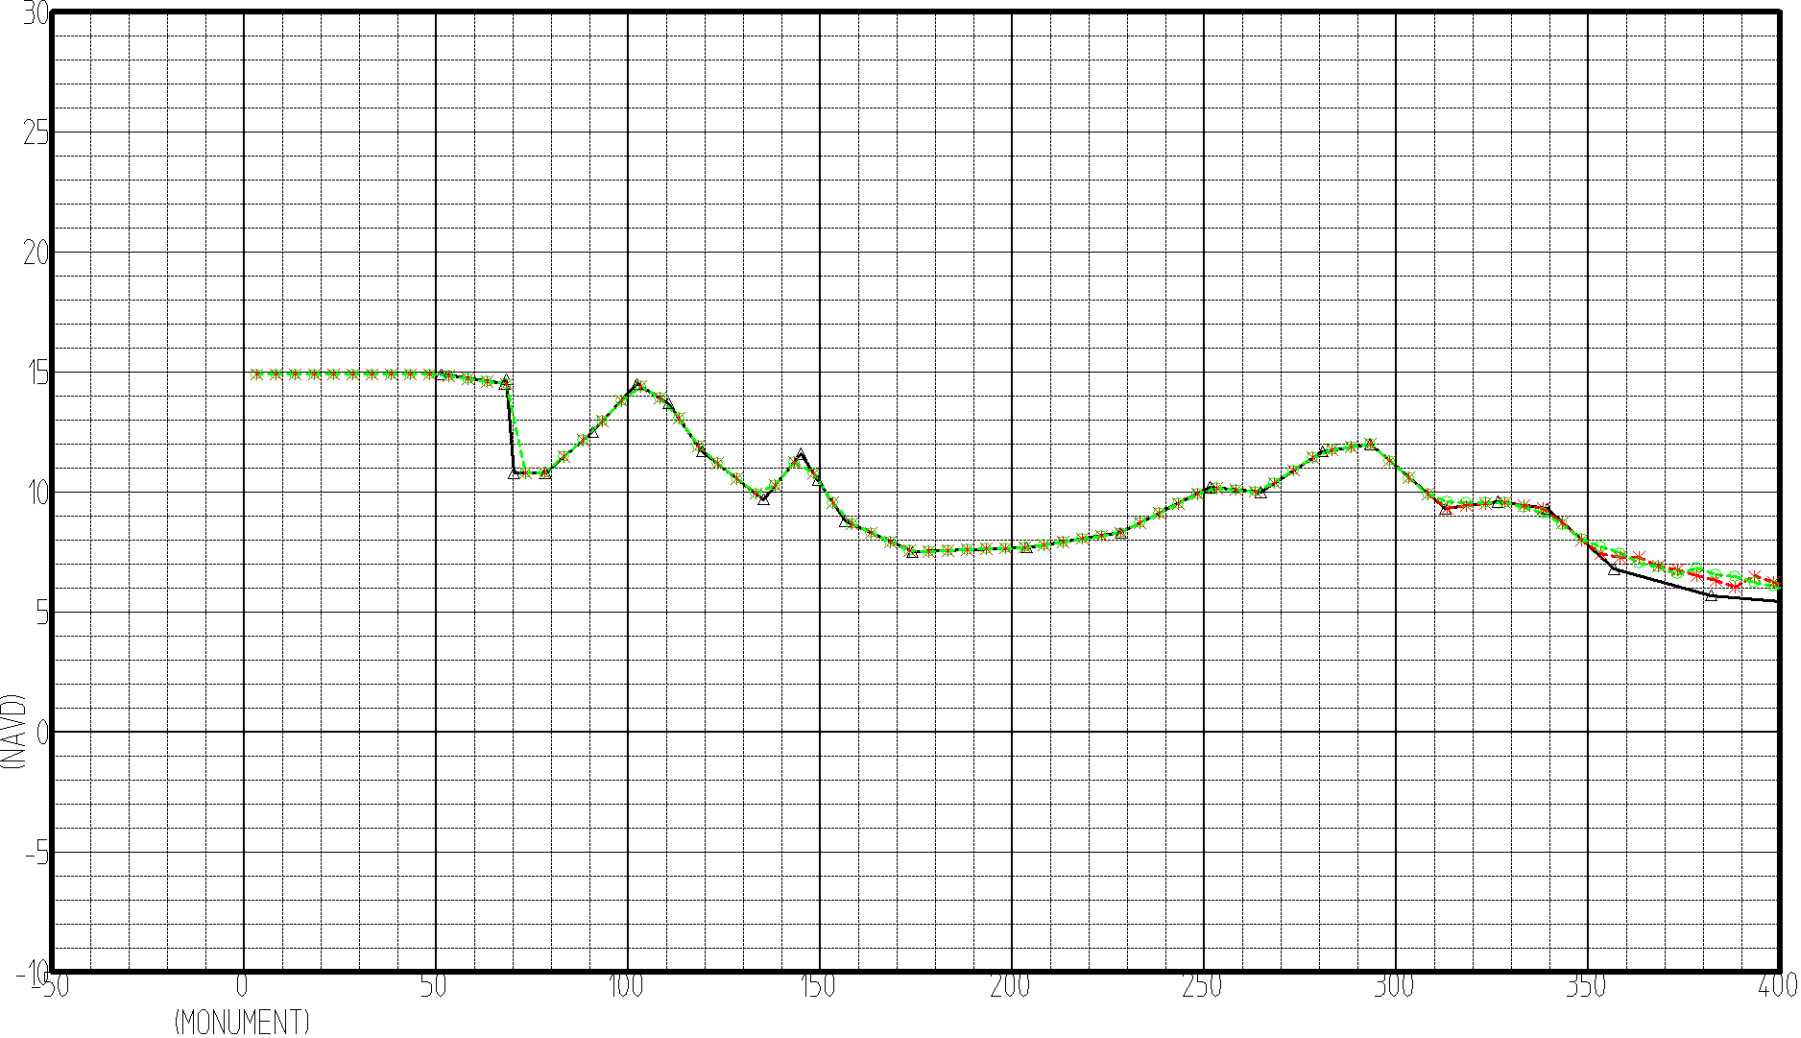
Range: W-72 1/2
 BEARING: 200.00

BEACH PROFILE
 —△—△— WALTON JULY 2007 PRF
 - - * - - SBEACH 15-YR ERODED PRF
 - - o - - SBEACH 25-YR ERODED PRF

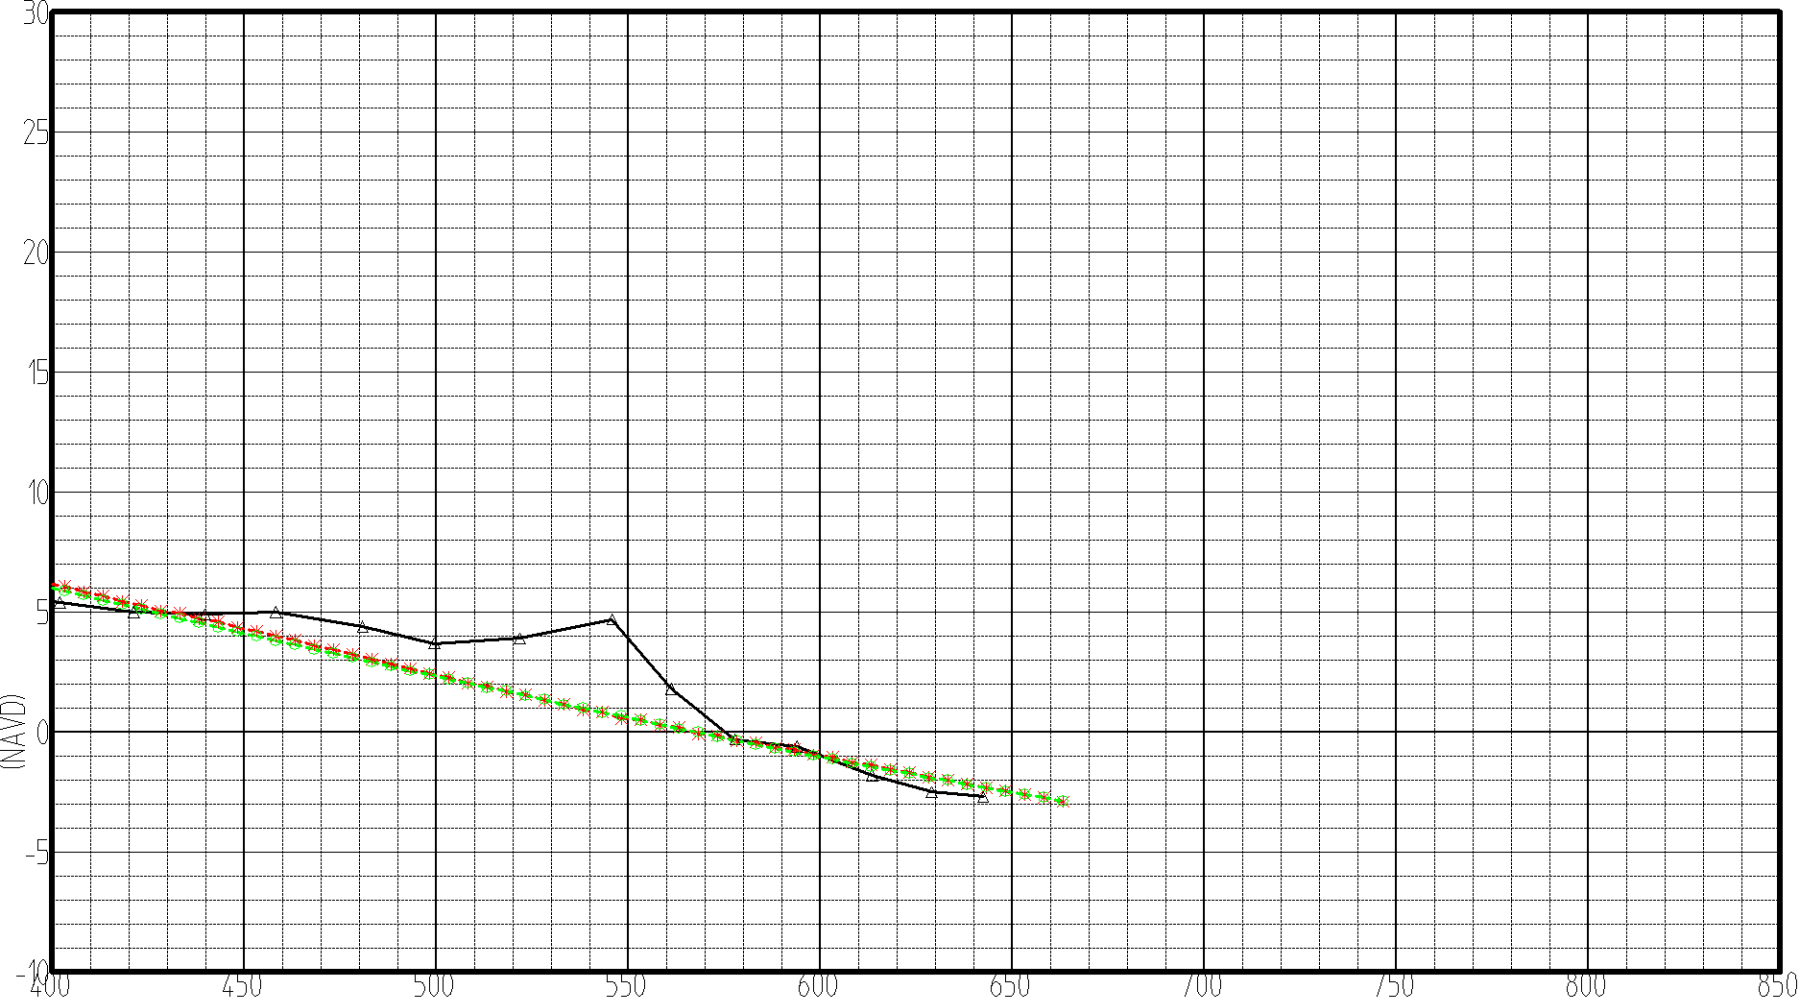
Range: W-72 2/2
 BEARING: 200.00

BEACH PROFILE
 —△—△— WALTON JULY 2007 PRF
 - - * - - SBEACH 15-YR ERODED PRF
 - - o - - SBEACH 25-YR ERODED PRF

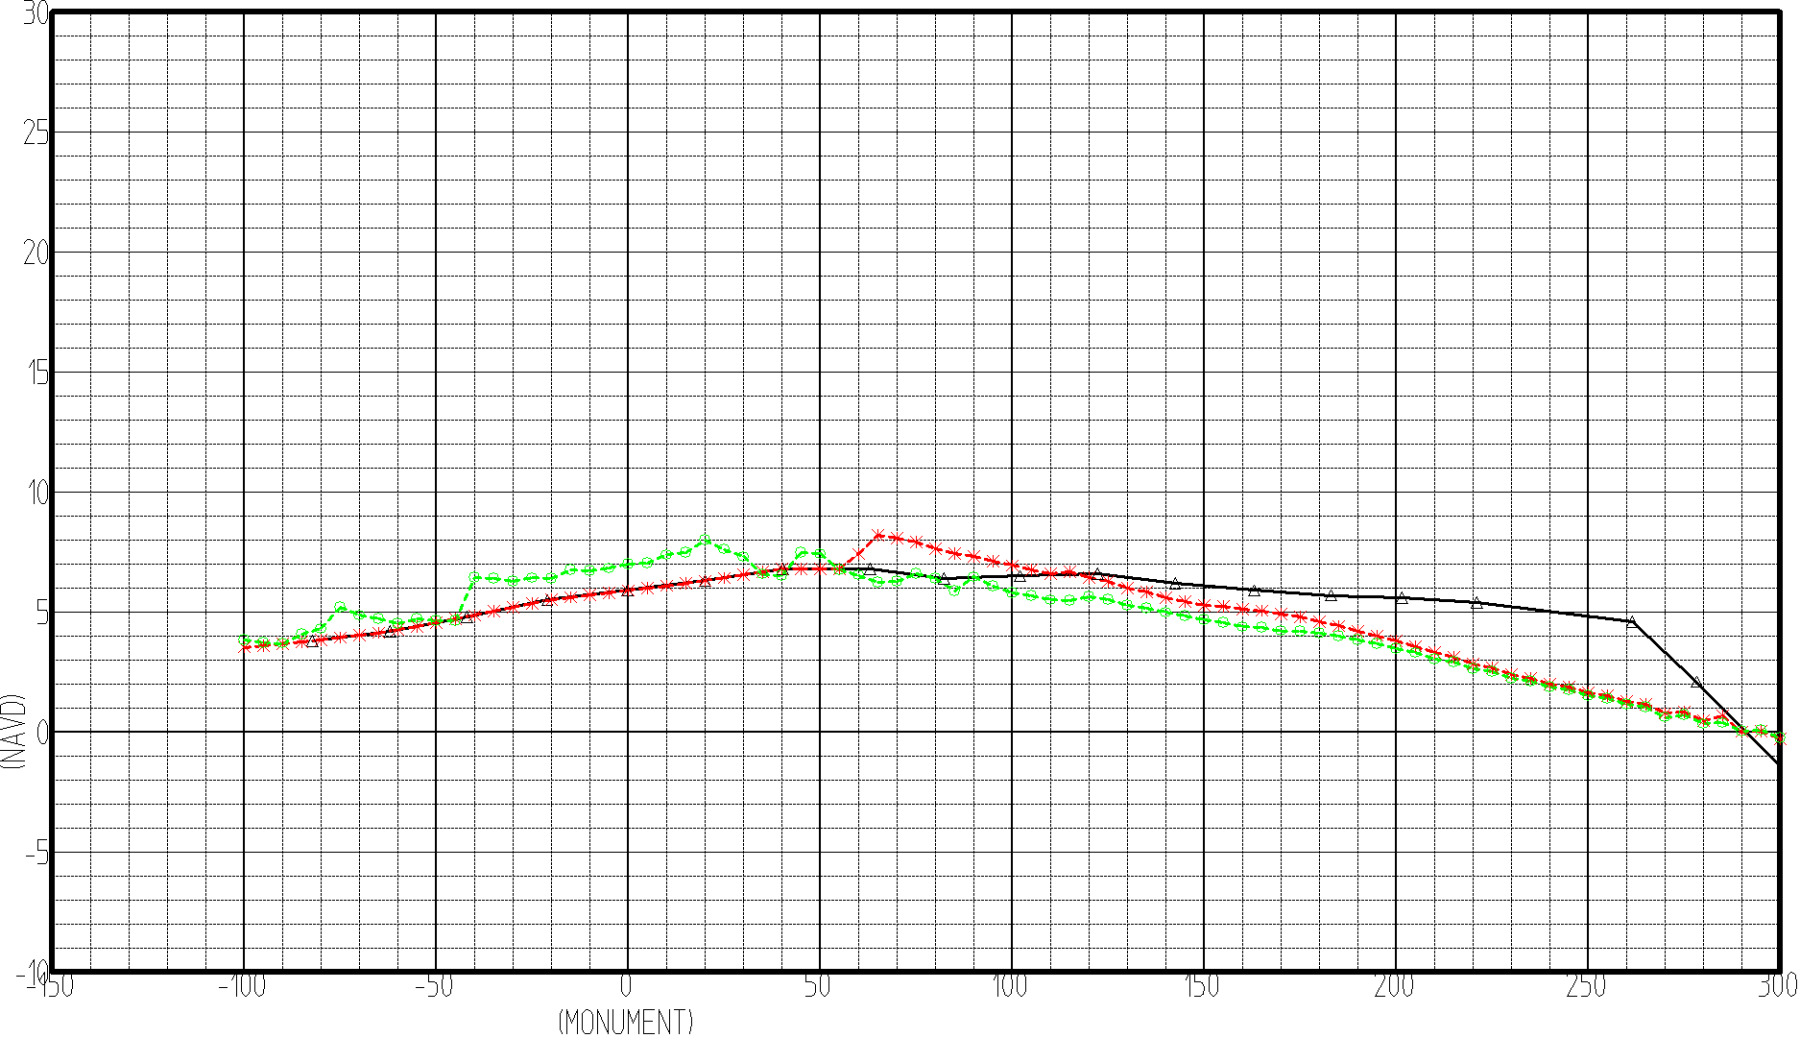
Range: R-73
 BEARING: 190.00
 1/2

BEACH PROFILE
 —△—△— WALTON JULY 2007 PRF
 - - * - - SBEACH 15-YR ERODED PRF
 - - o - - SBEACH 25-YR ERODED PRF
