Appendix II

SBEACH Model Erosion Profile Plots

Walton County

15-year and 25-year Storm Events

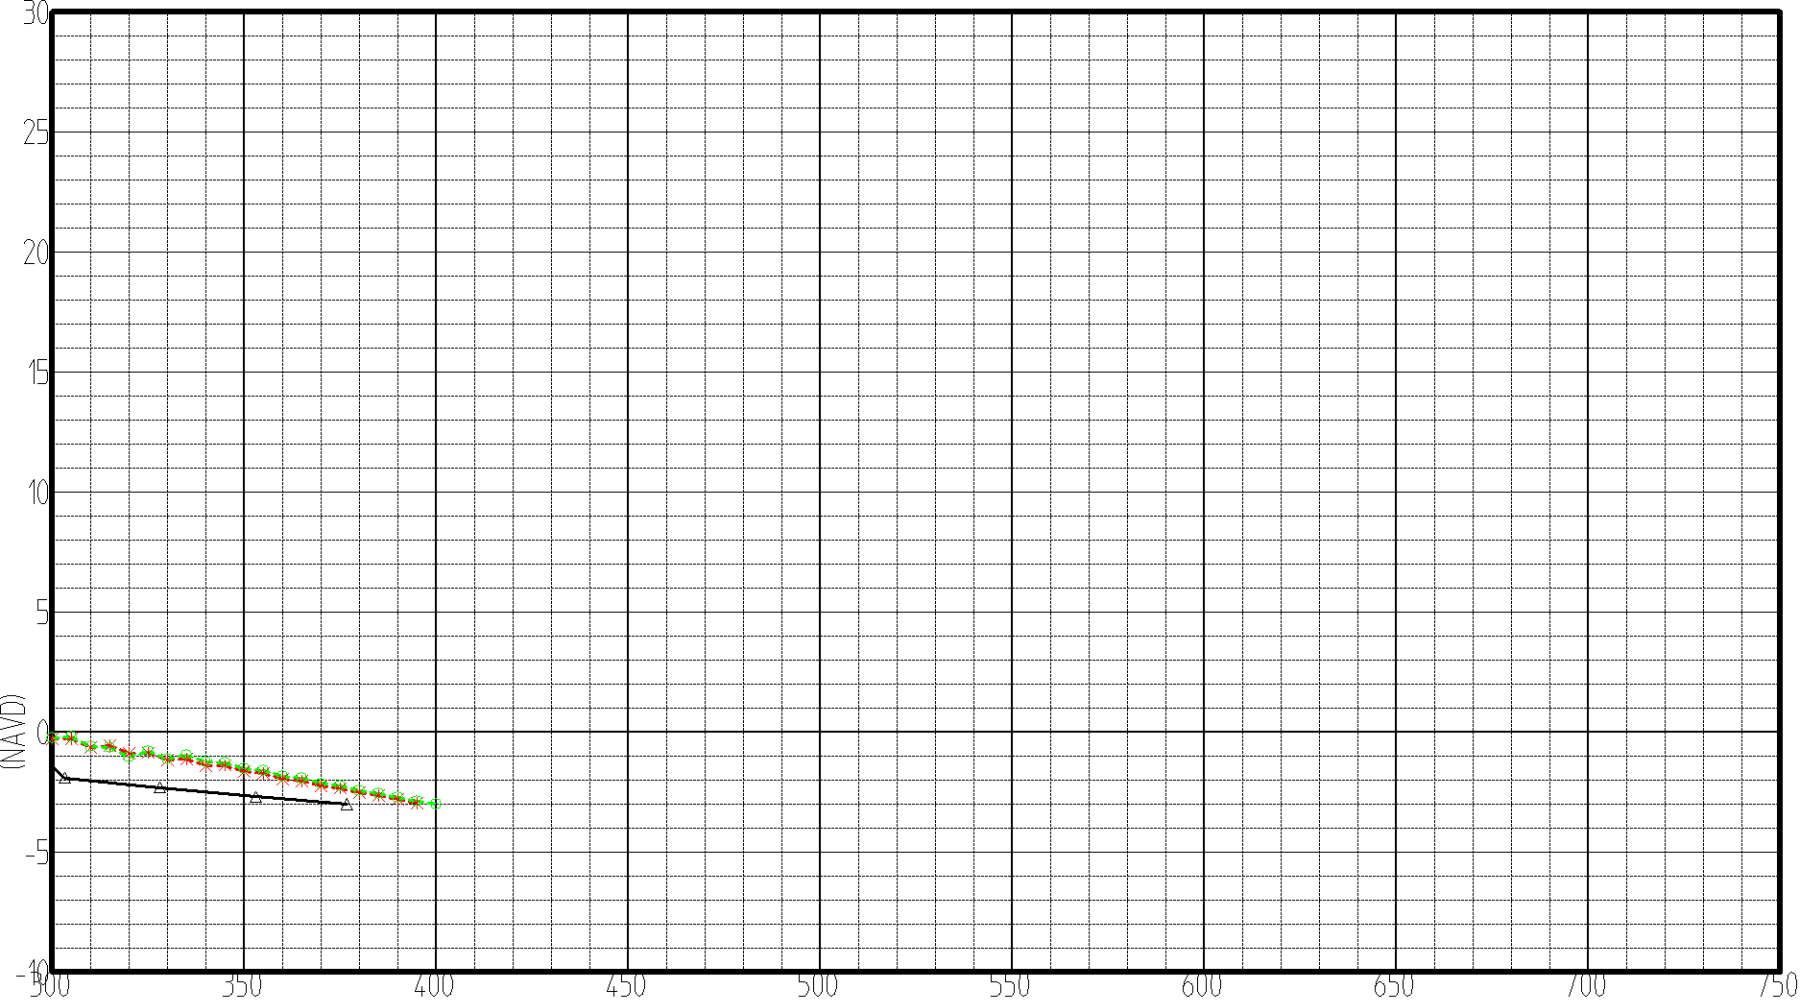
Range: R-73
 BEARING: 190.00
 2/2

BEACH PROFILE
 —△—△— WALTON JULY 2007 PRF
 - - * - - SBEACH 15-YR ERODED PRF
 - - o - - SBEACH 25-YR ERODED PRF

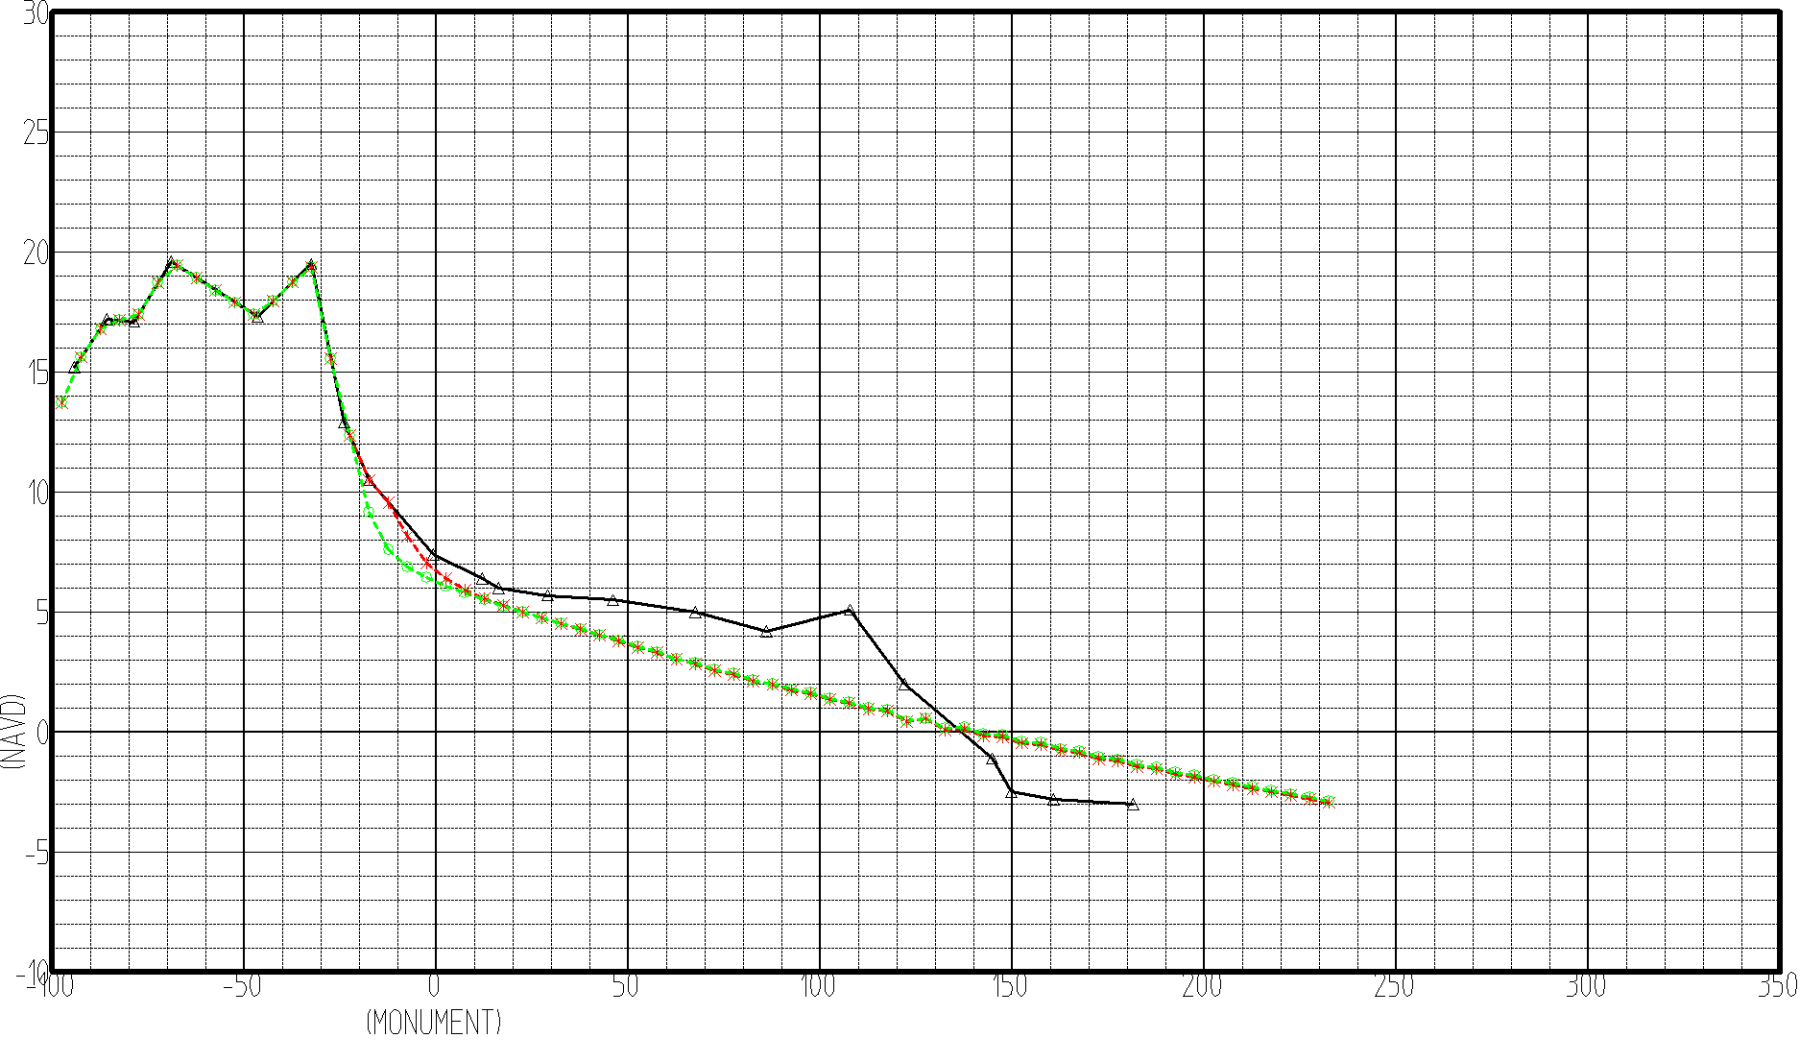
Range: R-74
 BEARING: 190.00
 1/1

BEACH PROFILE
 —△—△— WALTON JULY 2007 PRF
 - - * - - SBEACH 15-YR ERODED PRF
 - - o - - SBEACH 25-YR ERODED PRF

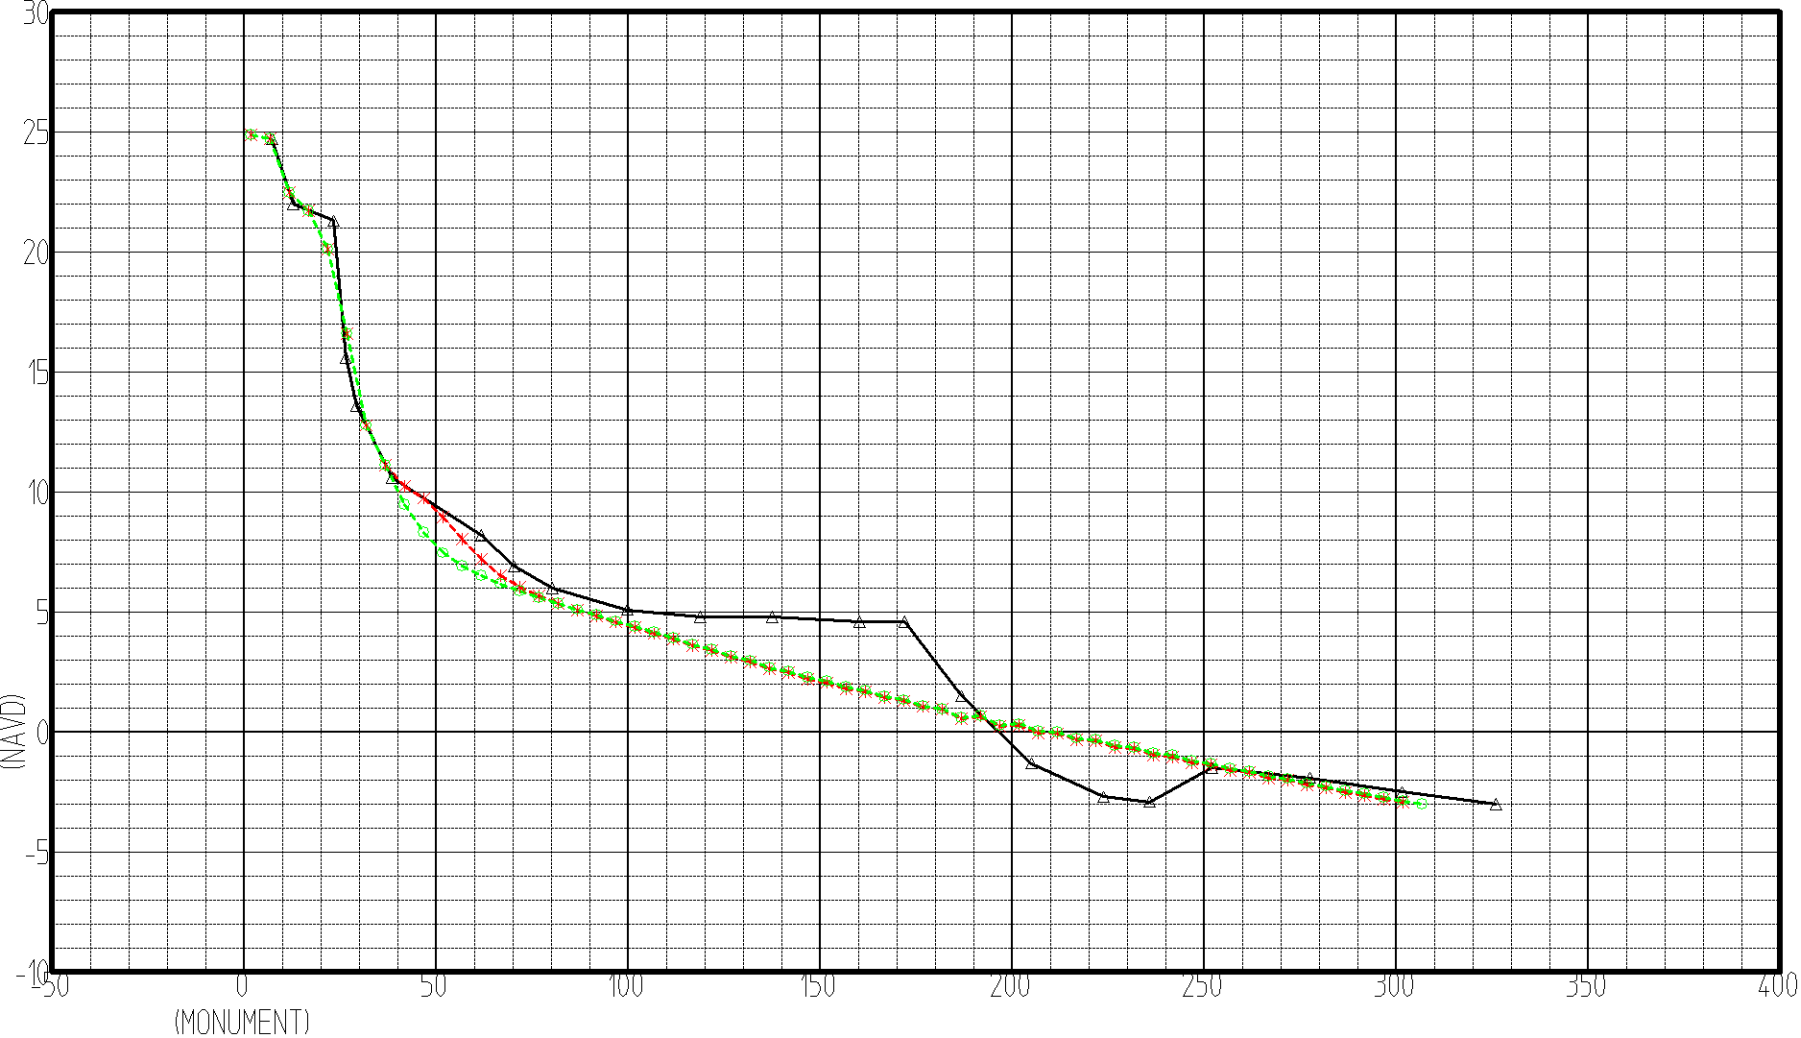
Range: R-75
 BEARING: 190.00
 1/1

BEACH PROFILE
 —△—△— WALTON JULY 2007 PRF
 - - * - - SBEACH 15-YR ERODED PRF
 - - o - - SBEACH 25-YR ERODED PRF

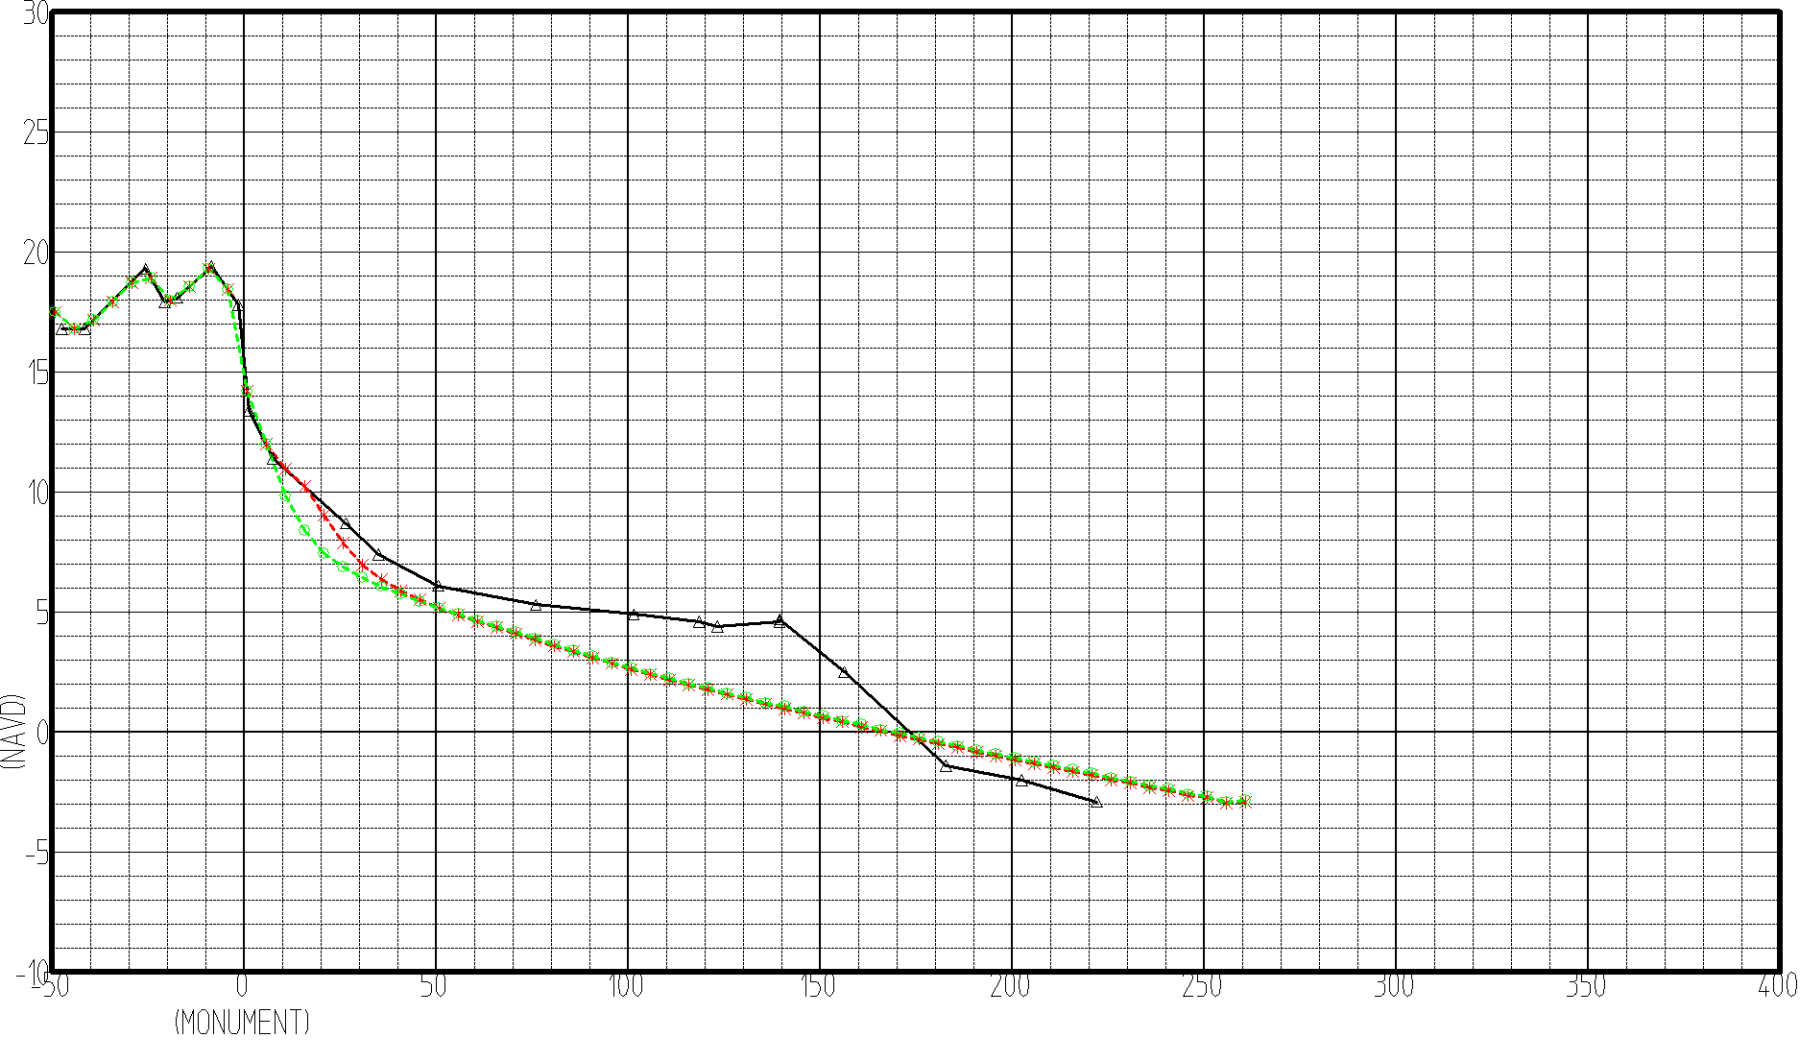
Range: R-76
 BEARING: 205.00
 1/1

BEACH PROFILE
 —△—△— WALTON JULY 2007 PRF
 - - * - - * - - SBEACH 15-YR ERODED PRF
 - - o - - o - - SBEACH 25-YR ERODED PRF

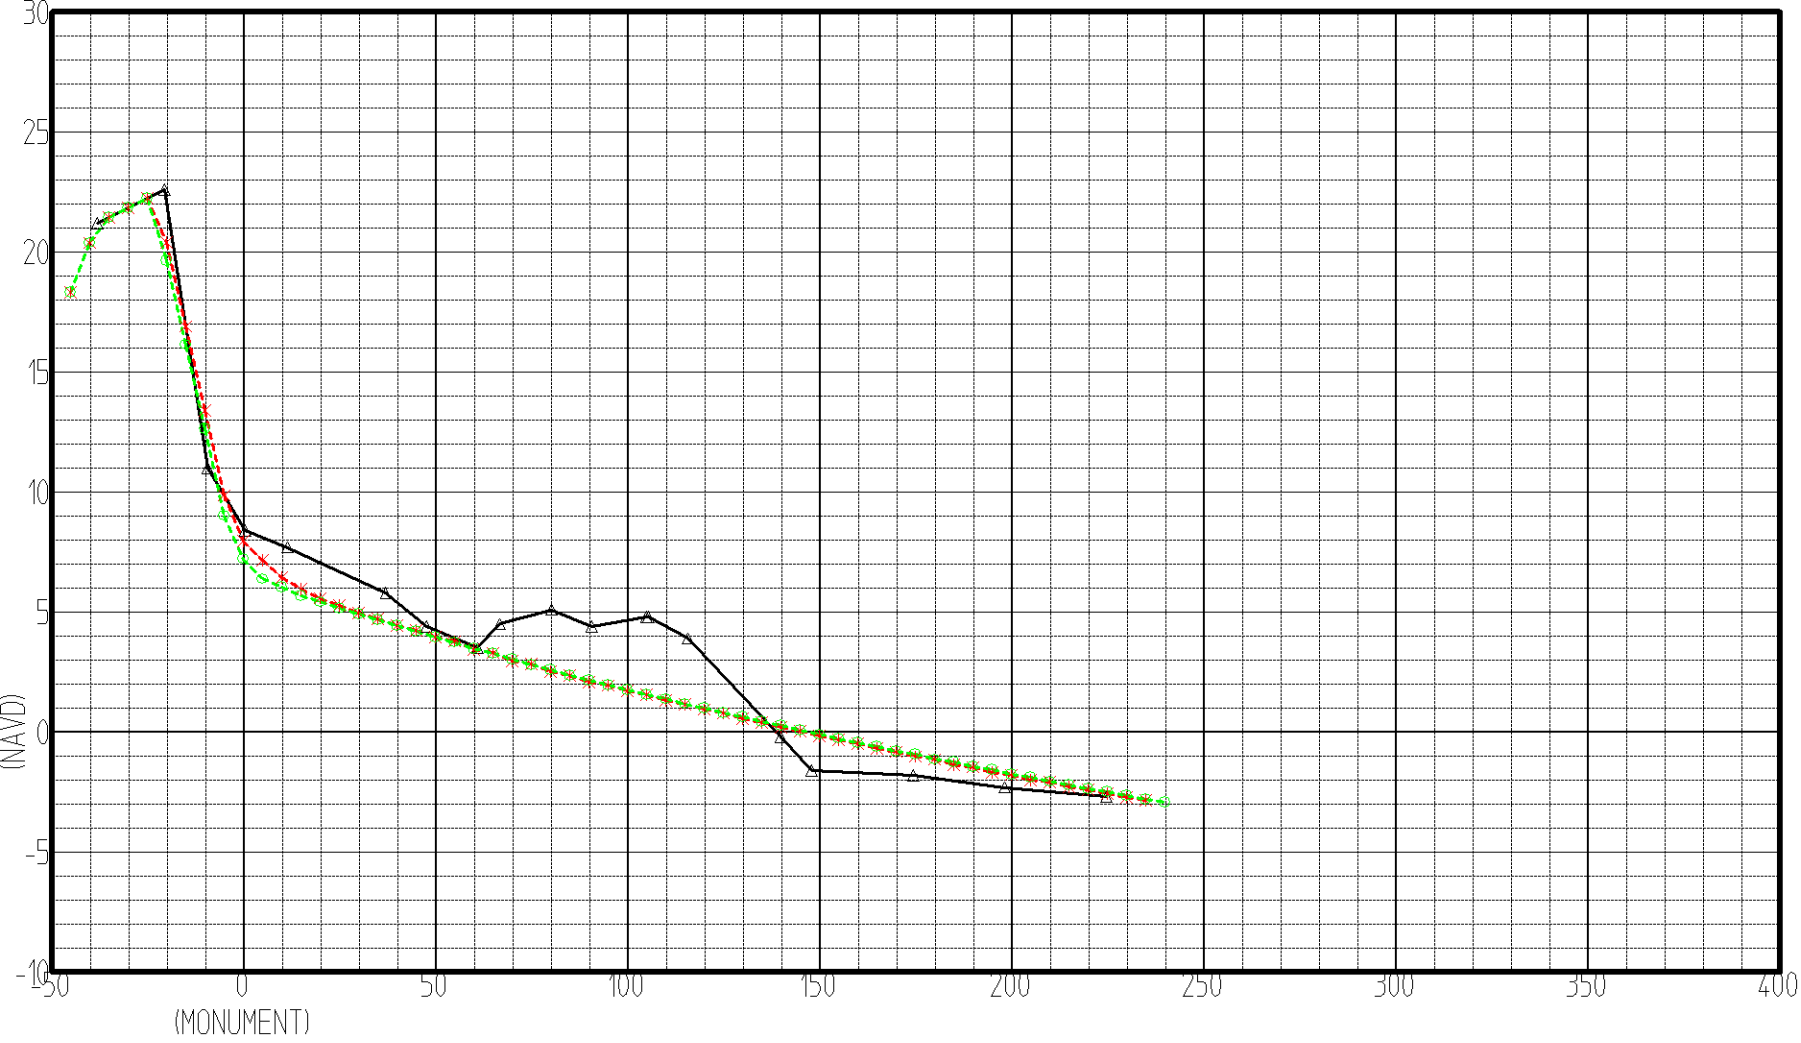
Range: R-77
 BEARING: 205.00
 1/1

BEACH PROFILE
 —△—△— WALTON JULY 2007 PRF
 - - * - - SBEACH 15-YR ERODED PRF
 - - o - - SBEACH 25-YR ERODED PRF

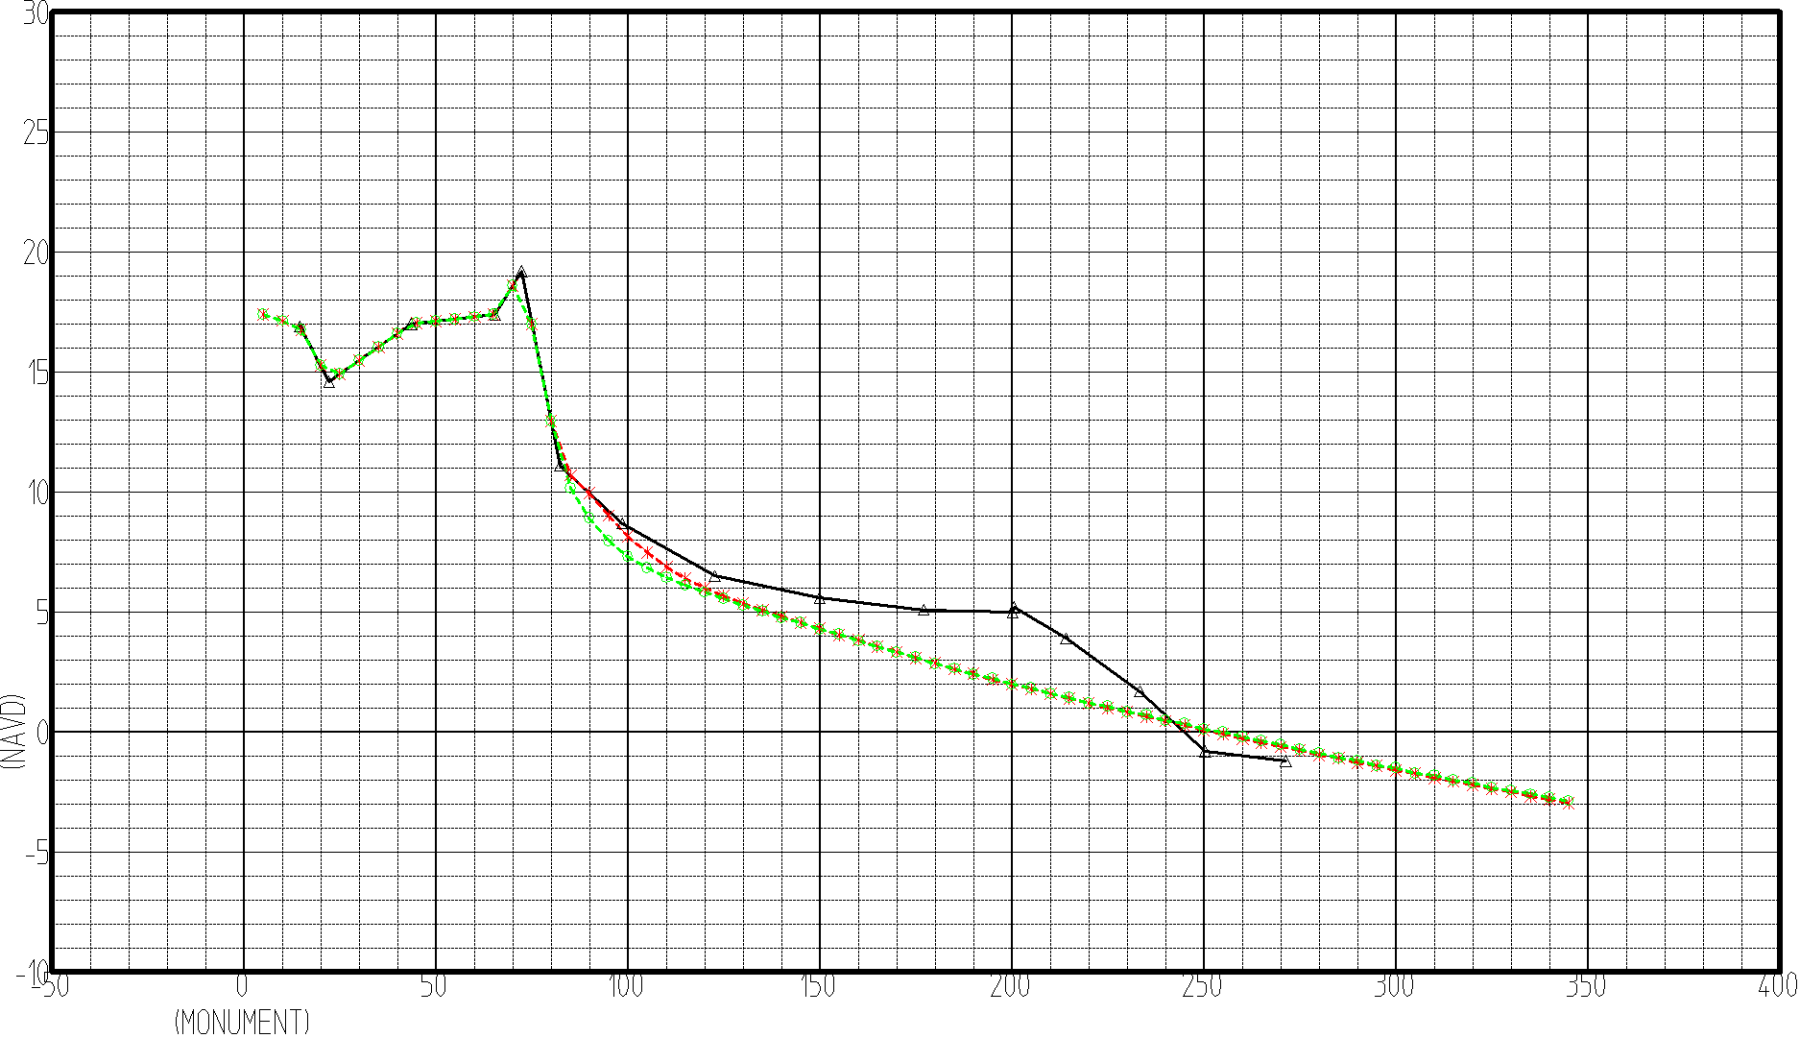
Range: R-78
 BEARING: 202.00
 1/1

BEACH PROFILE
 —△—△— WALTON JULY 2007 PRF
 - - * - - SBEACH 15-YR ERODED PRF
 - - o - - SBEACH 25-YR ERODED PRF

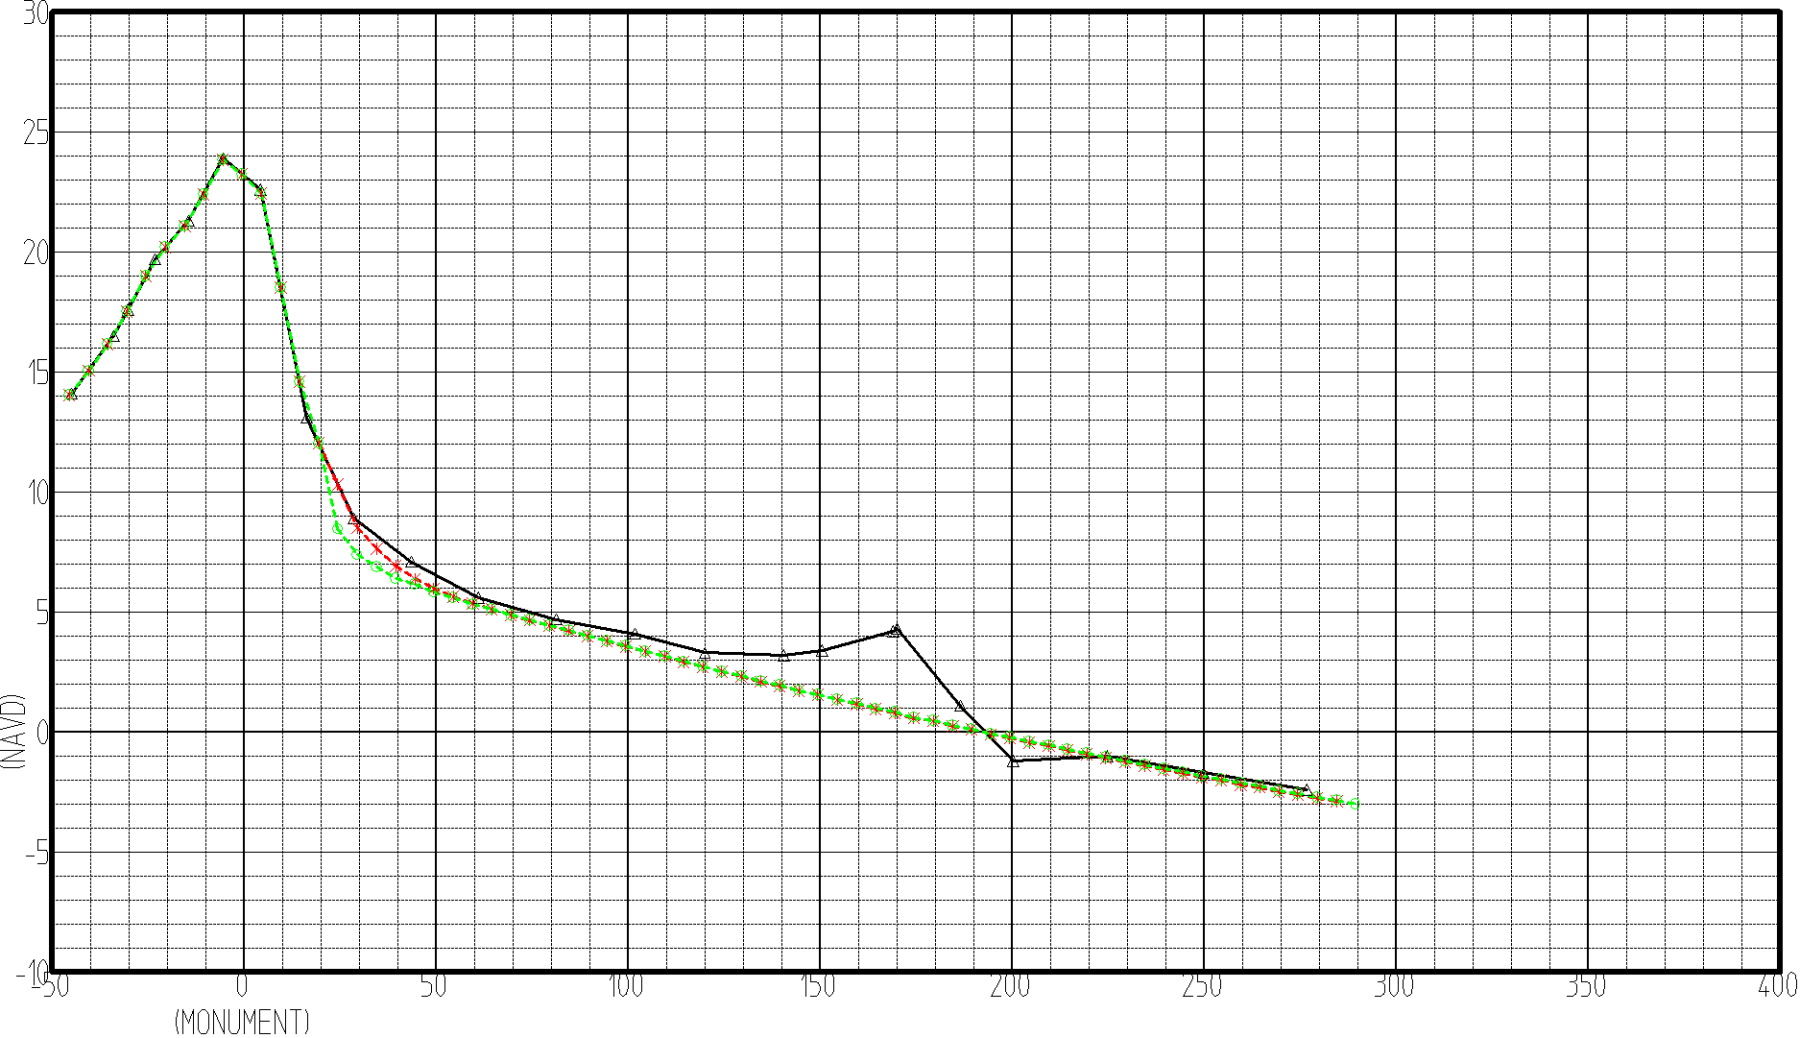
Range: R-79
 BEARING: 202.00
 1/1

BEACH PROFILE
 —△—△— WALTON JULY 2007 PRF
 - - * - - SBEACH 15-YR ERODED PRF
 - - o - - SBEACH 25-YR ERODED PRF

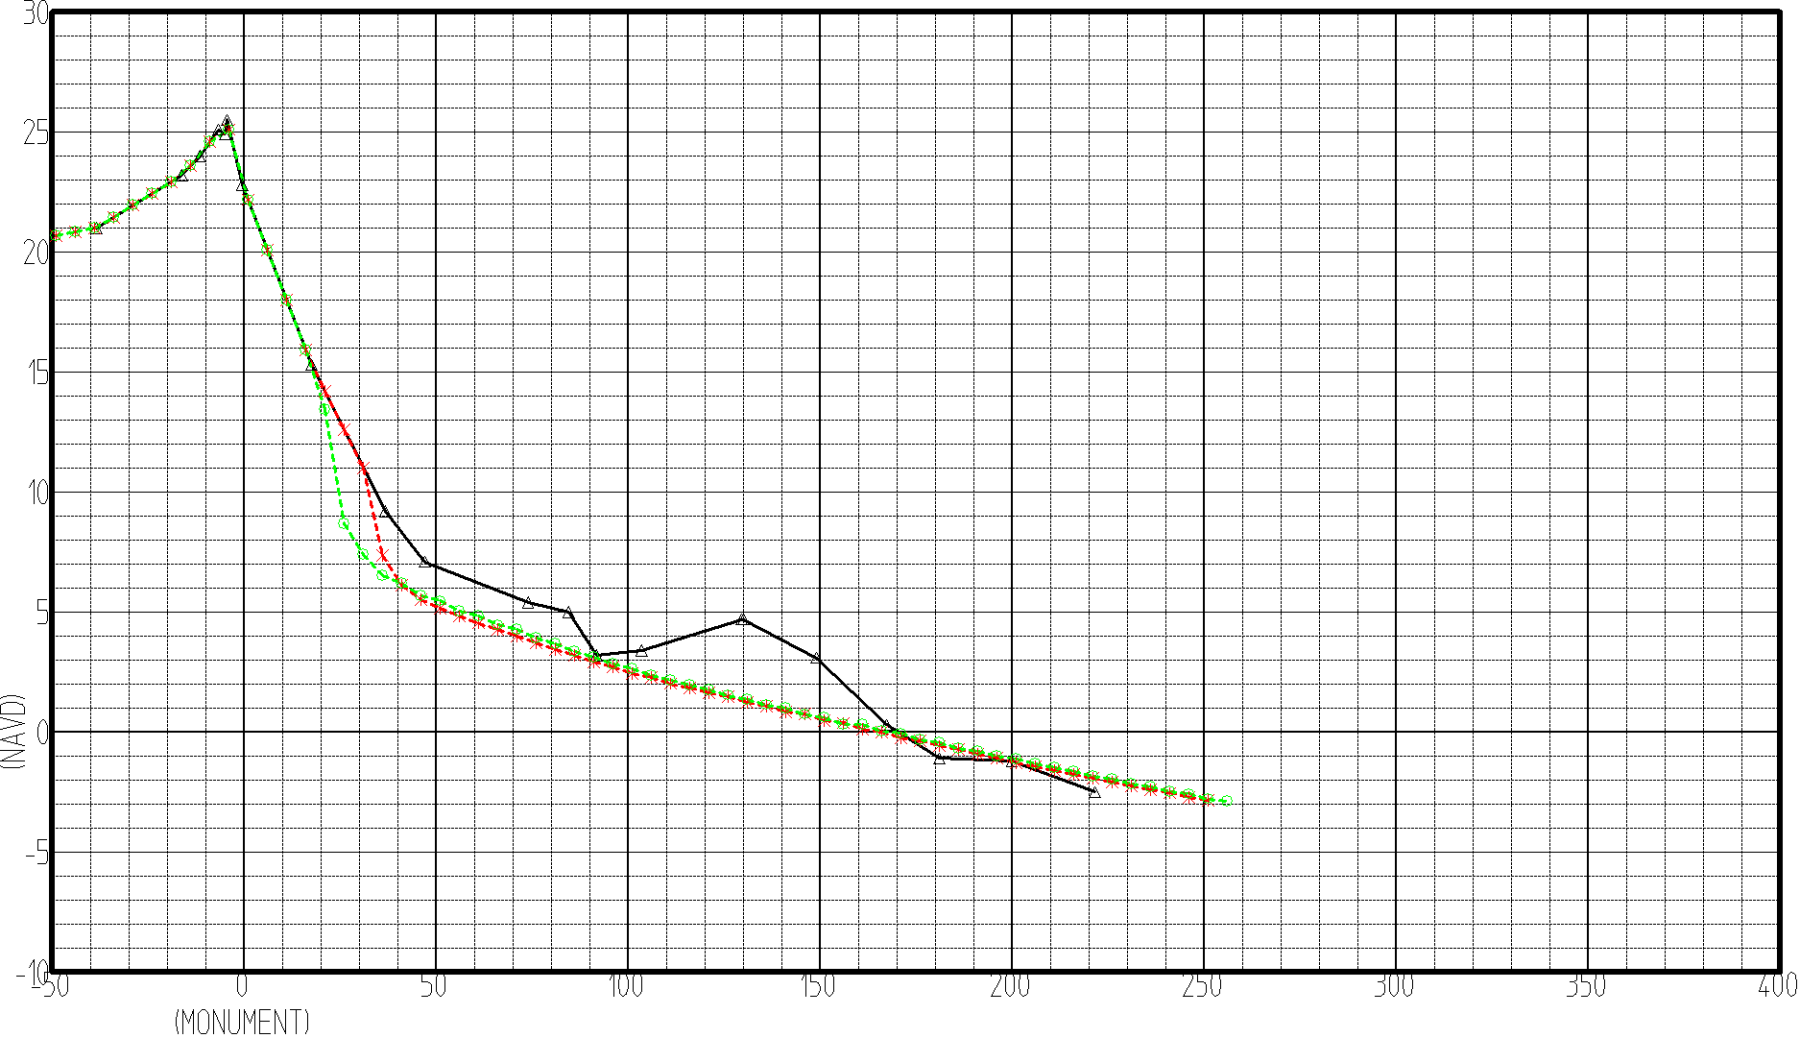
Range: R-80
 BEARING: 202.00
 1/1

BEACH PROFILE
 —△—△— WALTON JULY 2007 PRF
 - - * - - * - - SBEACH 15-YR ERODED PRF
 - - o - - o - - SBEACH 25-YR ERODED PRF

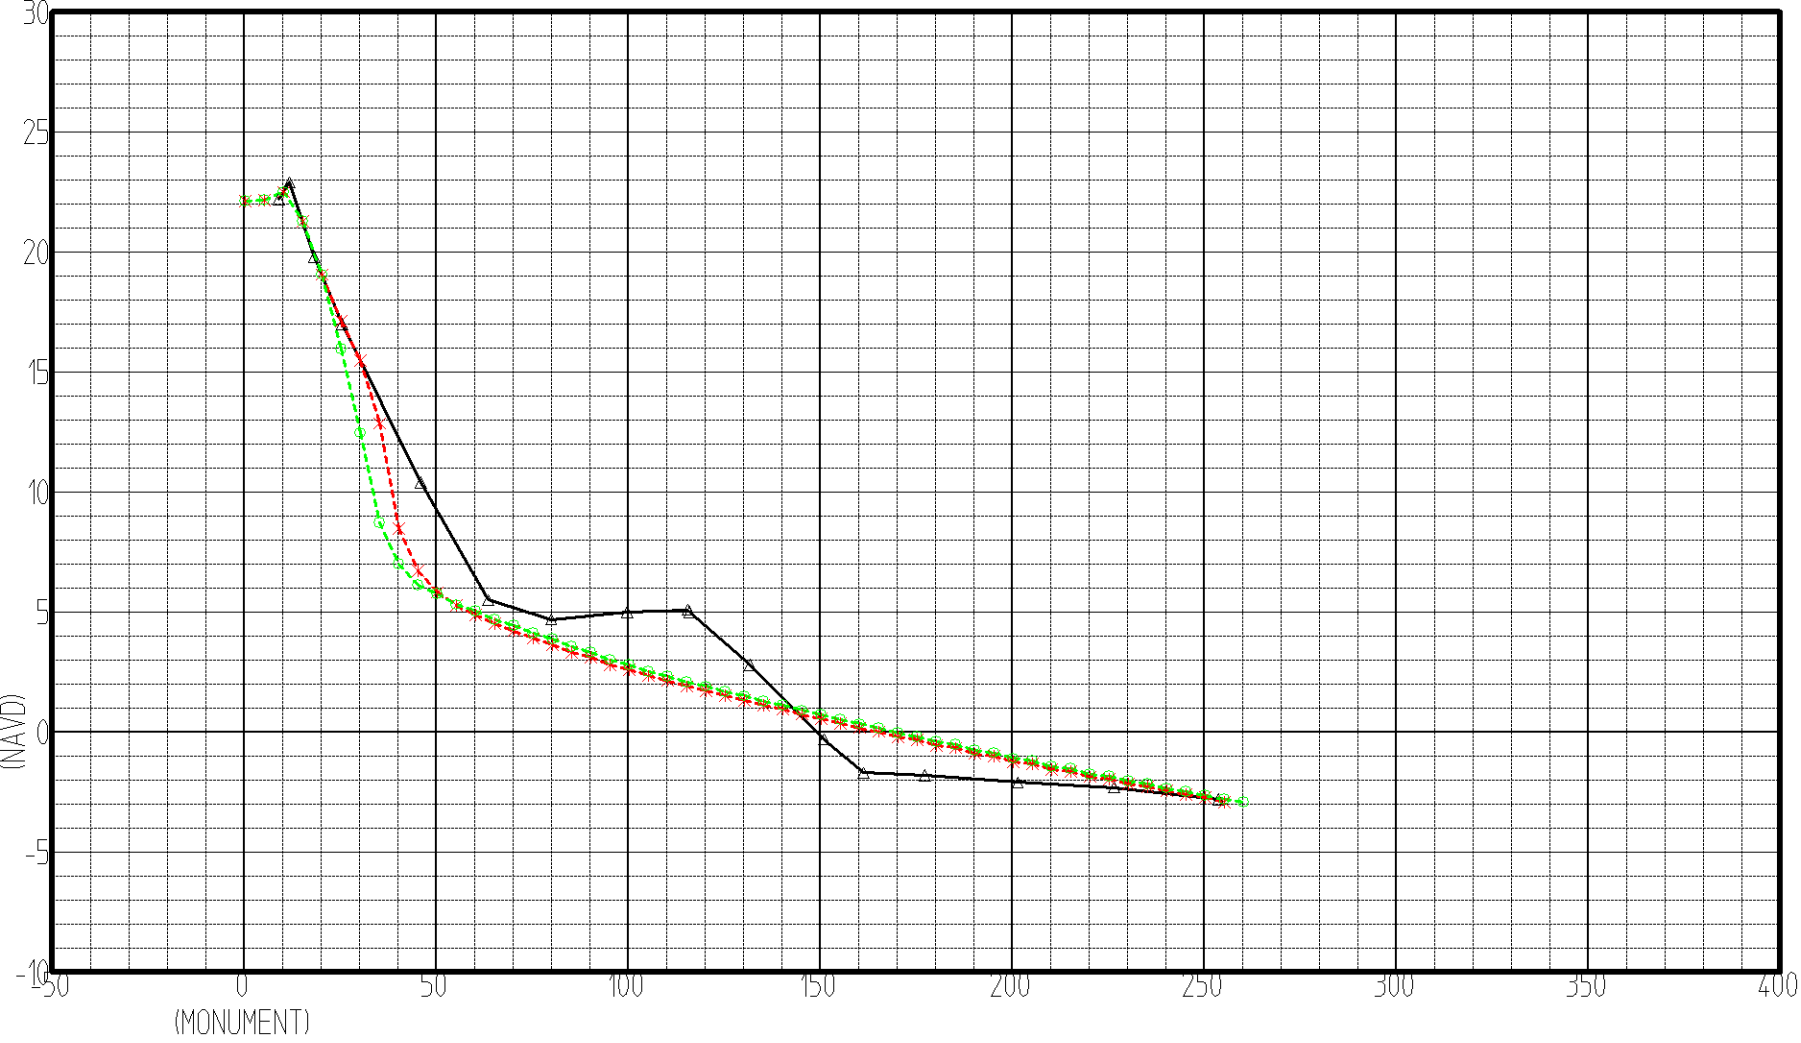
Range: R-81
 BEARING: 202.00
 1/1

BEACH PROFILE
 —△—△— WALTON JULY 2007 PRF
 - - * - - SBEACH 15-YR ERODED PRF
 - - o - - SBEACH 25-YR ERODED PRF

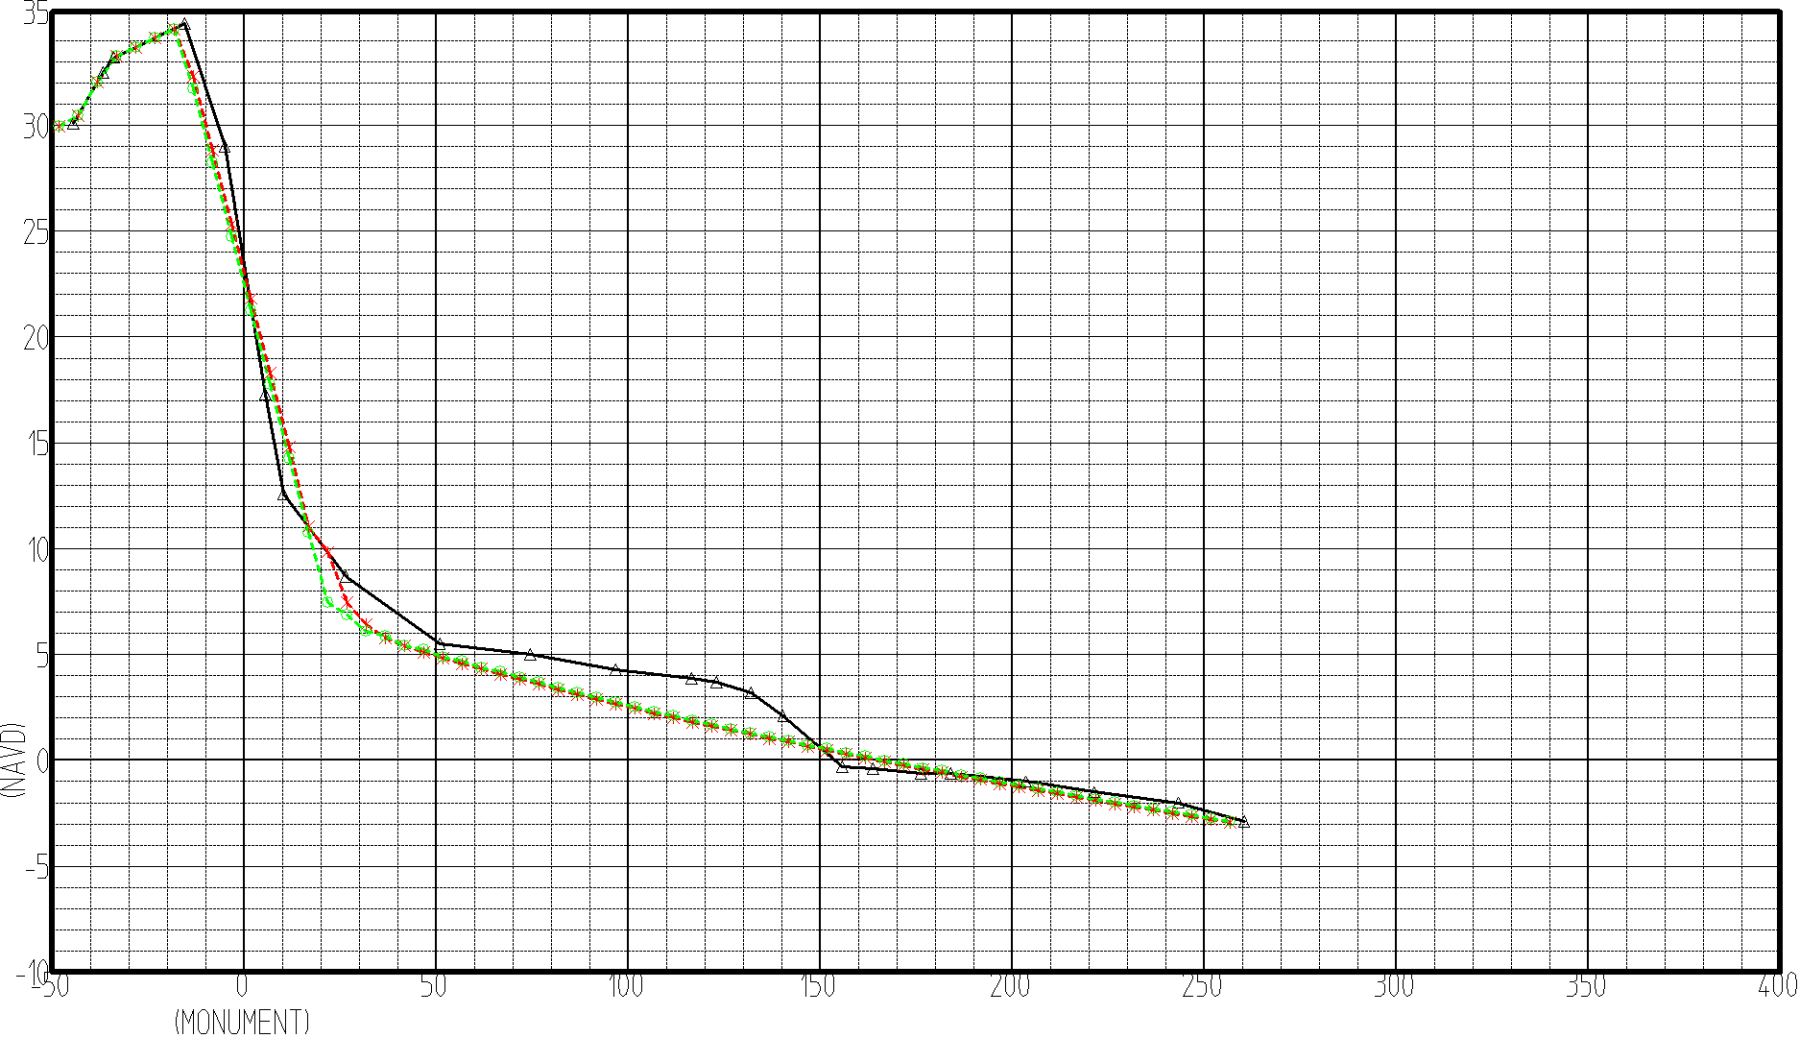
Range: R-82
 BEARING: 202.00
 1/1

BEACH PROFILE
 —△—△— WALTON JULY 2007 PRF
 - - * - - SBEACH 15-YR ERODED PRF
 - - o - - SBEACH 25-YR ERODED PRF

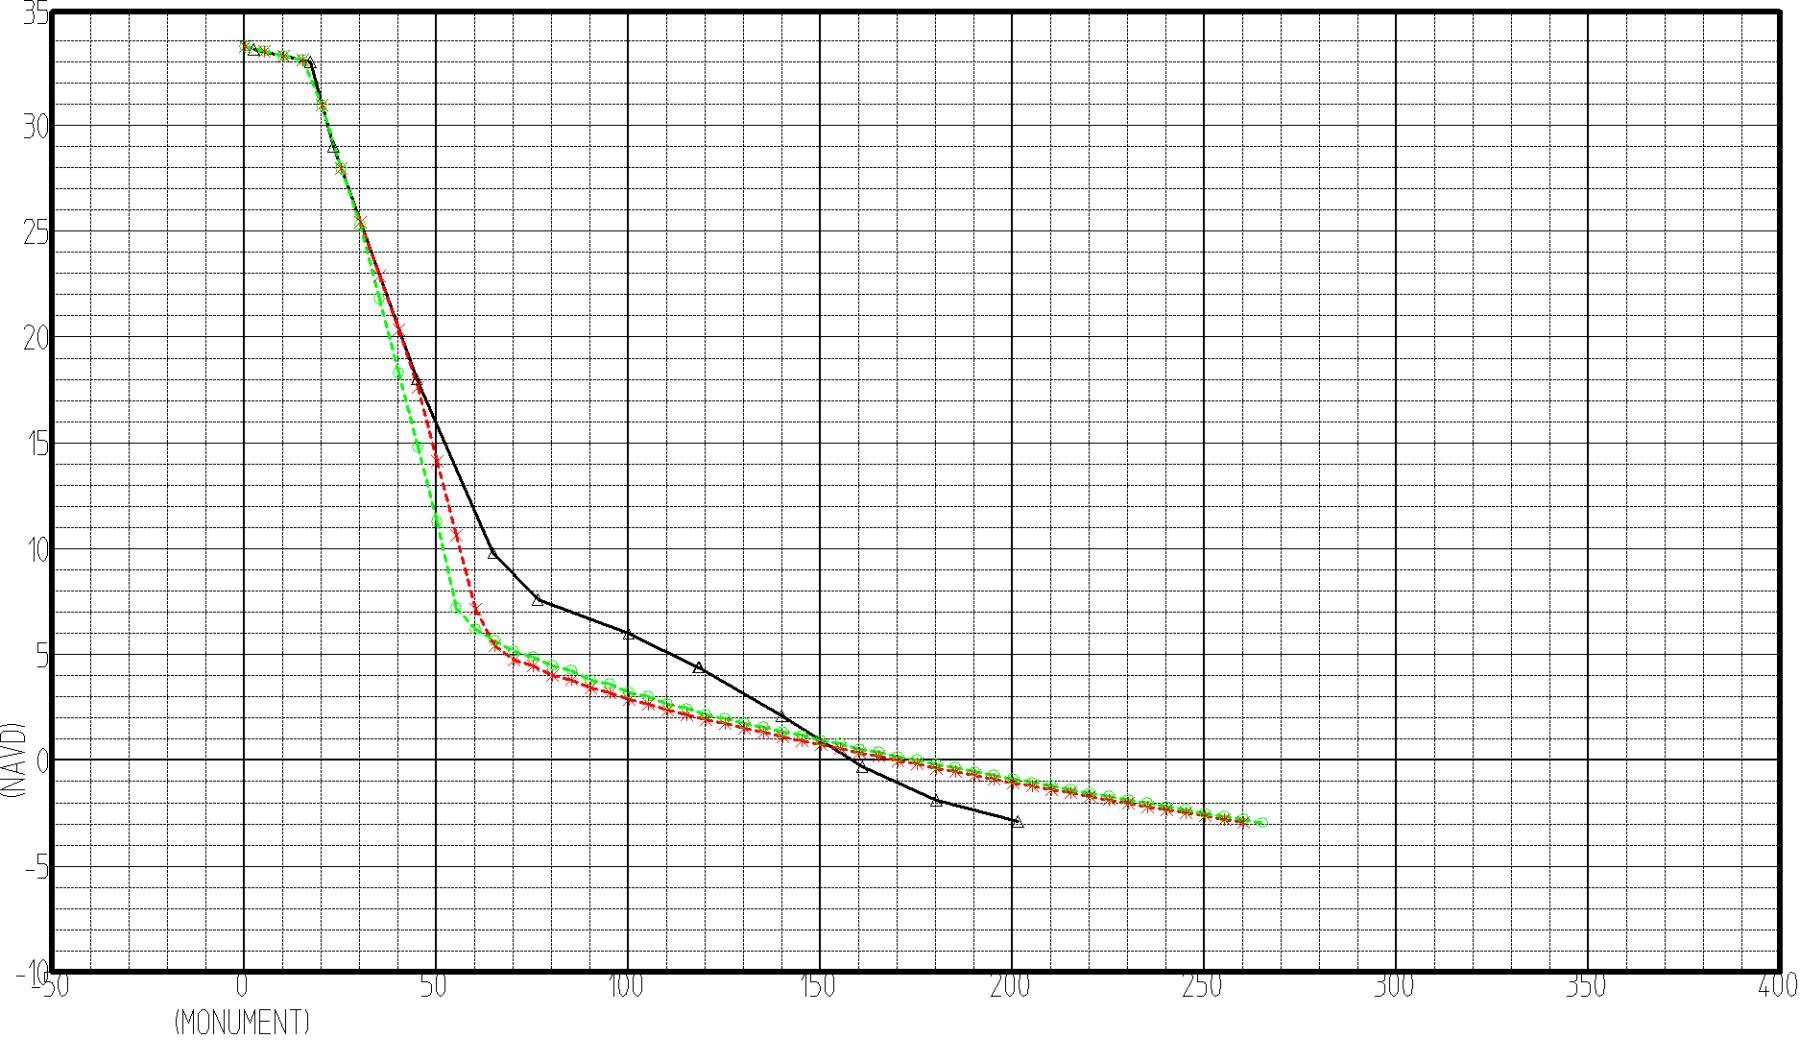
Range: R-83
 BEARING: 202.00
 1/1

BEACH PROFILE
 —△—△— WALTON JULY 2007 PRF
 - - * - - SBEACH 15-YR ERODED PRF
 - - o - - SBEACH 25-YR ERODED PRF

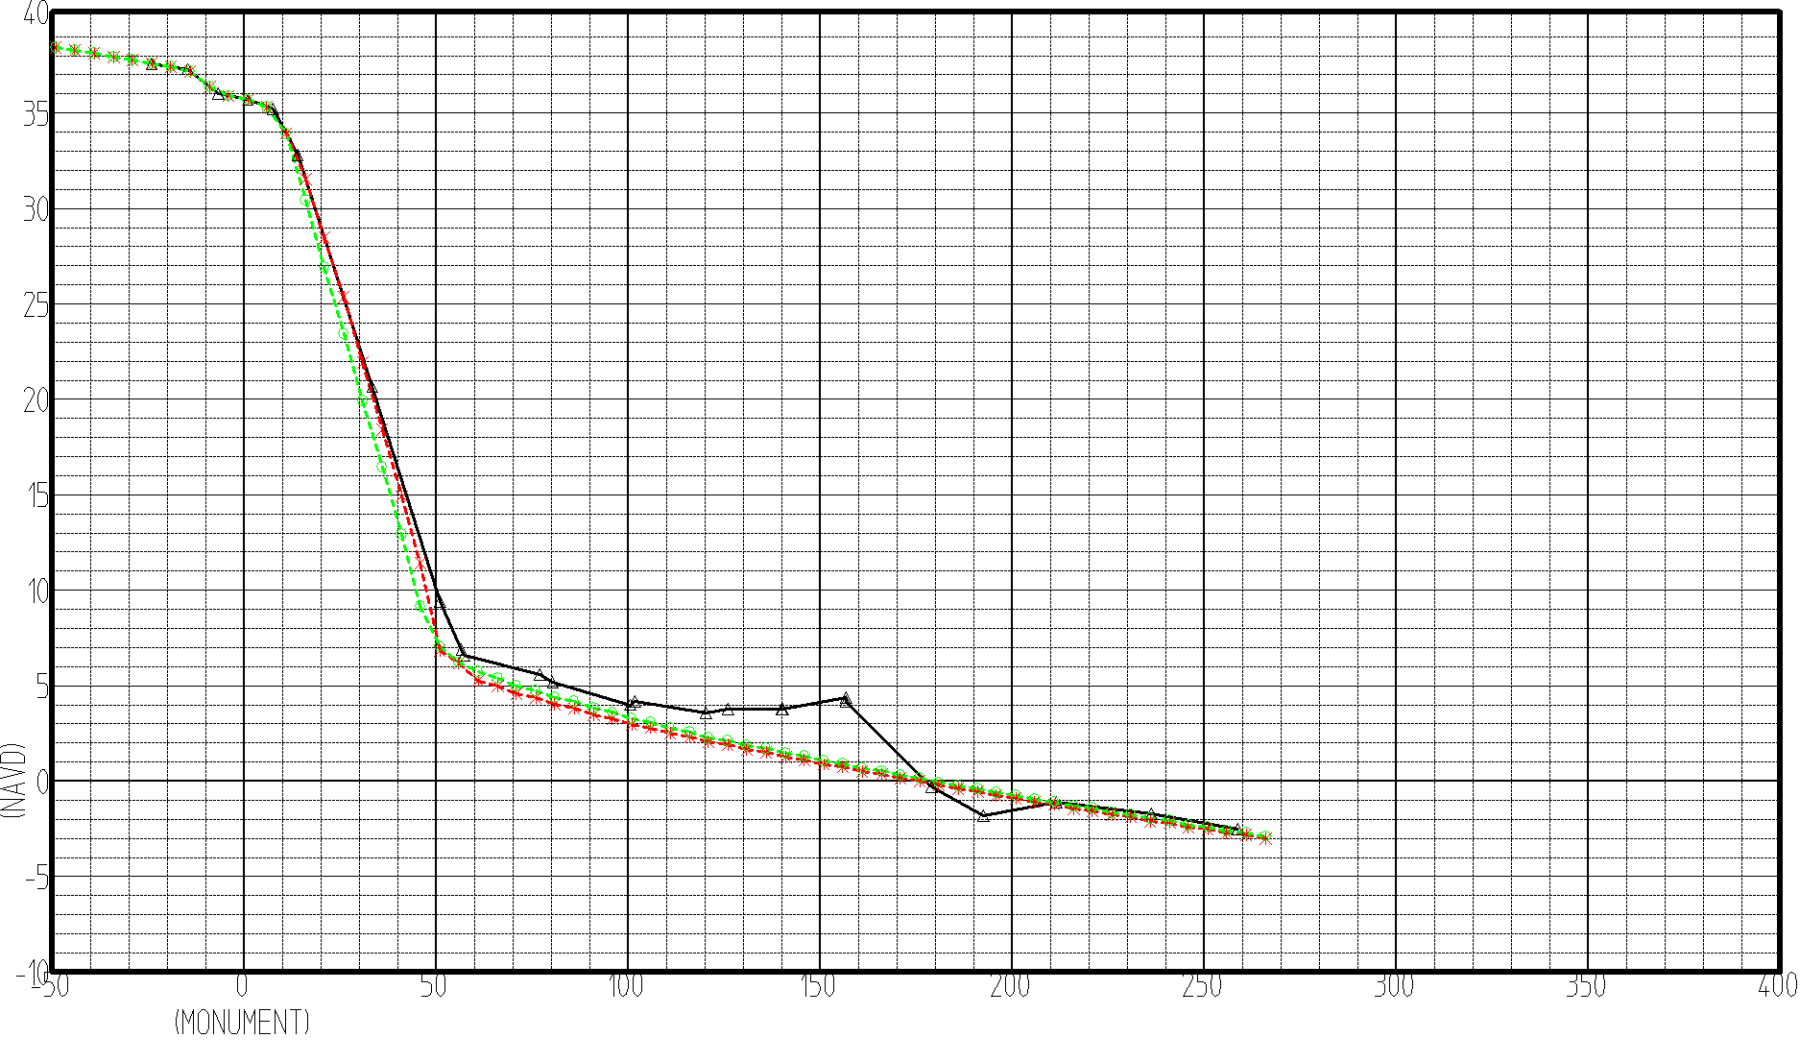
Range: R-84
 BEARING: 202.00
 1/1

BEACH PROFILE
 —△—△— WALTON JULY 2007 PRF
 - - * - - SBEACH 15-YR ERODED PRF
 - - o - - SBEACH 25-YR ERODED PRF
