Appendix II

SBEACH Model Erosion Profile Plots

Walton County

15-year and 25-year Storm Events

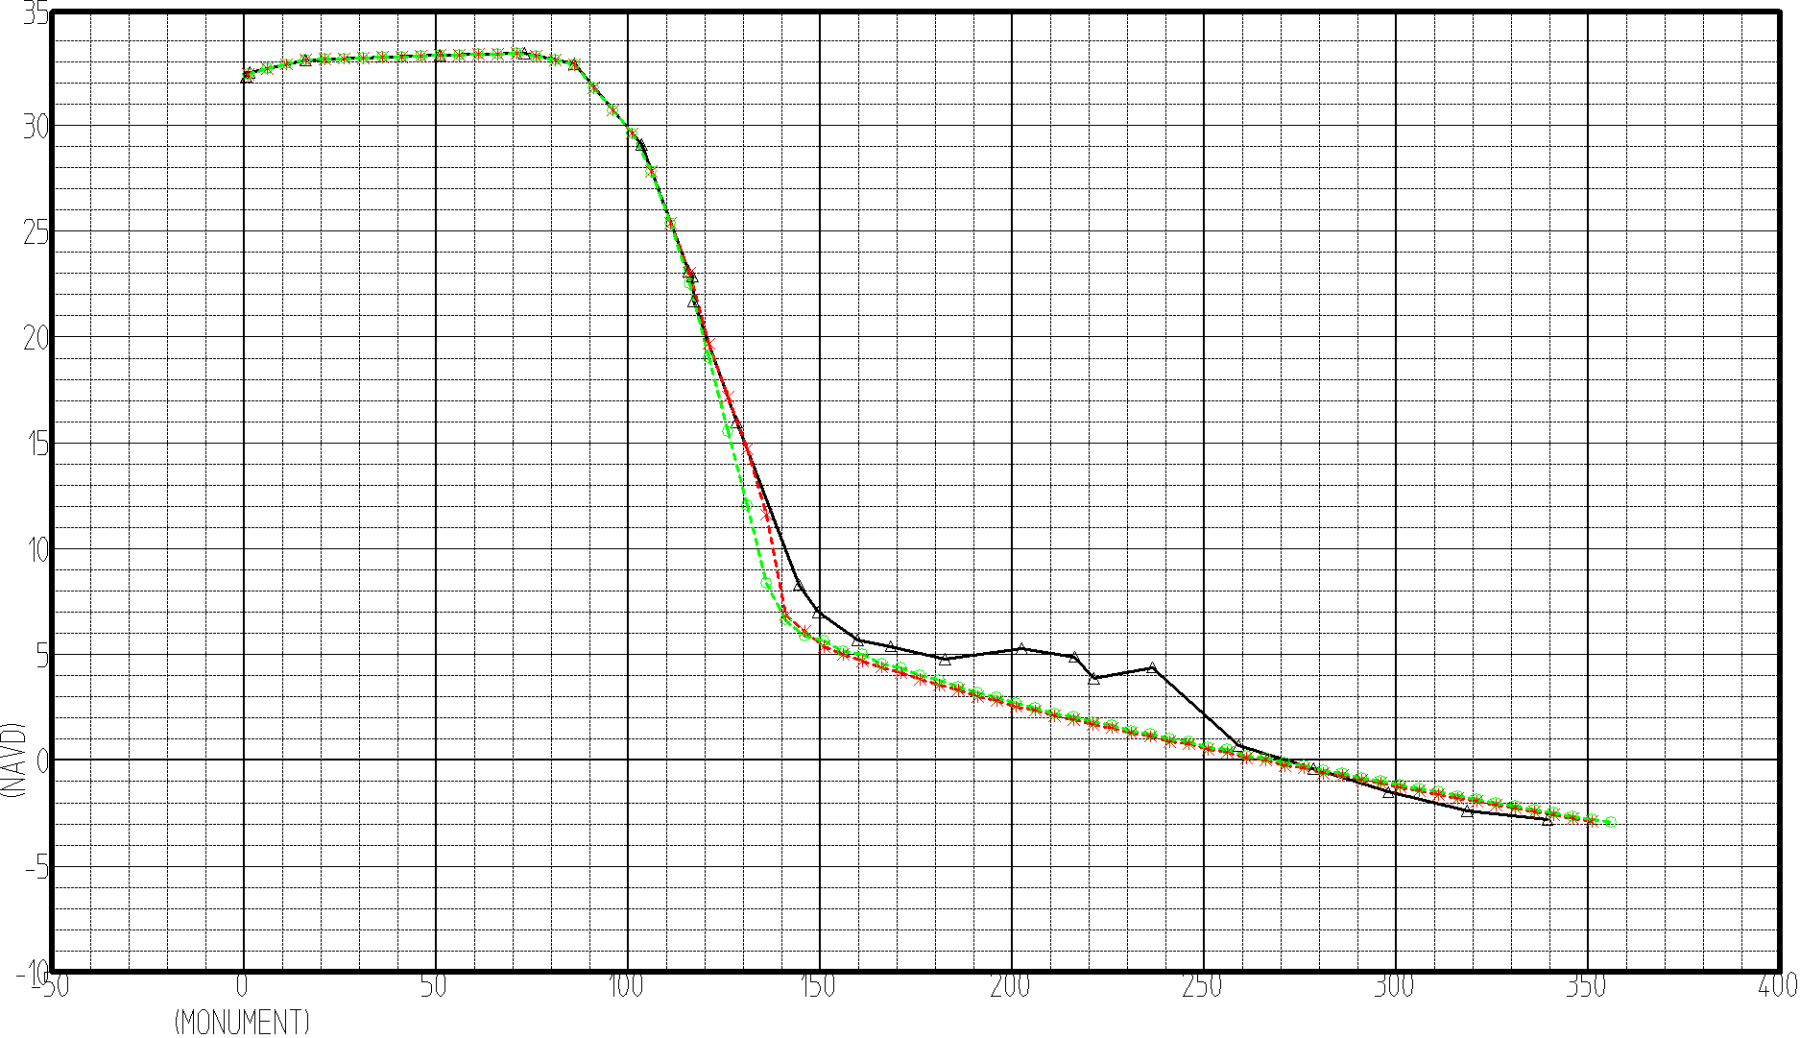
BEACH PROFILE
 —△—△— WALTON JULY 2007 PRF
 - - * - - SBEACH 15-YR ERODED PRF
 - - o - - SBEACH 25-YR ERODED PRF

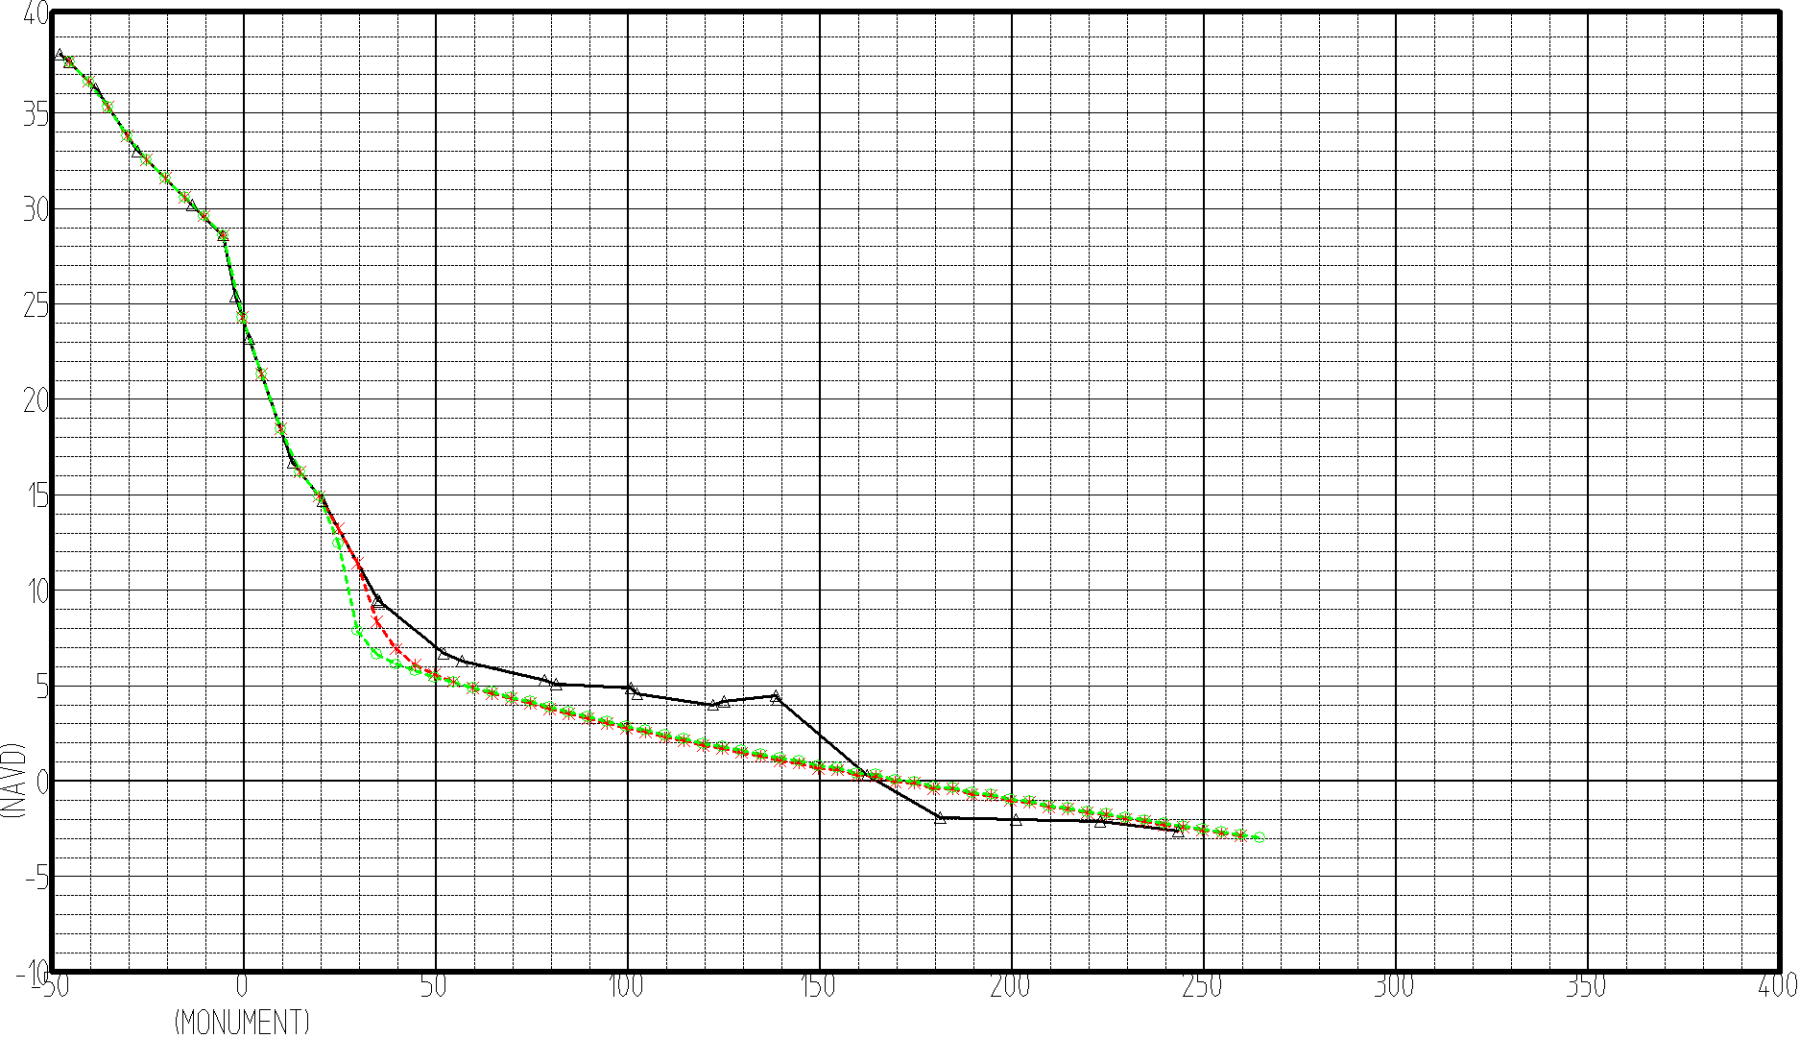
Range: R-86
 BEARING: 202.00
 1/1

BEACH PROFILE
 —△—△— WALTON JULY 2007 PRF
 - - * - - * - - SBEACH 15-YR ERODED PRF
 - - o - - o - - SBEACH 25-YR ERODED PRF

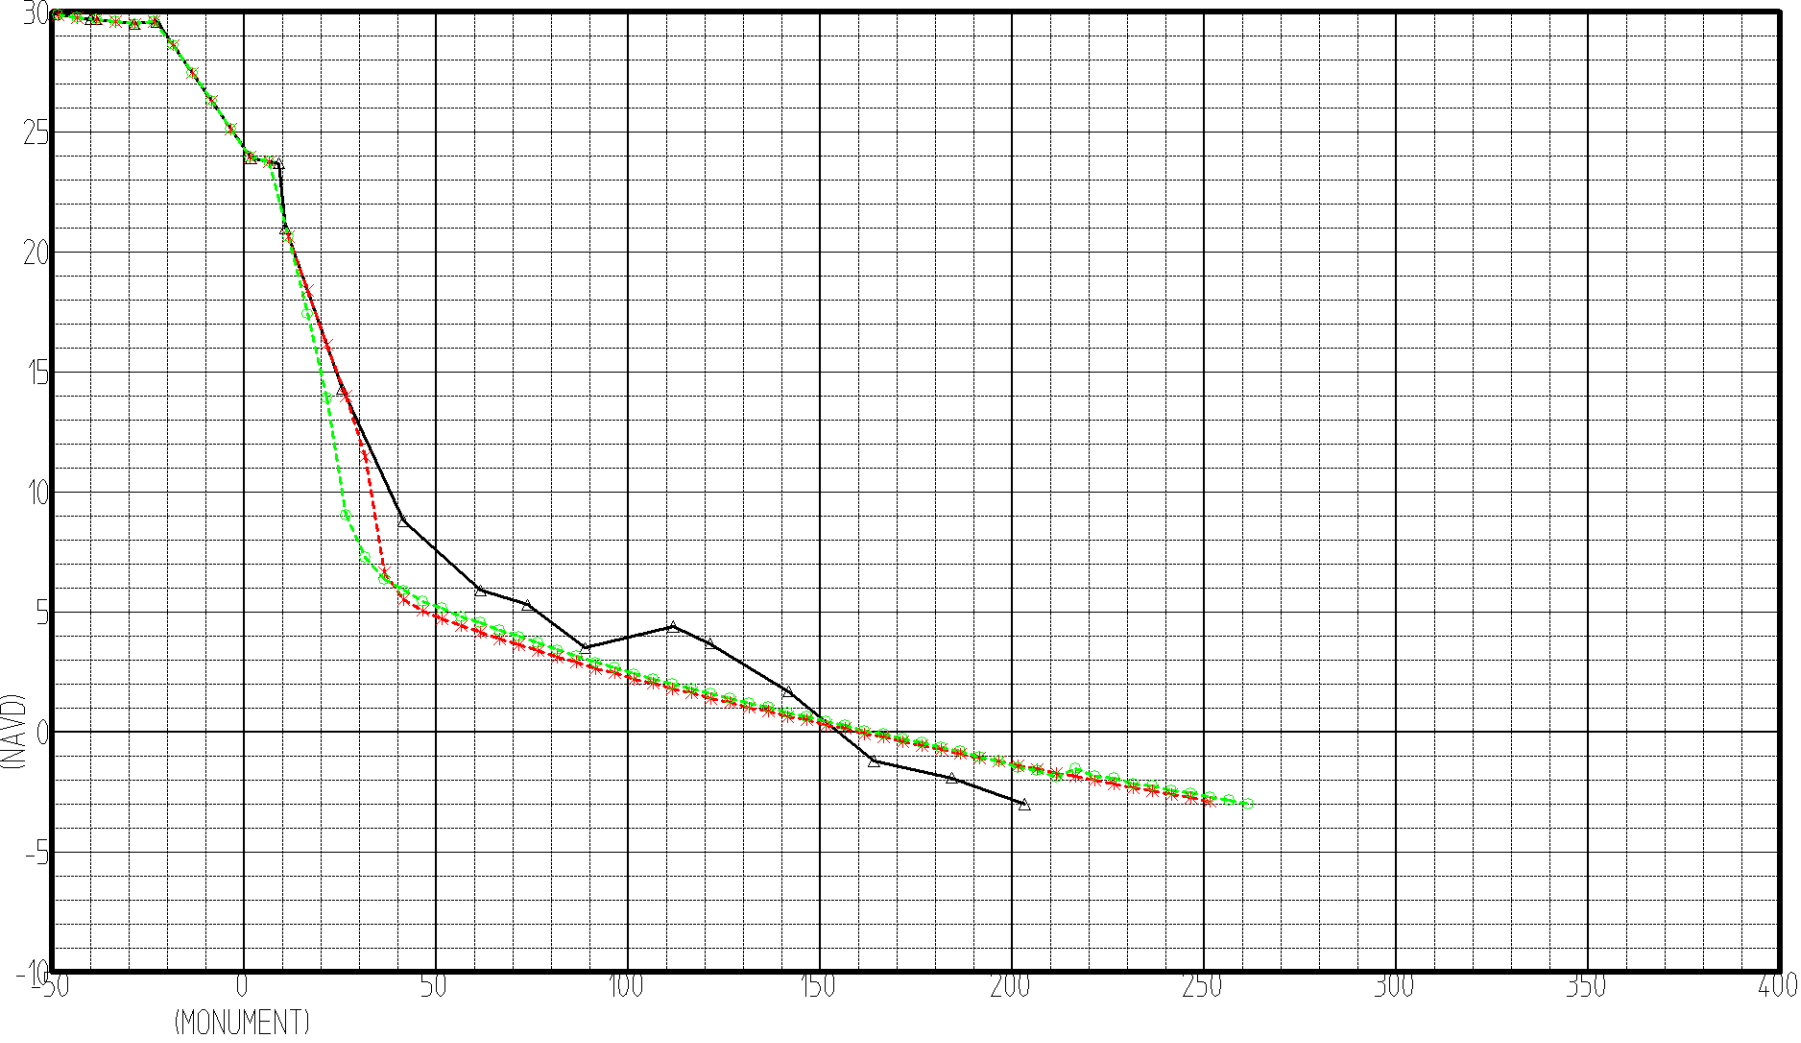
Range: R-87
 BEARING: 202.00
 1/1

BEACH PROFILE
 —△—△— WALTON JULY 2007 PRF
 - - * - - SBEACH 15-YR ERODED PRF
 - - o - - SBEACH 25-YR ERODED PRF

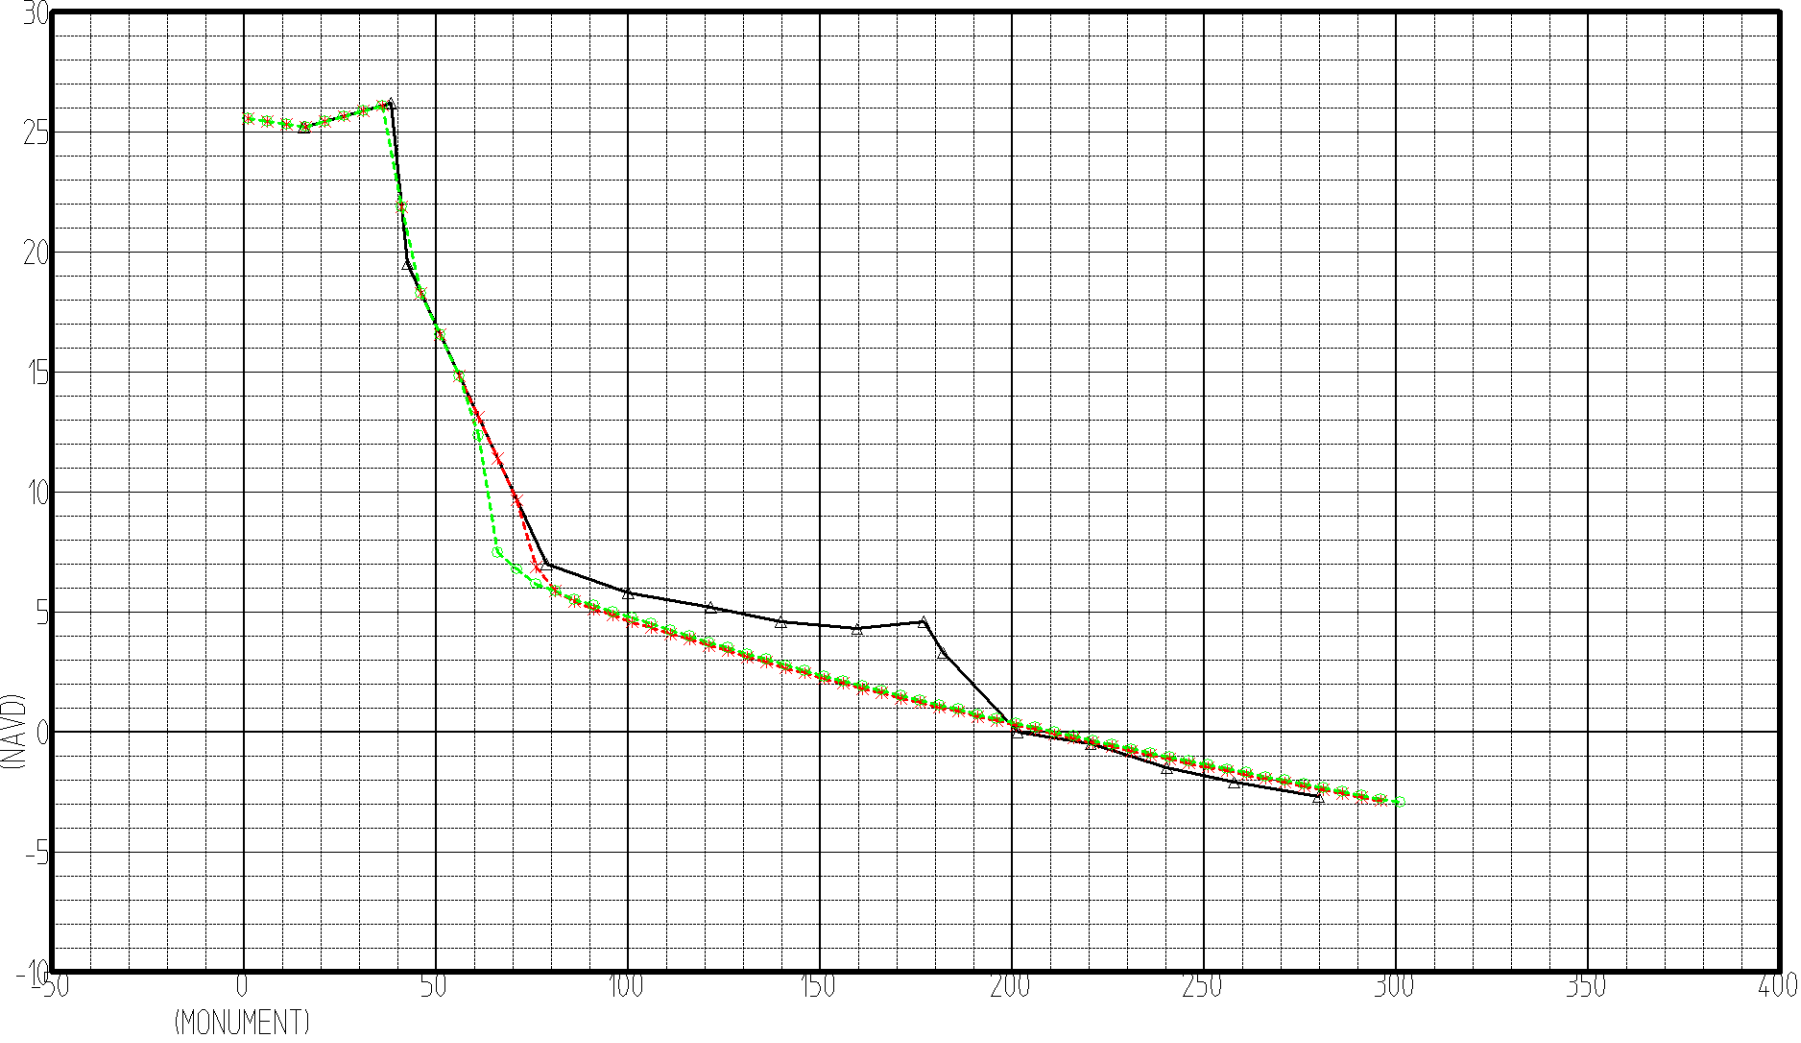
Range: R-88
 BEARING: 202.00
 1/1

BEACH PROFILE
 —△—△— WALTON JULY 2007 PRF
 - - * - - * - - SBEACH 15-YR ERODED PRF
 - - o - - o - - SBEACH 25-YR ERODED PRF

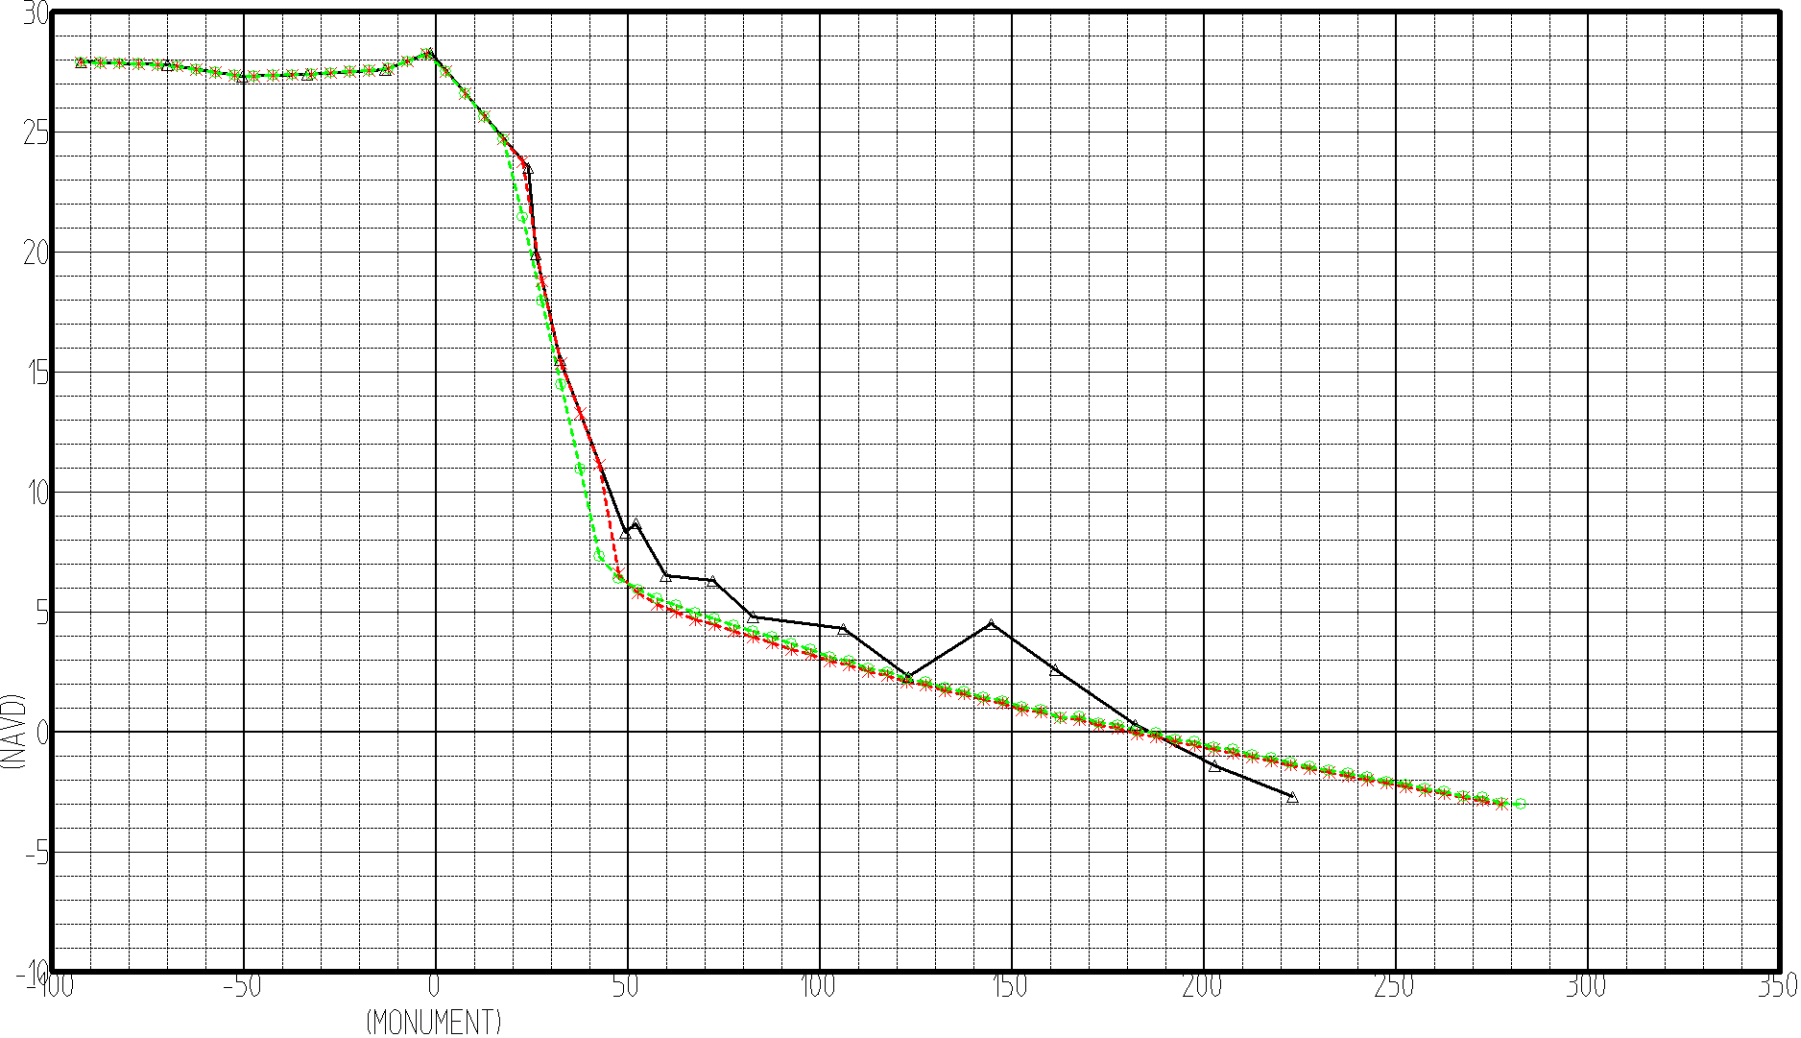
Range: R-89
 BEARING: 202.00
 1/1

BEACH PROFILE
 —△—△— WALTON JULY 2007 PRF
 - - * - - SBEACH 15-YR ERODED PRF
 - - ○ - - SBEACH 25-YR ERODED PRF

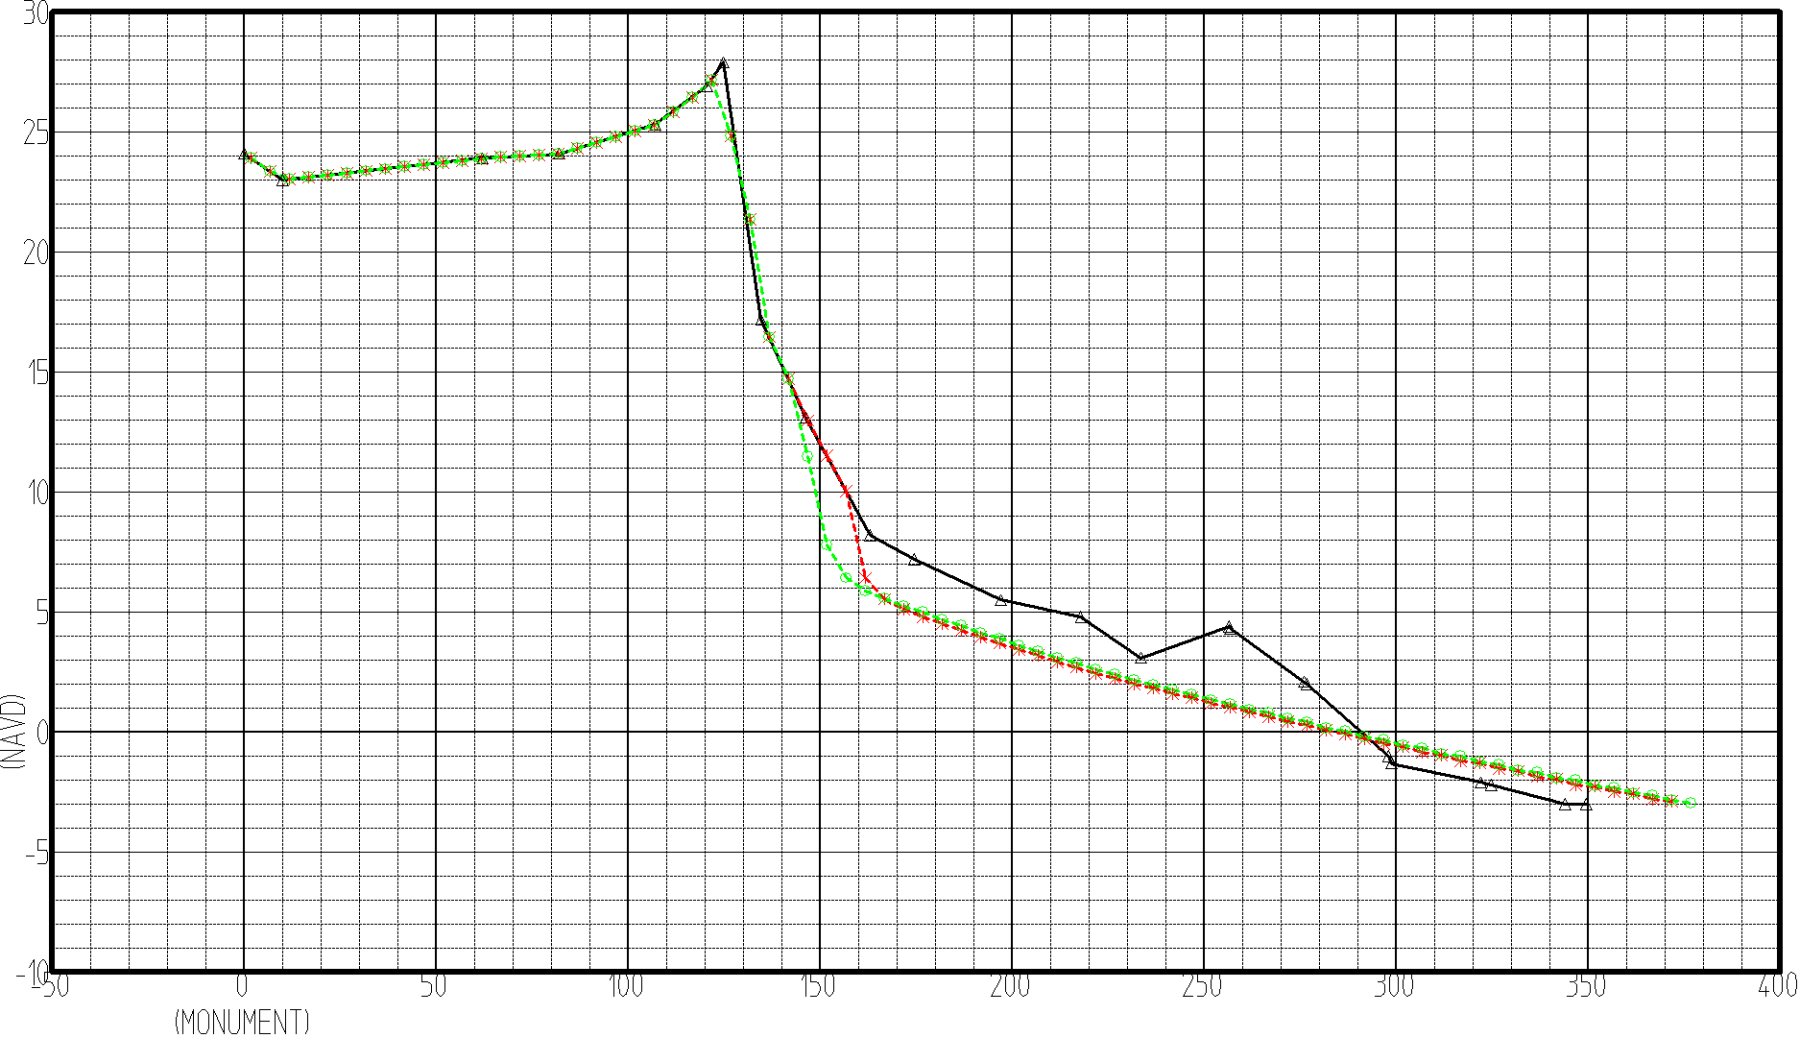
Range: R-91
 BEARING: 202.00
 1/1

BEACH PROFILE
 —△—△— WALTON JULY 2007 PRF
 - - * - - * - - SBEACH 15-YR ERODED PRF
 - - o - - o - - SBEACH 25-YR ERODED PRF

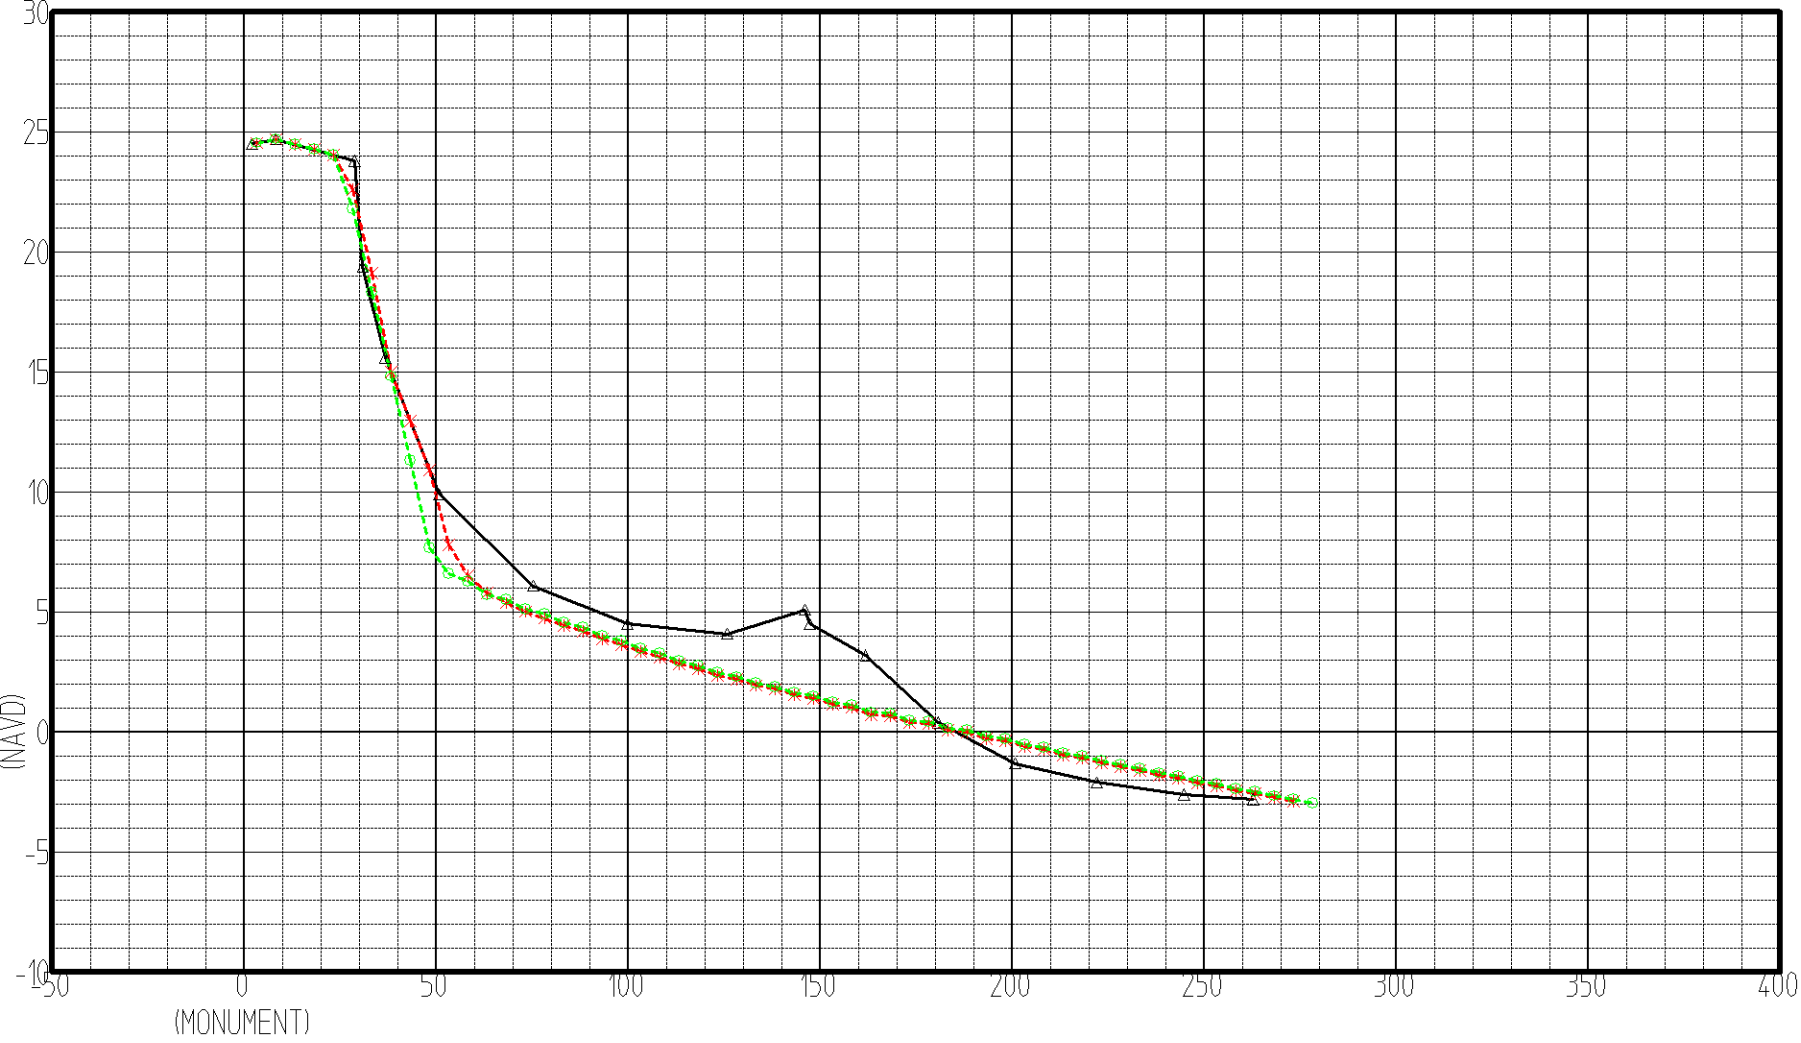
Range: R-92
 BEARING: 202.00
 1/1

BEACH PROFILE
 —△—△— WALTON JULY 2007 PRF
 - - * - - SBEACH 15-YR ERODED PRF
 - - o - - SBEACH 25-YR ERODED PRF

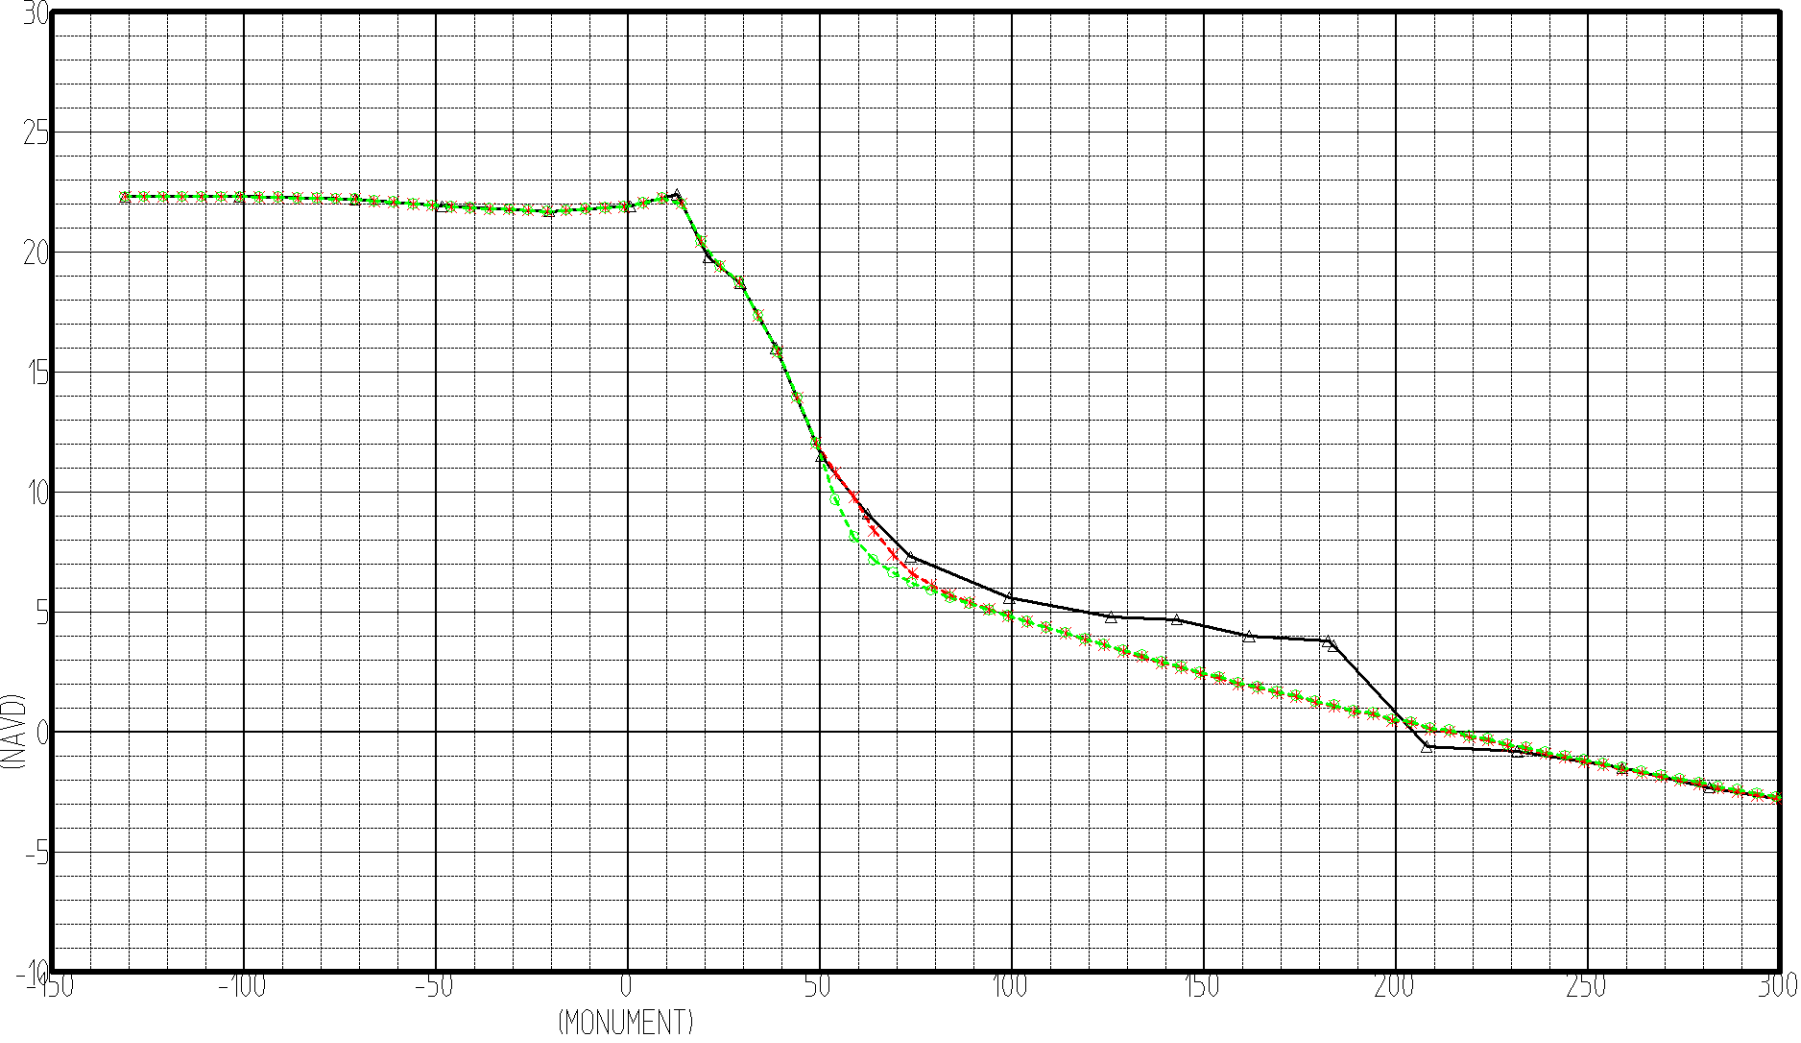
Range: R-93
 BEARING: 202.00
 1/2

BEACH PROFILE
 —△—△— WALTON JULY 2007 PRF
 - - * - - SBEACH 15-YR ERODED PRF
 - - o - - SBEACH 25-YR ERODED PRF

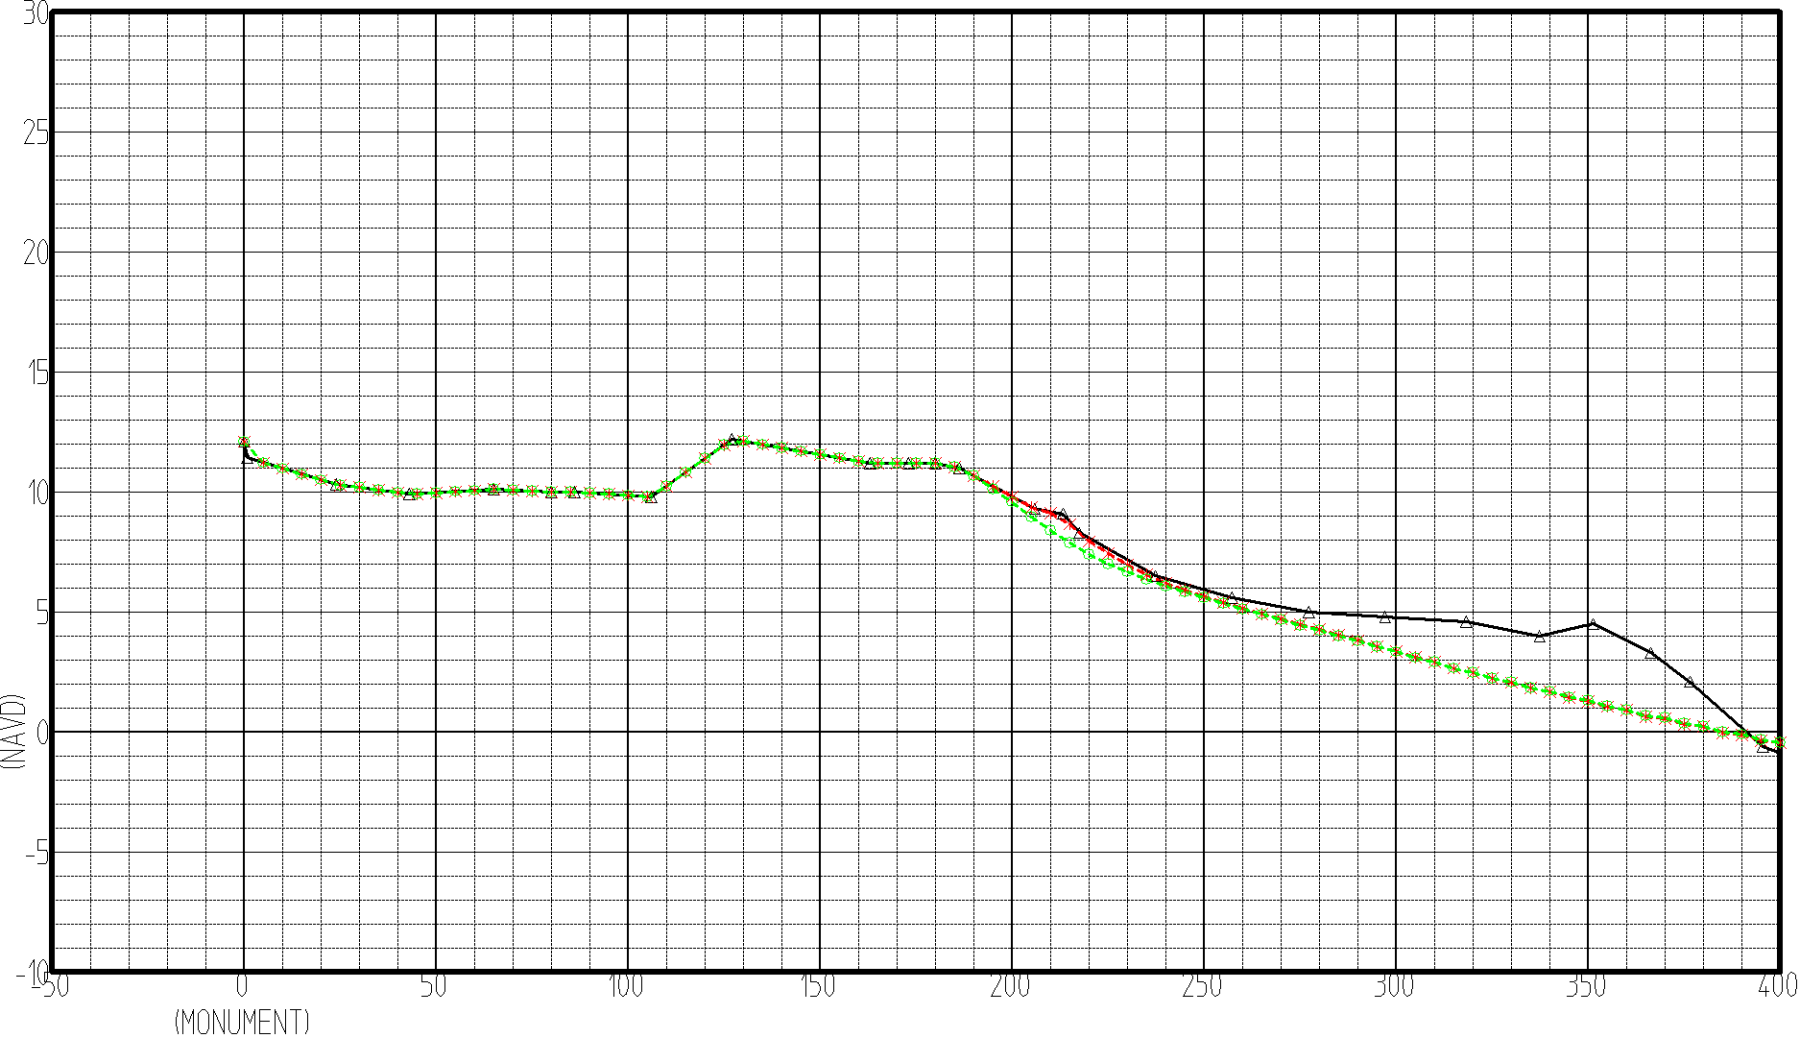
Range: R-94
 BEARING: 202.00
 1/2

BEACH PROFILE
 —△—△— WALTON JULY 2007 PRF
 - - * - - * - - SBEACH 15-YR ERODED PRF
 - - o - - o - - SBEACH 25-YR ERODED PRF

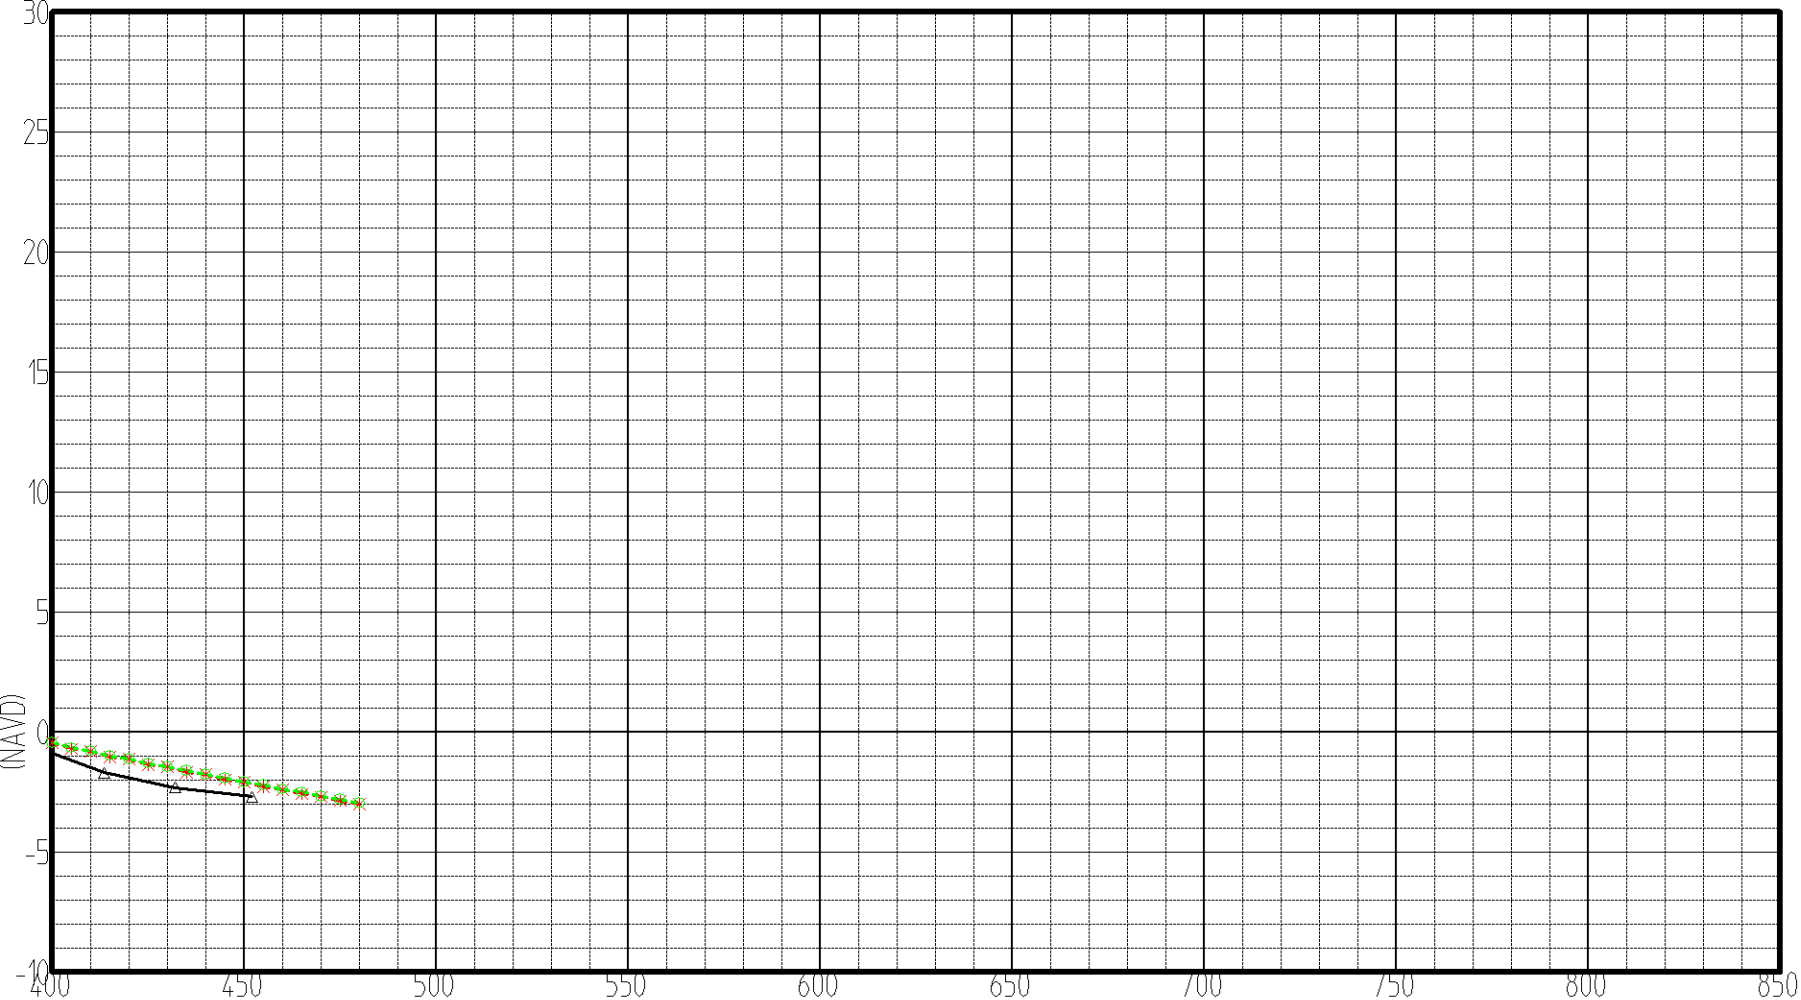
Range: R-94 2/2
 BEARING: 202.00

BEACH PROFILE
 —△—△— WALTON JULY 2007 PRF
 - - * - - SBEACH 15-YR ERODED PRF
 - - o - - SBEACH 25-YR ERODED PRF

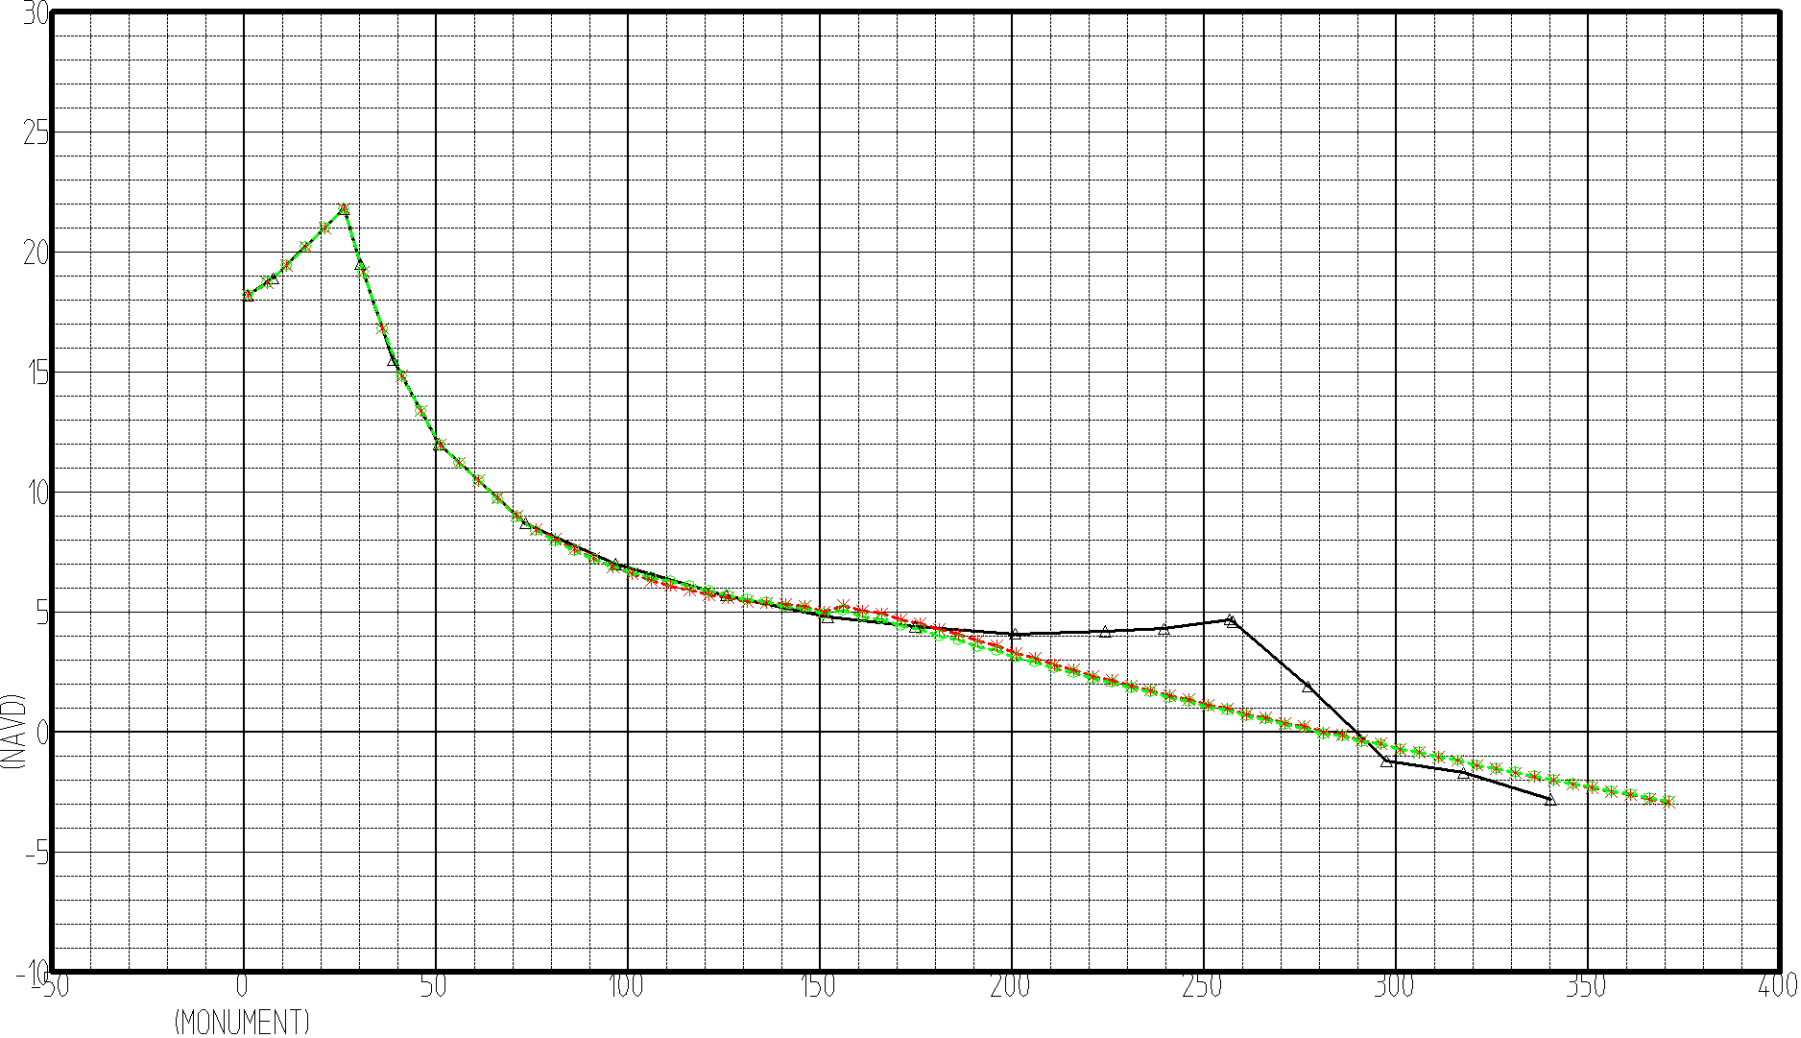
Range: R-95
 BEARING: 202.00
 1/1

BEACH PROFILE
 —△—△— WALTON JULY 2007 PRF
 - - * - - SBEACH 15-YR ERODED PRF
 - - o - - SBEACH 25-YR ERODED PRF

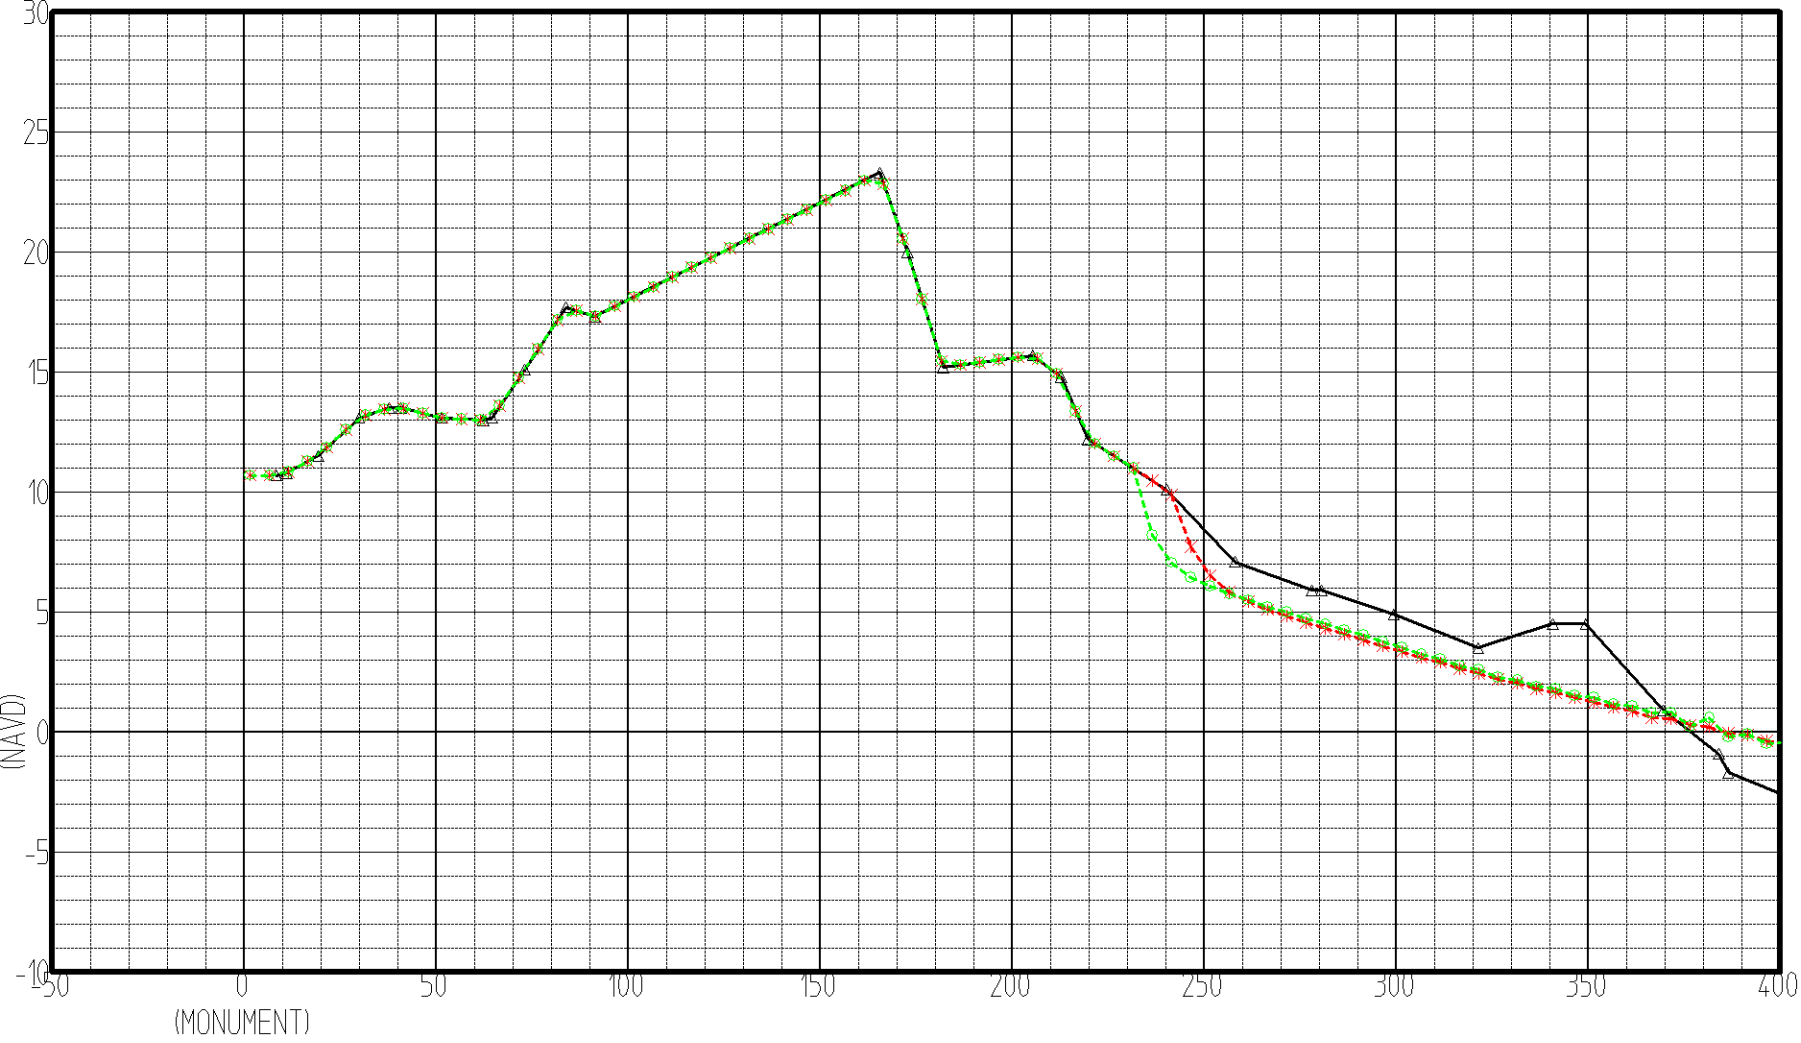
Range: R-97
 BEARING: 202.00
 1/2

BEACH PROFILE
 —△—△— WALTON JULY 2007 PRF
 - - * - - SBEACH 15-YR ERODED PRF
 - - o - - SBEACH 25-YR ERODED PRF
