Appendix II

SBEACH Model Erosion Profile Plots

Walton County

15-year and 25-year Storm Events

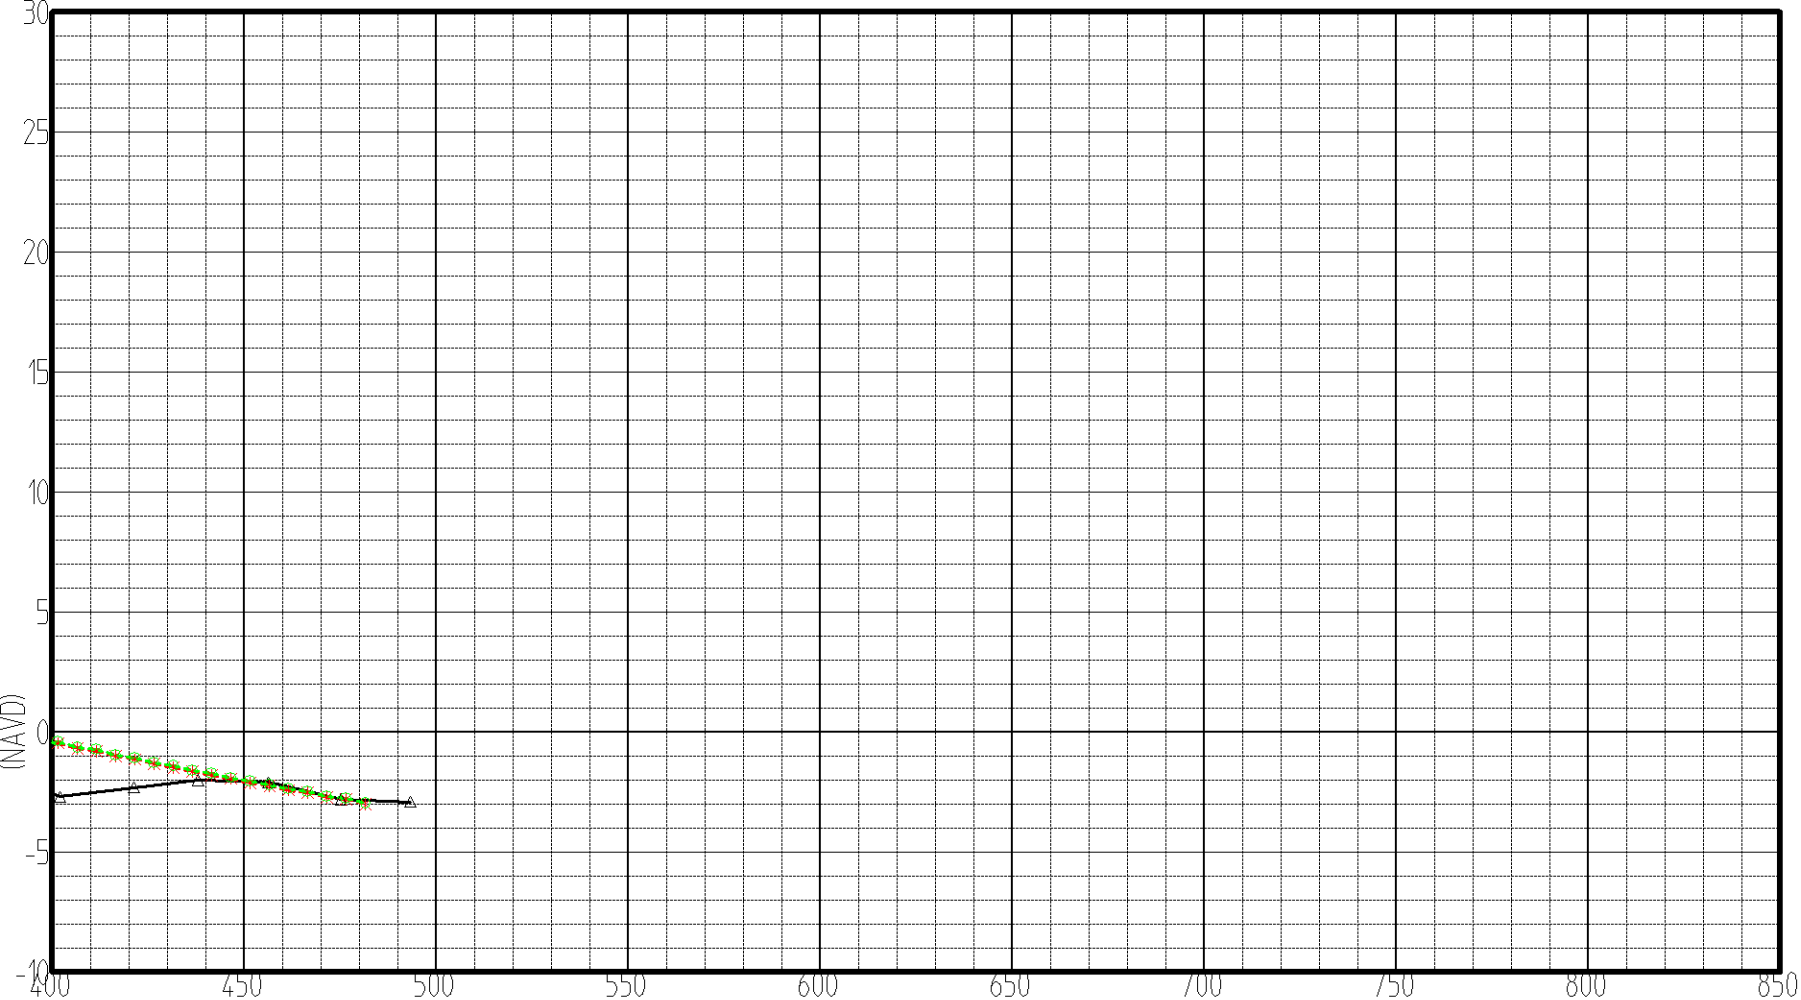
Range: R-97 2/2
 BEARING: 202.00

BEACH PROFILE
 —△—△— WALTON JULY 2007 PRF
 - - * - - SBEACH 15-YR ERODED PRF
 - - o - - SBEACH 25-YR ERODED PRF

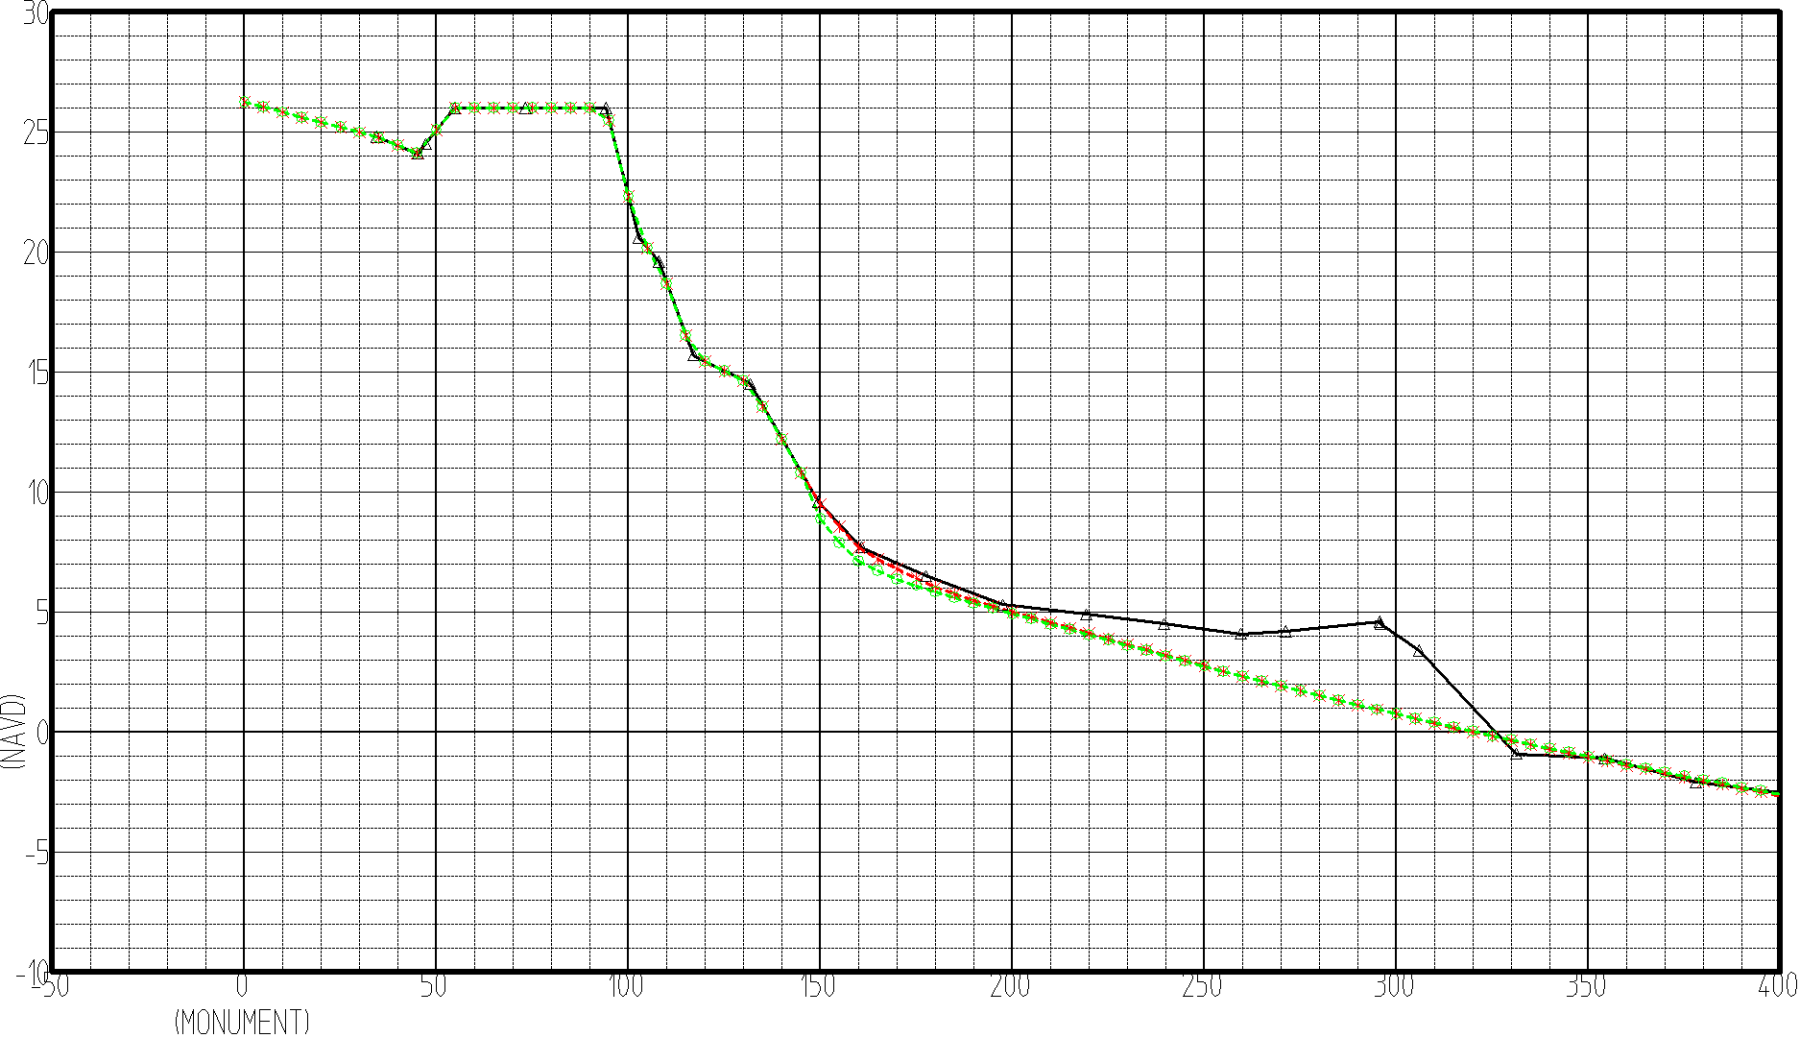
Range: R-98
 BEARING: 202.00
 1/2

BEACH PROFILE
 —△—△— WALTON JULY 2007 PRF
 - - * - - * - - SBEACH 15-YR ERODED PRF
 - - o - - o - - SBEACH 25-YR ERODED PRF

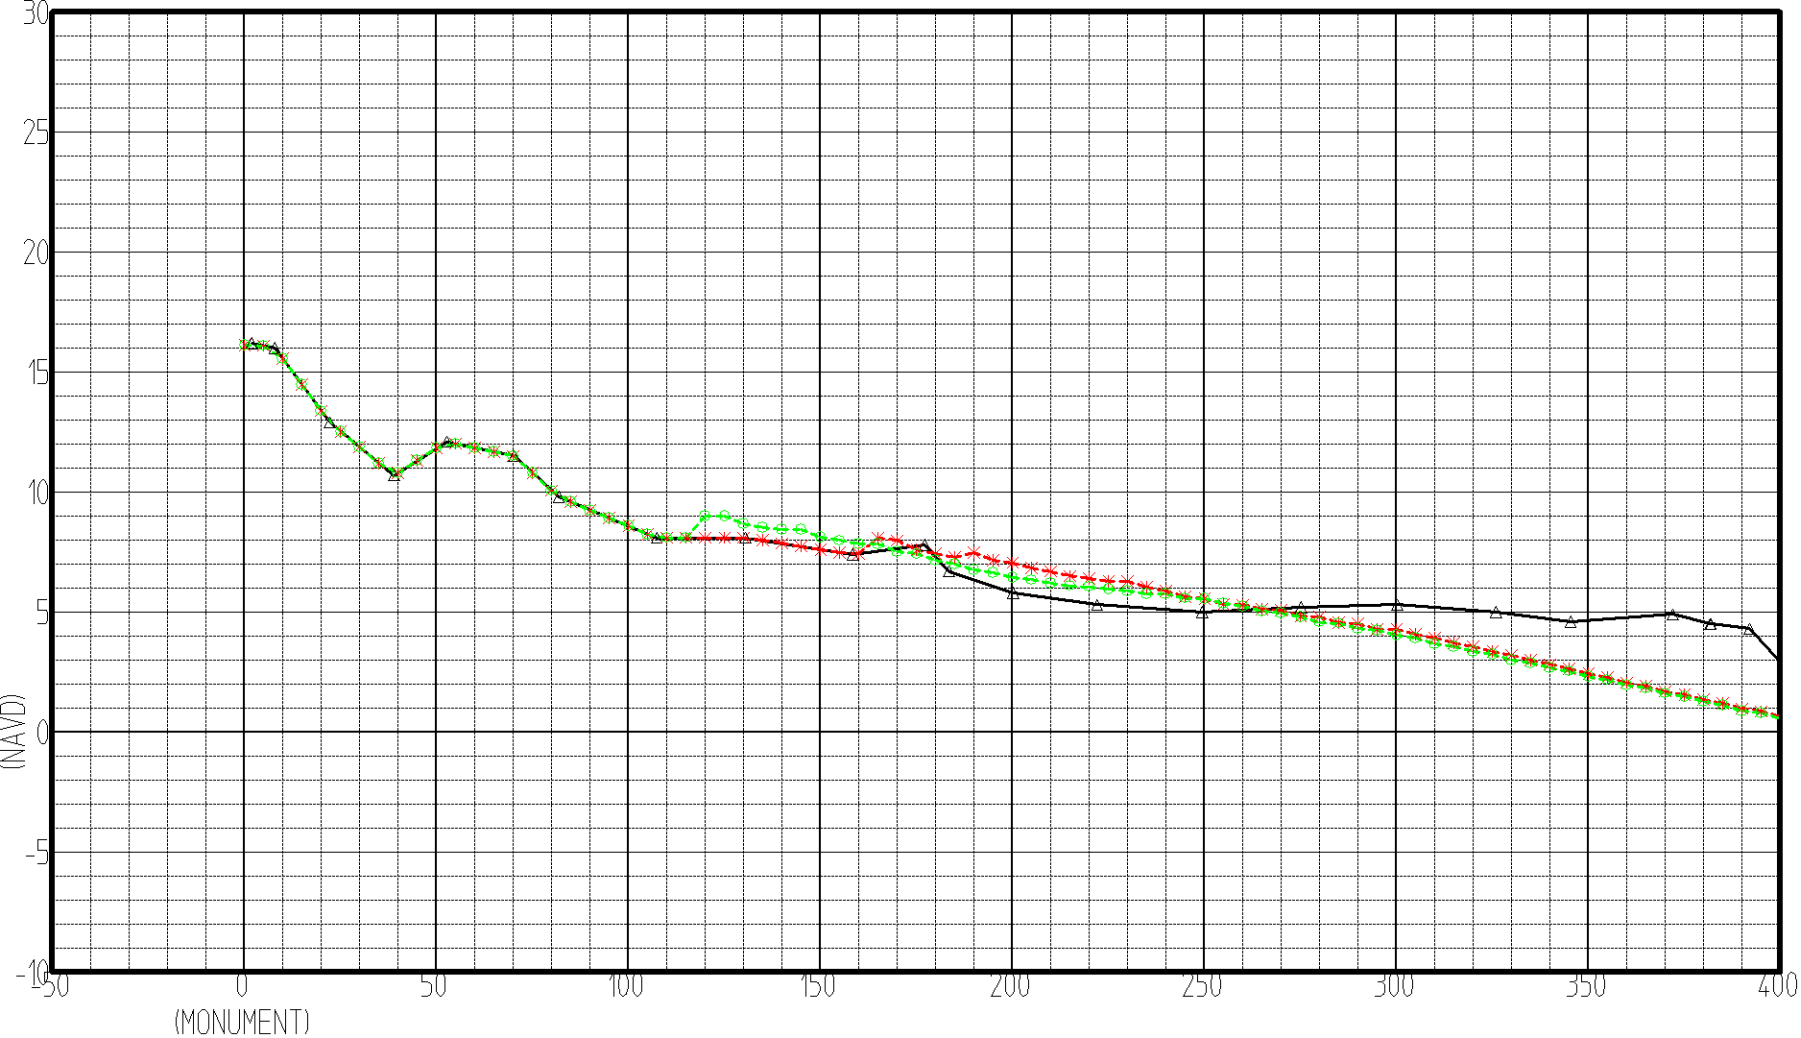
Range: R-99
 BEARING: 202.00
 1/2

BEACH PROFILE
 —△—△— WALTON JULY 2007 PRF
 - - * - - SBEACH 15-YR ERODED PRF
 - - o - - SBEACH 25-YR ERODED PRF

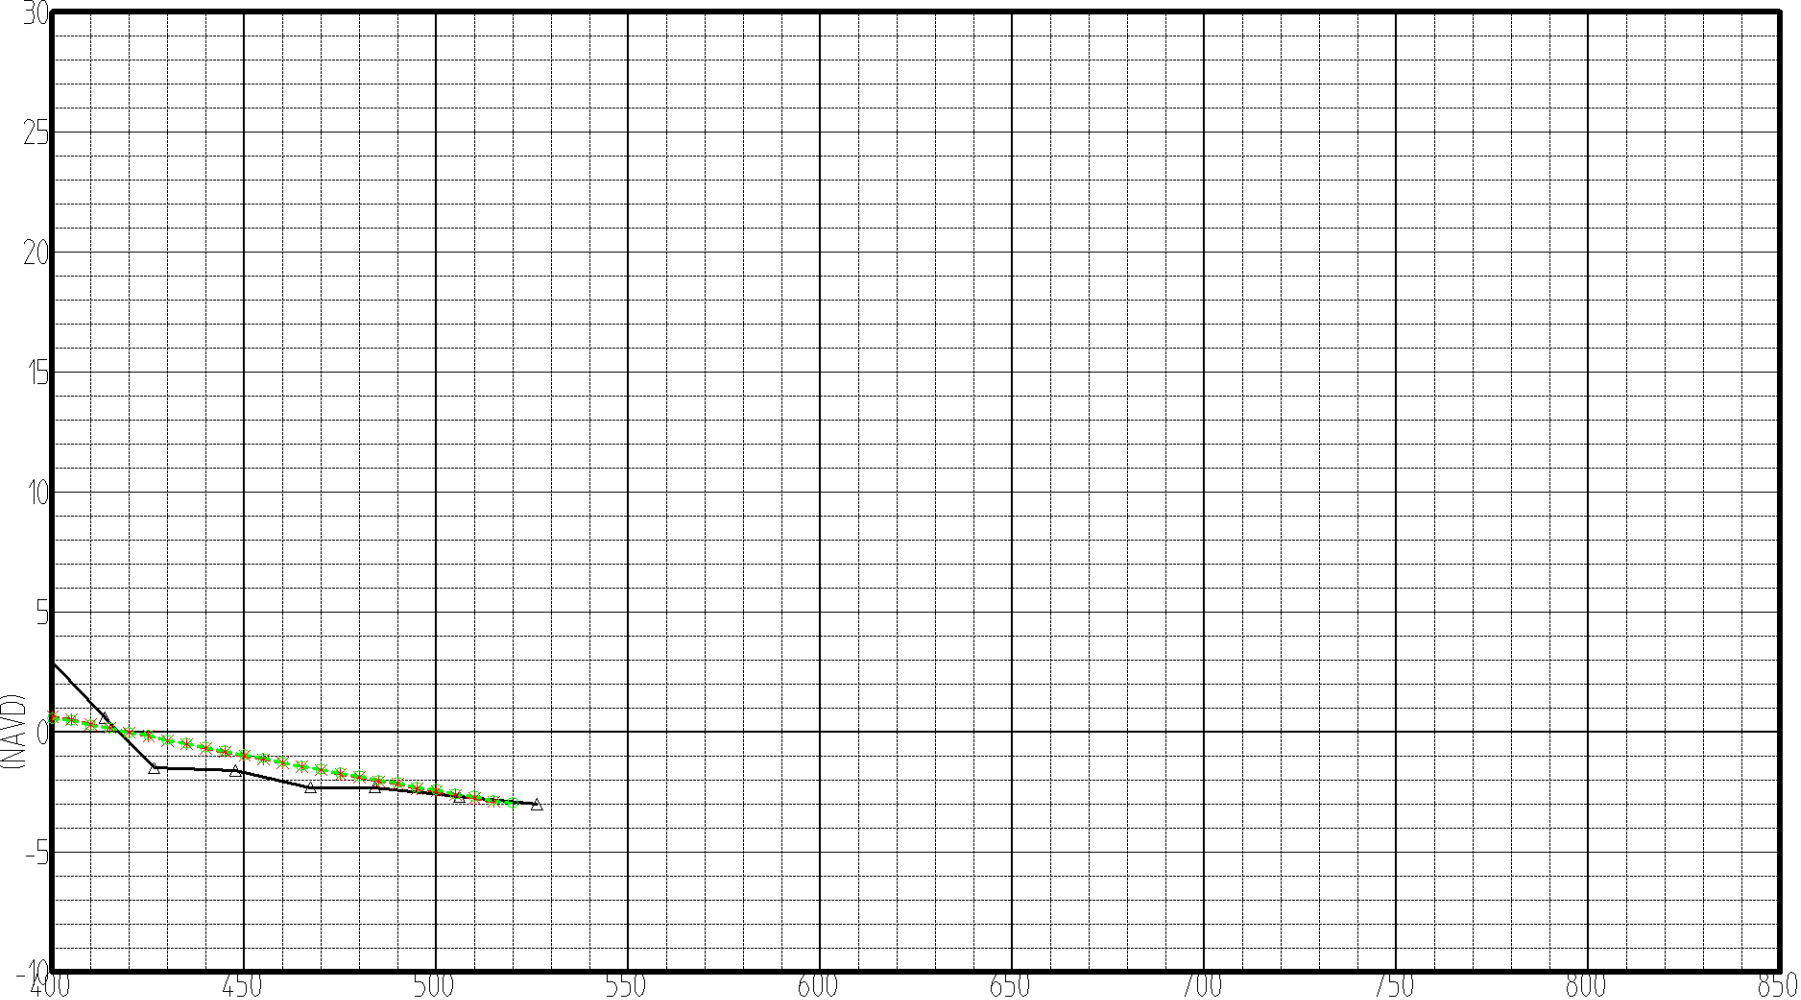
Range: R-99 2/2
 BEARING: 202.00

BEACH PROFILE
 —△—△— WALTON JULY 2007 PRF
 - - * - - SBEACH 15-YR ERODED PRF
 - - o - - SBEACH 25-YR ERODED PRF

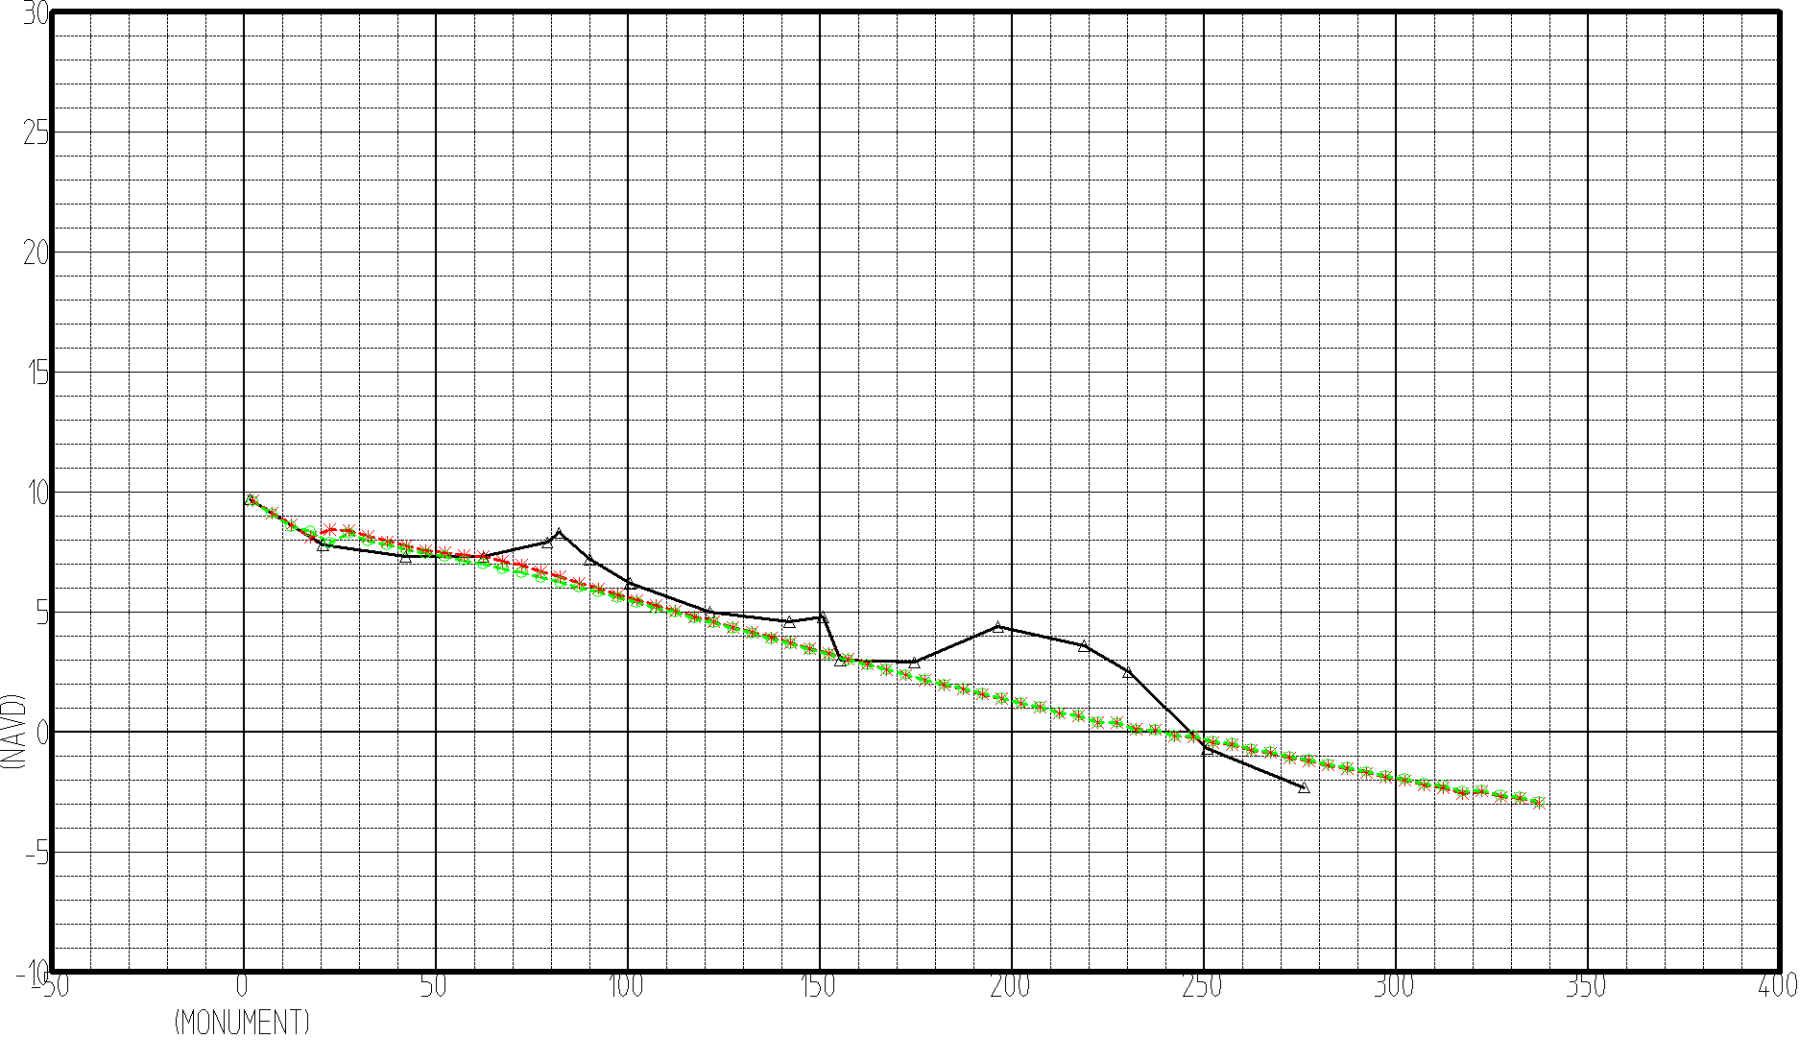
Range: R-100
 BEARING: 202.00
 1/1

BEACH PROFILE
 —△—△— WALTON JULY 2007 PRF
 - - * - - SBEACH 15-YR ERODED PRF
 - - o - - SBEACH 25-YR ERODED PRF

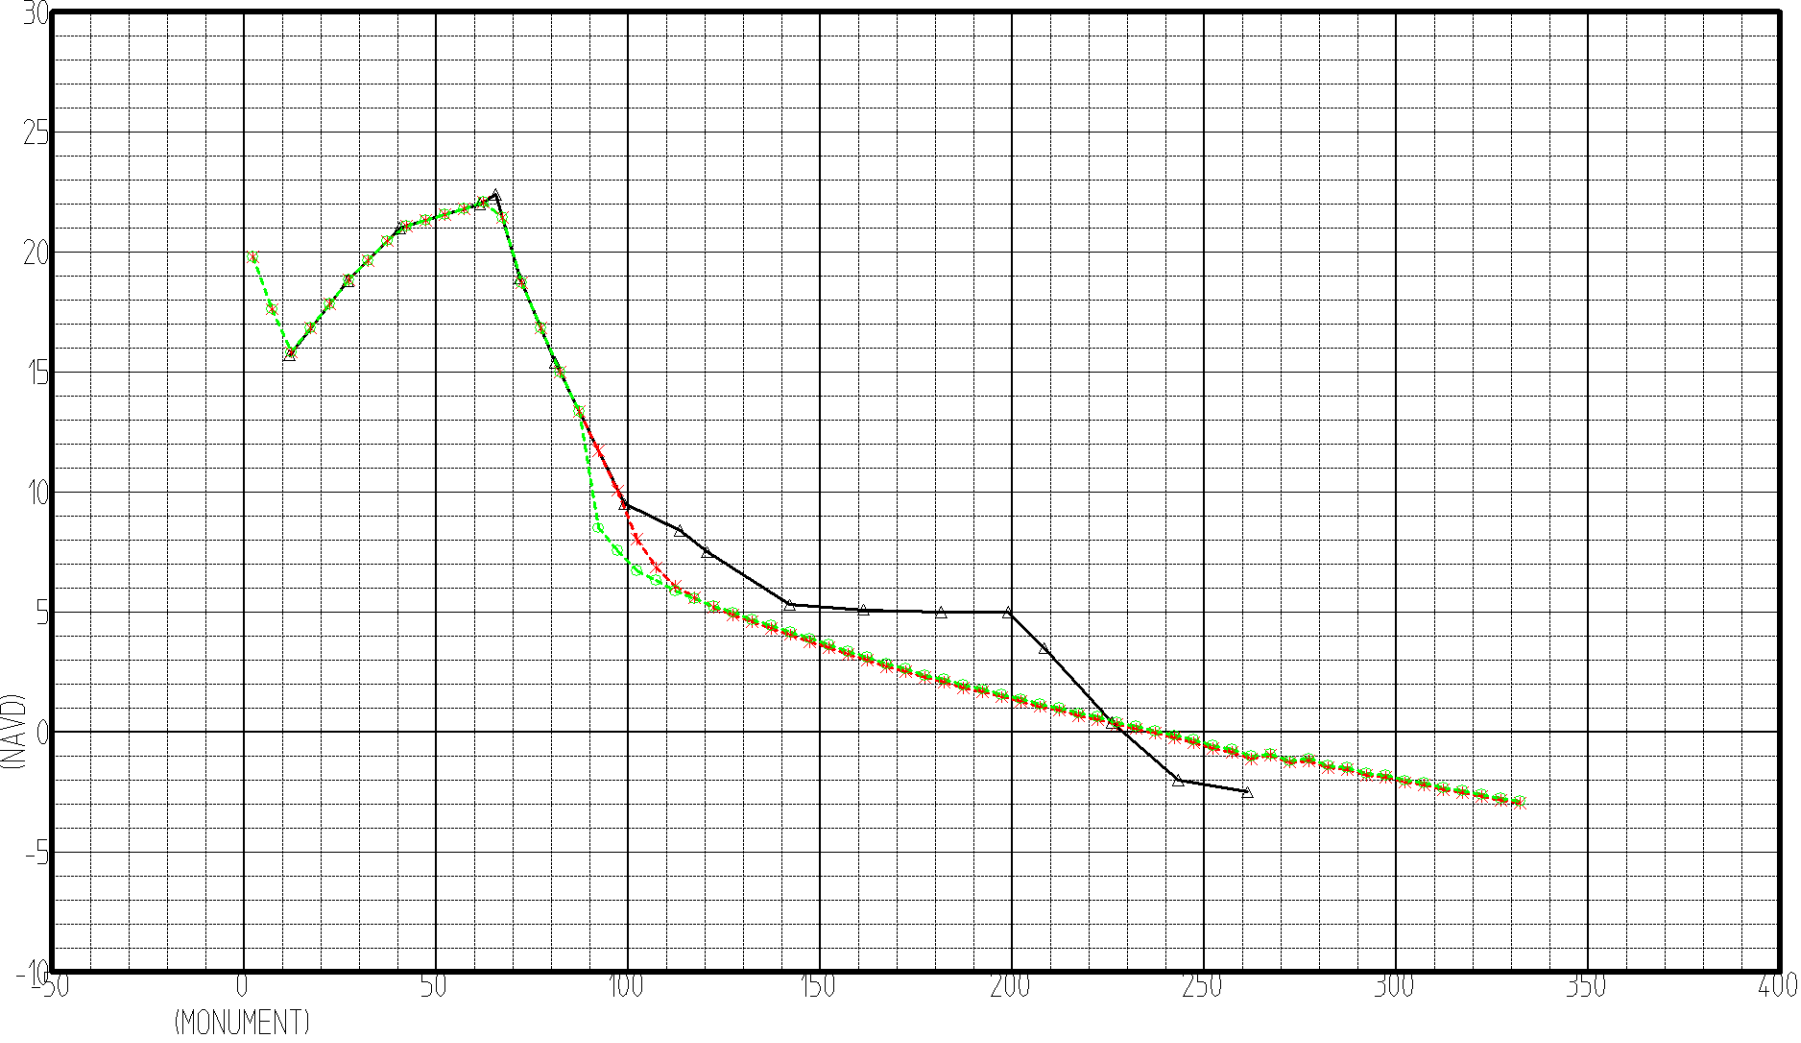
Range: R-101
 BEARING: 202.00
 1/1

BEACH PROFILE
 —△—△— WALTON JULY 2007 PRF
 - - * - - SBEACH 15-YR ERODED PRF
 - - o - - SBEACH 25-YR ERODED PRF

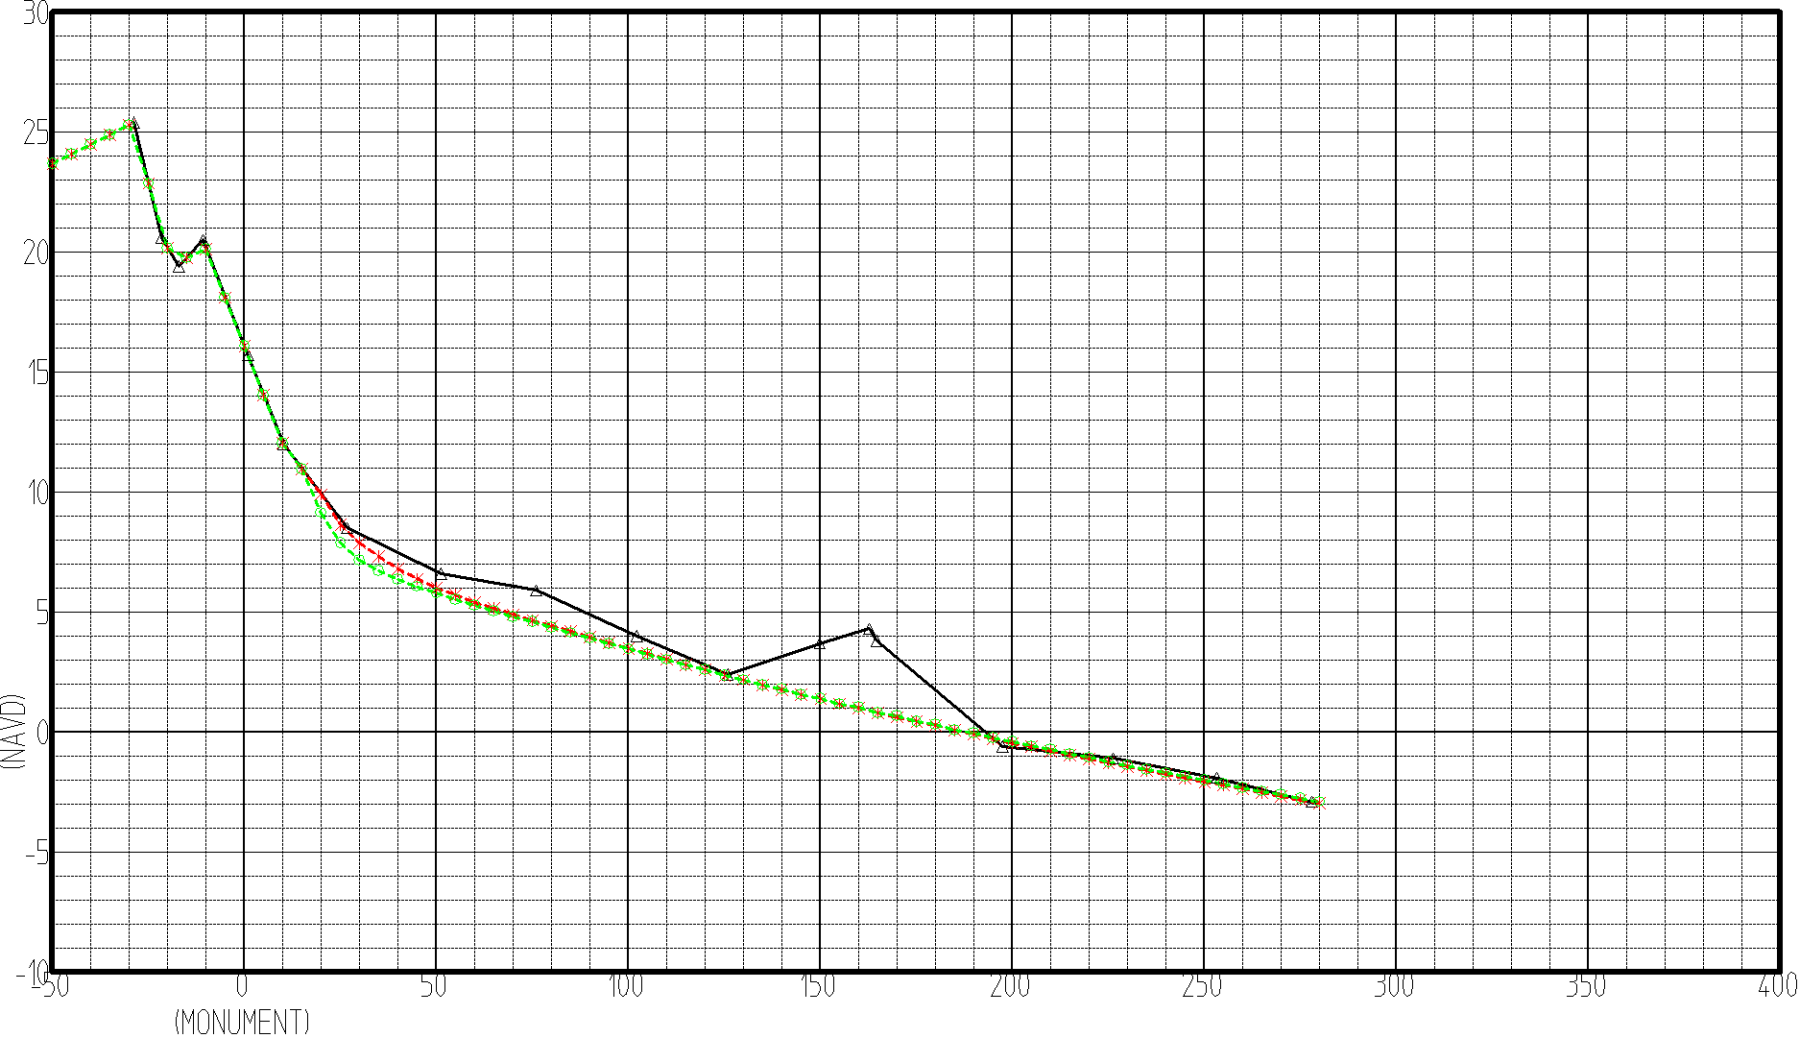
Range: R-102
 BEARING: 202.00
 1/1

BEACH PROFILE
 —△—△— WALTON JULY 2007 PRF
 - - * - - SBEACH 15-YR ERODED PRF
 - - o - - SBEACH 25-YR ERODED PRF

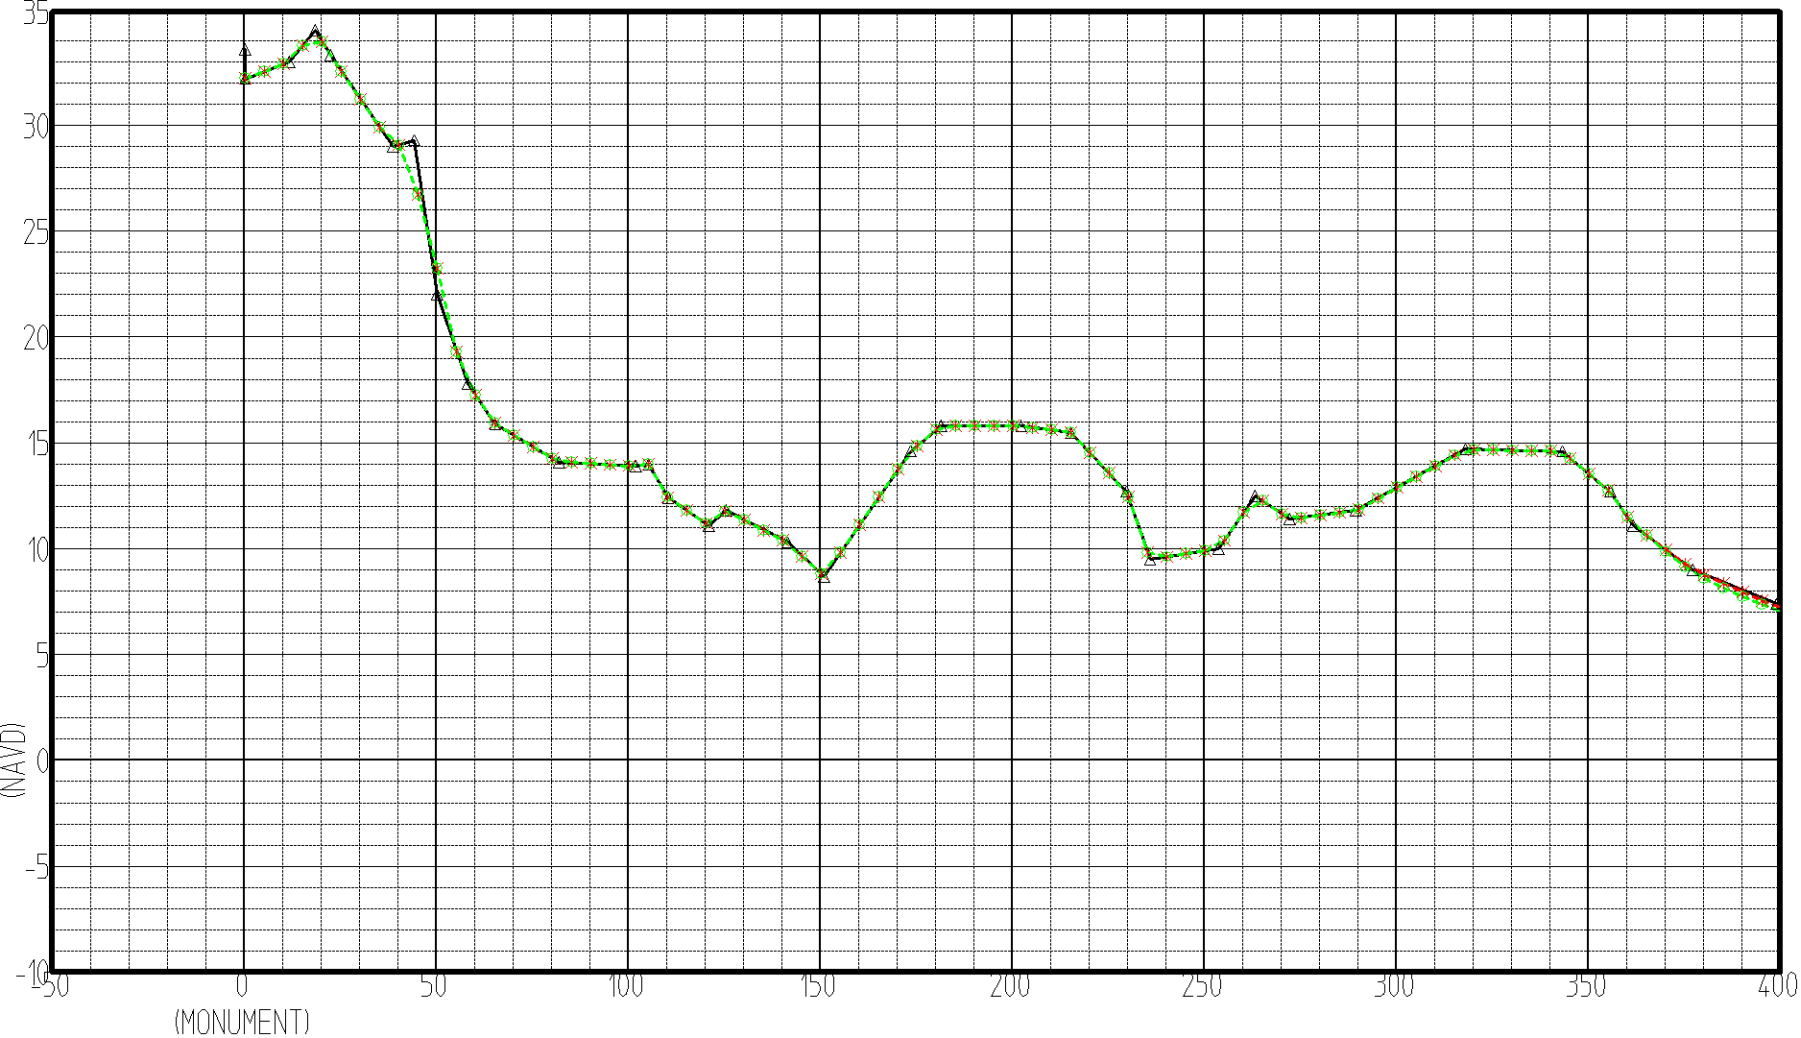
Range: R-103
 BEARING: 202.00
 1/2

BEACH PROFILE
 —△—△— WALTON JULY 2007 PRF
 - - * - - * - - SBEACH 15-YR ERODED PRF
 - - o - - o - - SBEACH 25-YR ERODED PRF

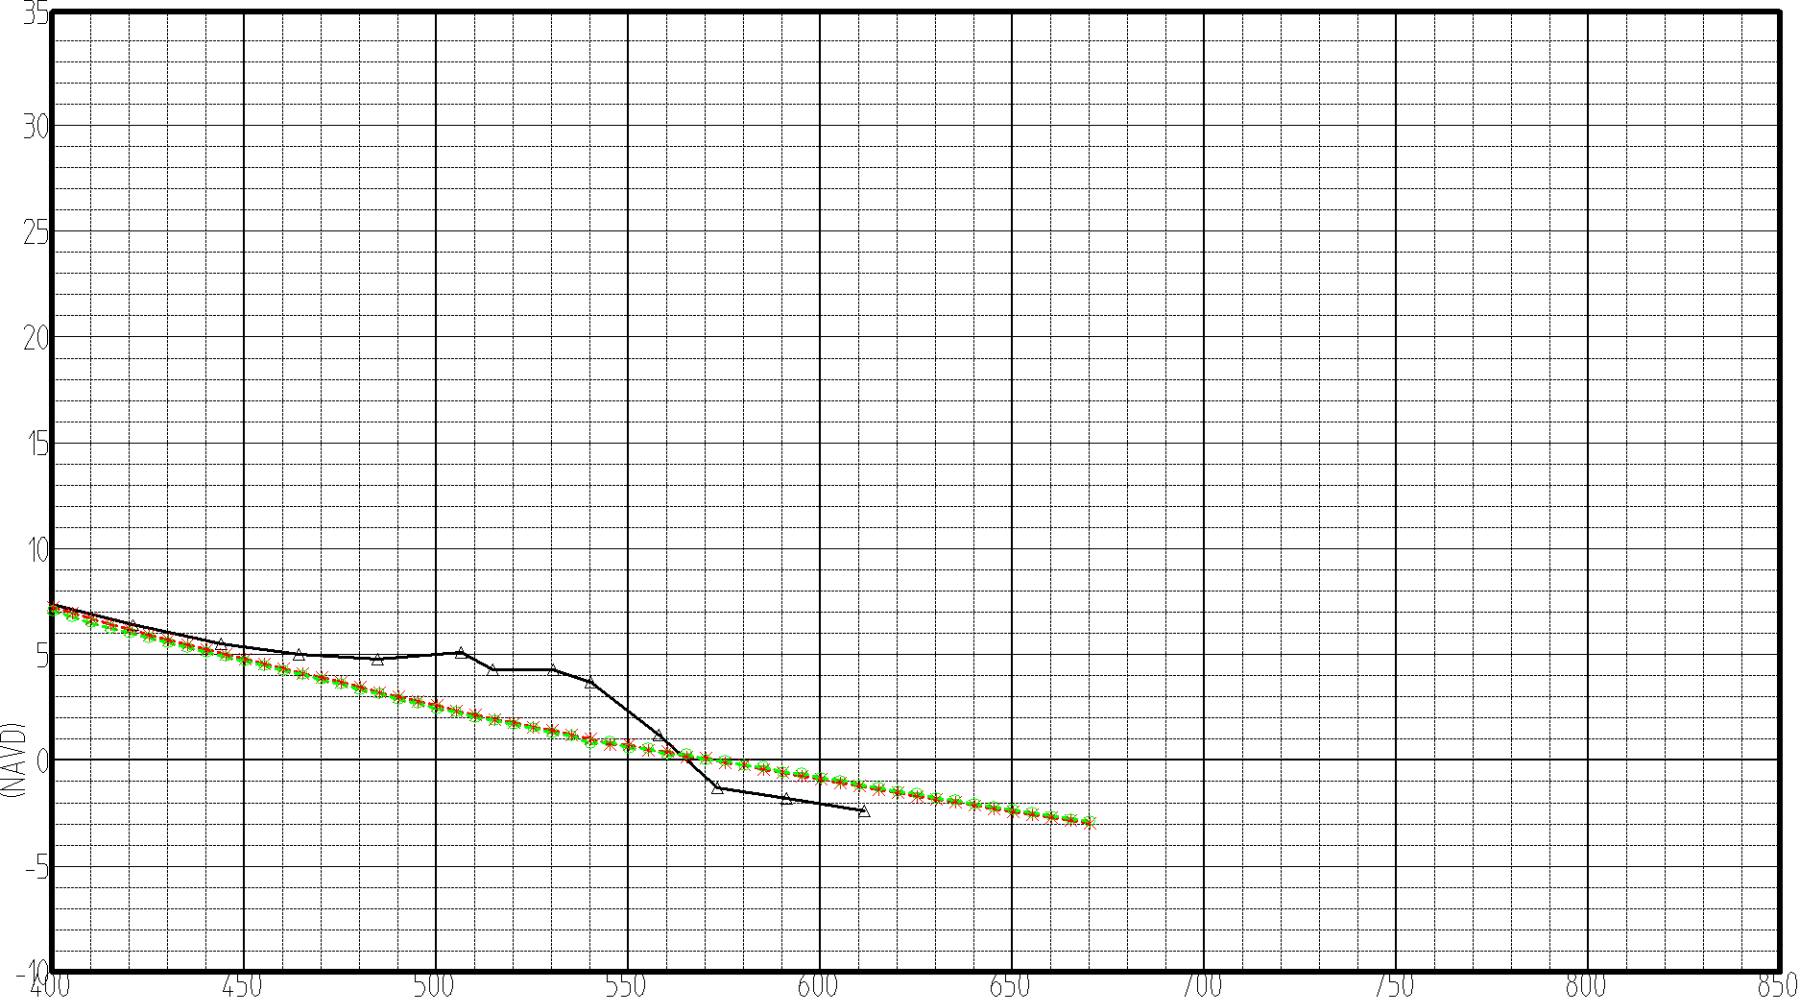
Range: R-103
 BEARING: 202.00
 2/2

BEACH PROFILE
 —△—△— WALTON JULY 2007 PRF
 - - * - - SBEACH 15-YR ERODED PRF
 - - o - - SBEACH 25-YR ERODED PRF

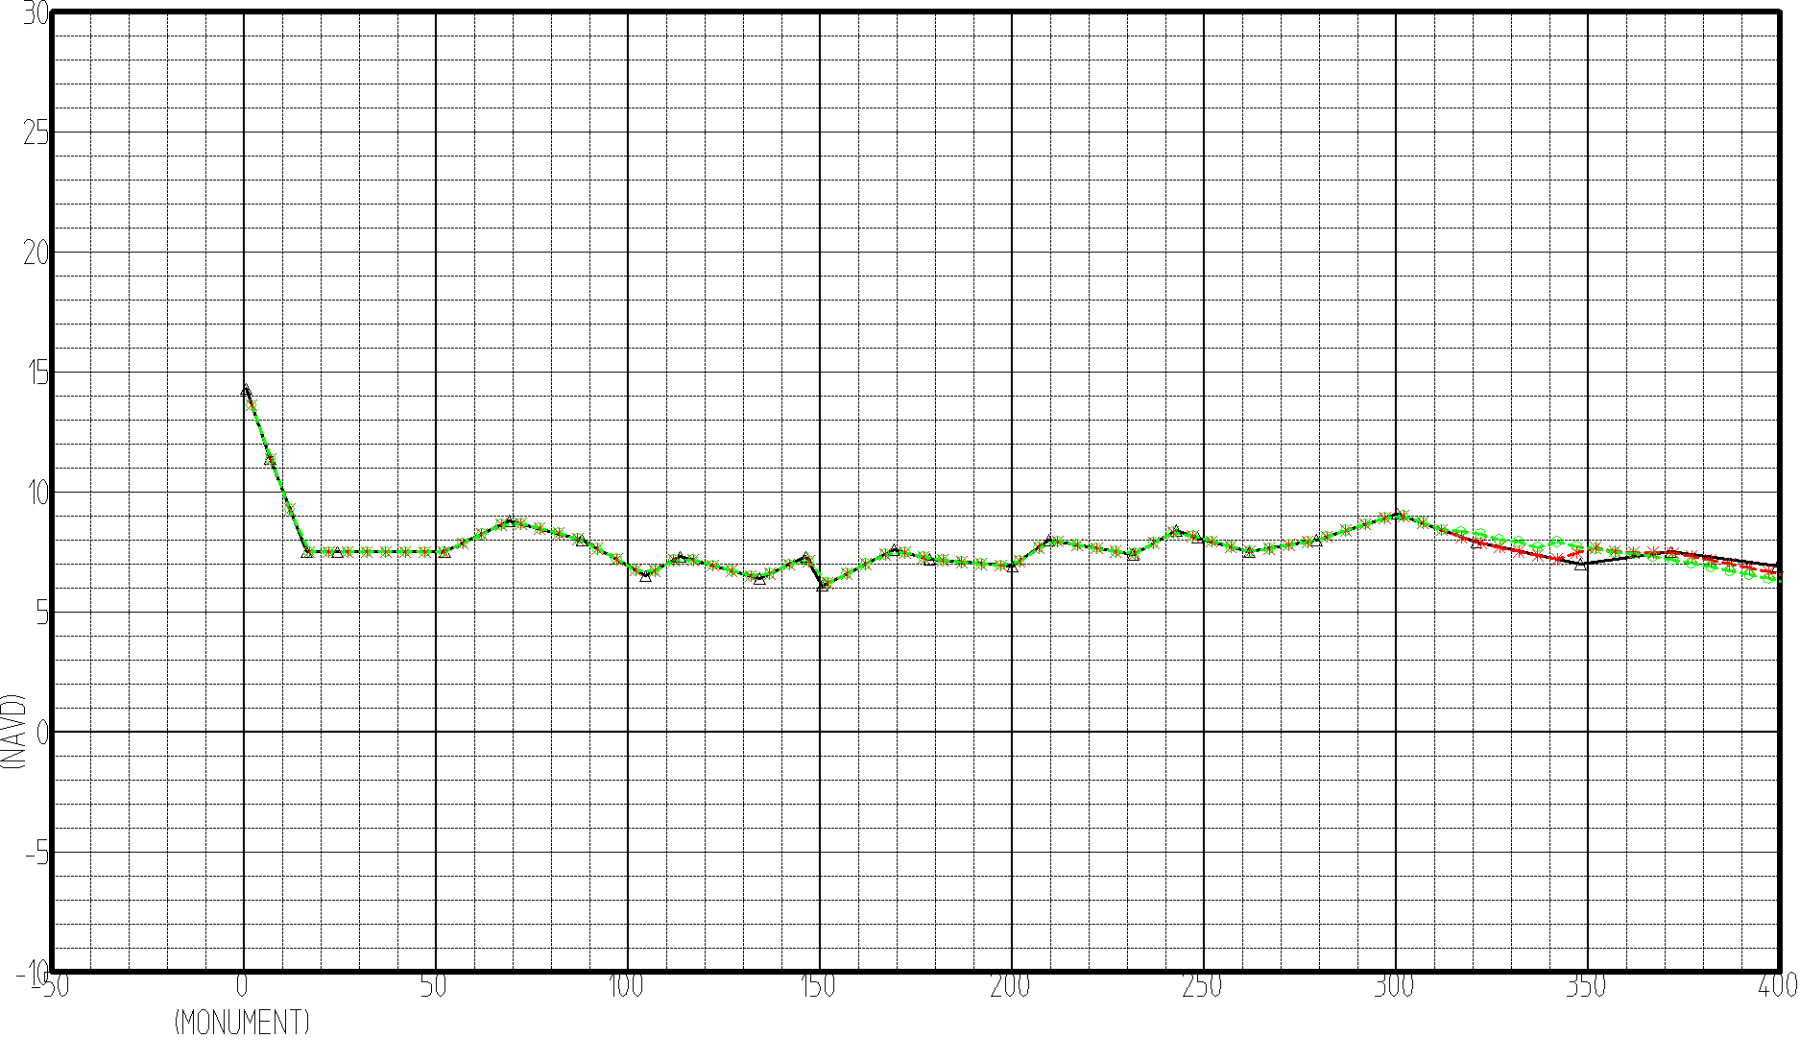
Range: R-103A
 BEARING: 202.00
 1/2

BEACH PROFILE
 —△—△— WALTON JULY 2007 PRF
 - - * - - SBEACH 15-YR ERODED PRF
 - - o - - SBEACH 25-YR ERODED PRF

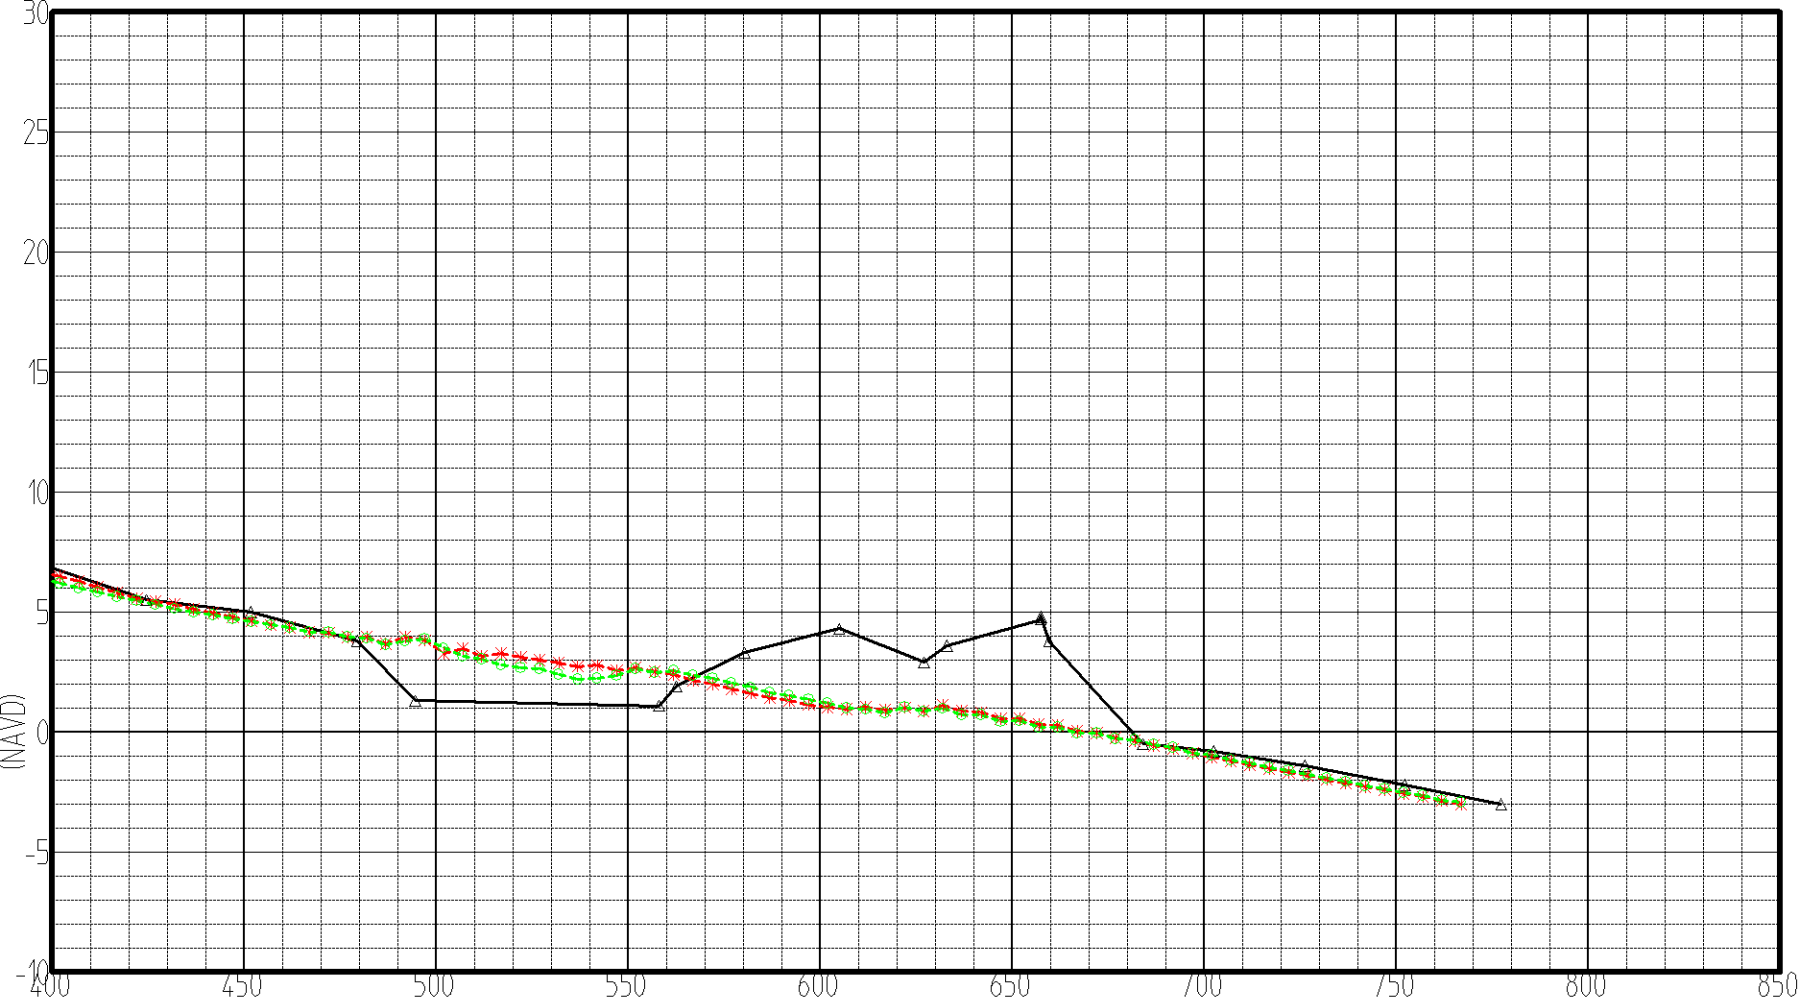
Range: R-103A 2/2
 BEARING: 202.00

BEACH PROFILE
 —△—△— WALTON JULY 2007 PRF
 - - * - - SBEACH 15-YR ERODED PRF
 - - o - - SBEACH 25-YR ERODED PRF

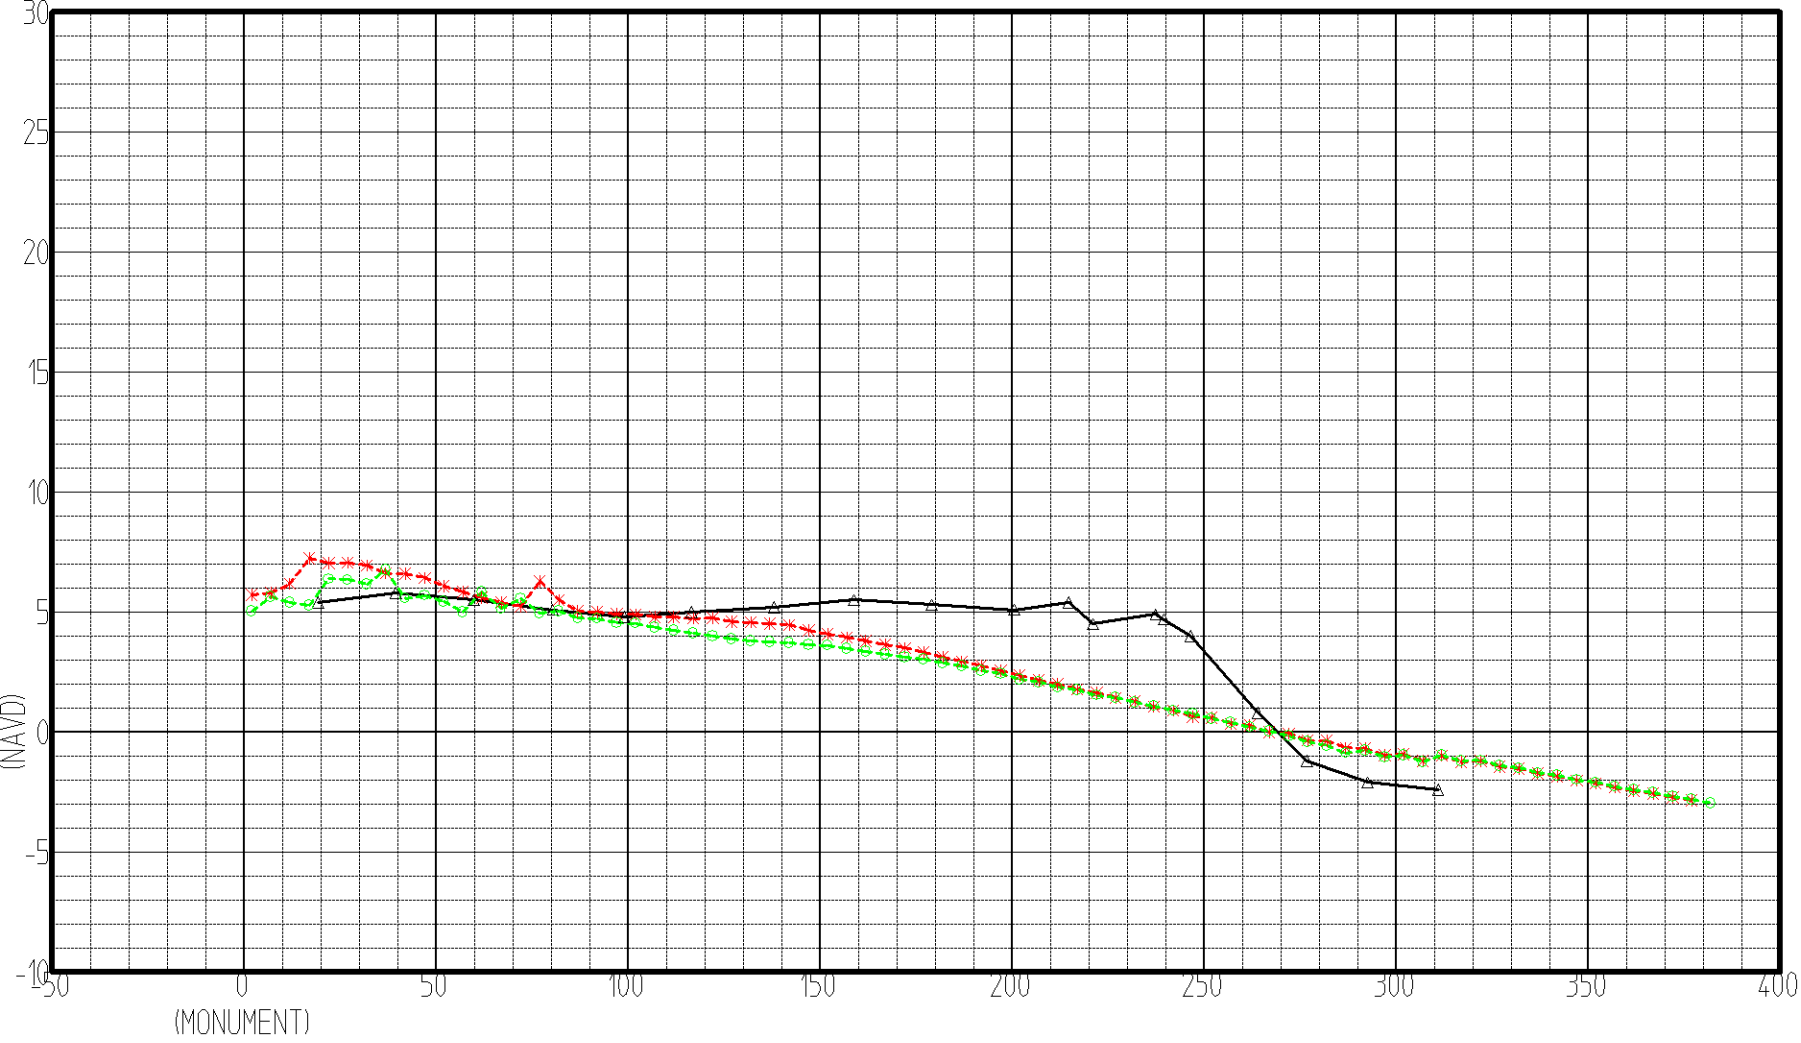
Range: R-104
 BEARING: 202.00
 1/1

BEACH PROFILE
 —△—△— WALTON JULY 2007 PRF
 - - * - - * - - SBEACH 15-YR ERODED PRF
 - - o - - o - - SBEACH 25-YR ERODED PRF
