Appendix II

SBEACH Model Erosion Profile Plots

Walton County

15-year and 25-year Storm Events

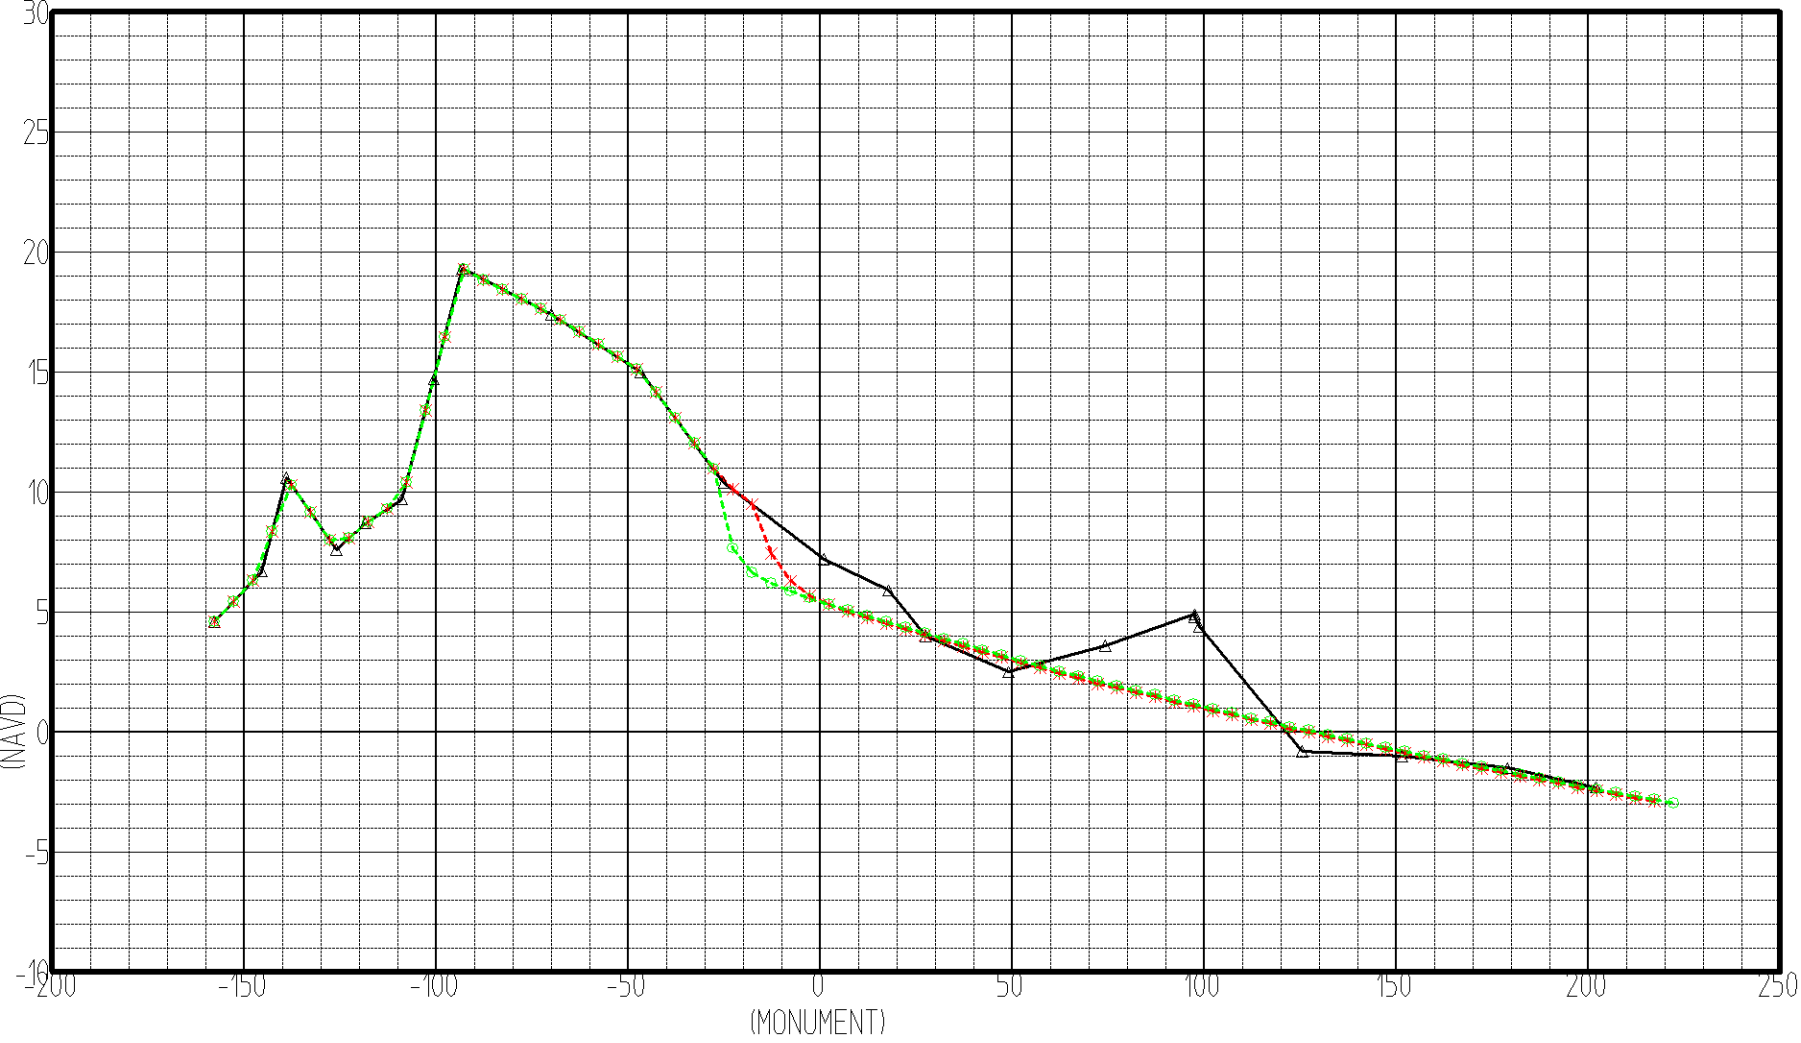
Range: R-105
 BEARING: 202.00
 1/1

BEACH PROFILE
 —△—△— WALTON JULY 2007 PRF
 - - * - - SBEACH 15-YR ERODED PRF
 - - o - - SBEACH 25-YR ERODED PRF

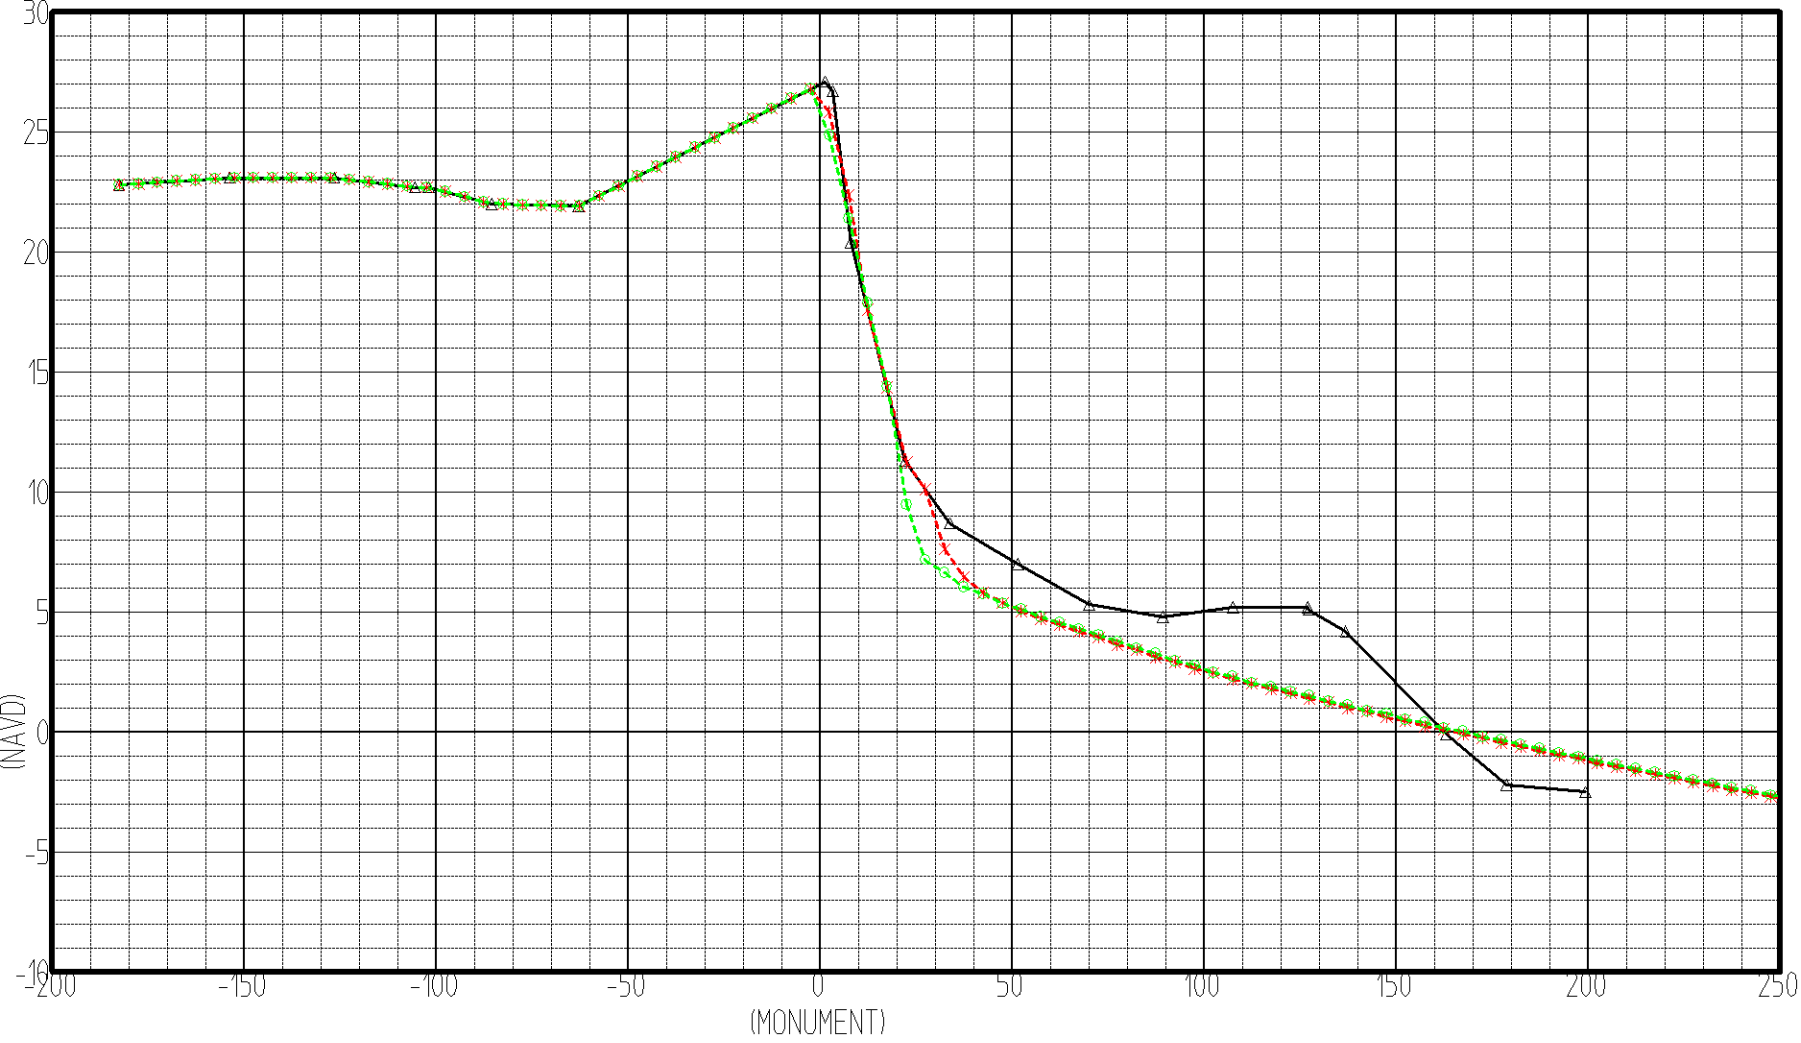
Range: R-106
 BEARING: 202.00
 1/2

BEACH PROFILE
 —△—△— WALTON JULY 2007 PRF
 - - * - - SBEACH 15-YR ERODED PRF
 - - o - - SBEACH 25-YR ERODED PRF

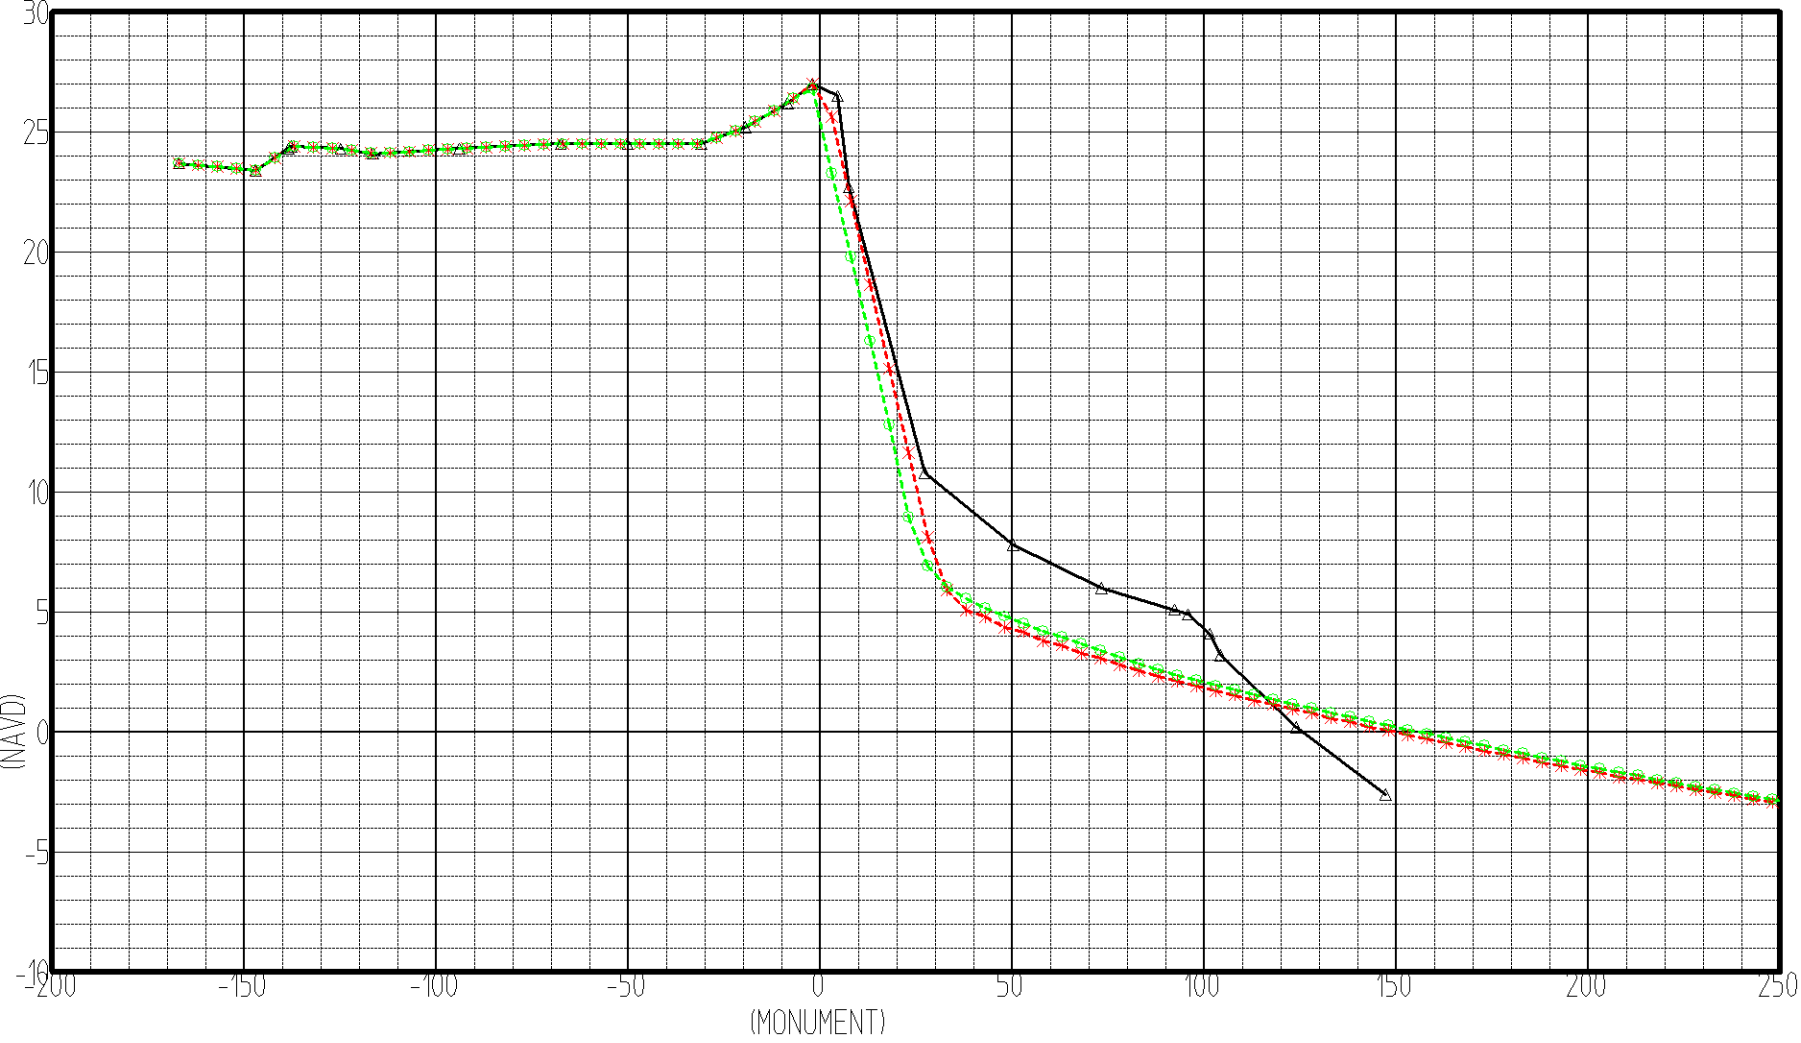
Range: R-107
 BEARING: 202.00
 1/2

BEACH PROFILE
 —△—△— WALTON JULY 2007 PRF
 - - * - - SBEACH 15-YR ERODED PRF
 - - o - - SBEACH 25-YR ERODED PRF

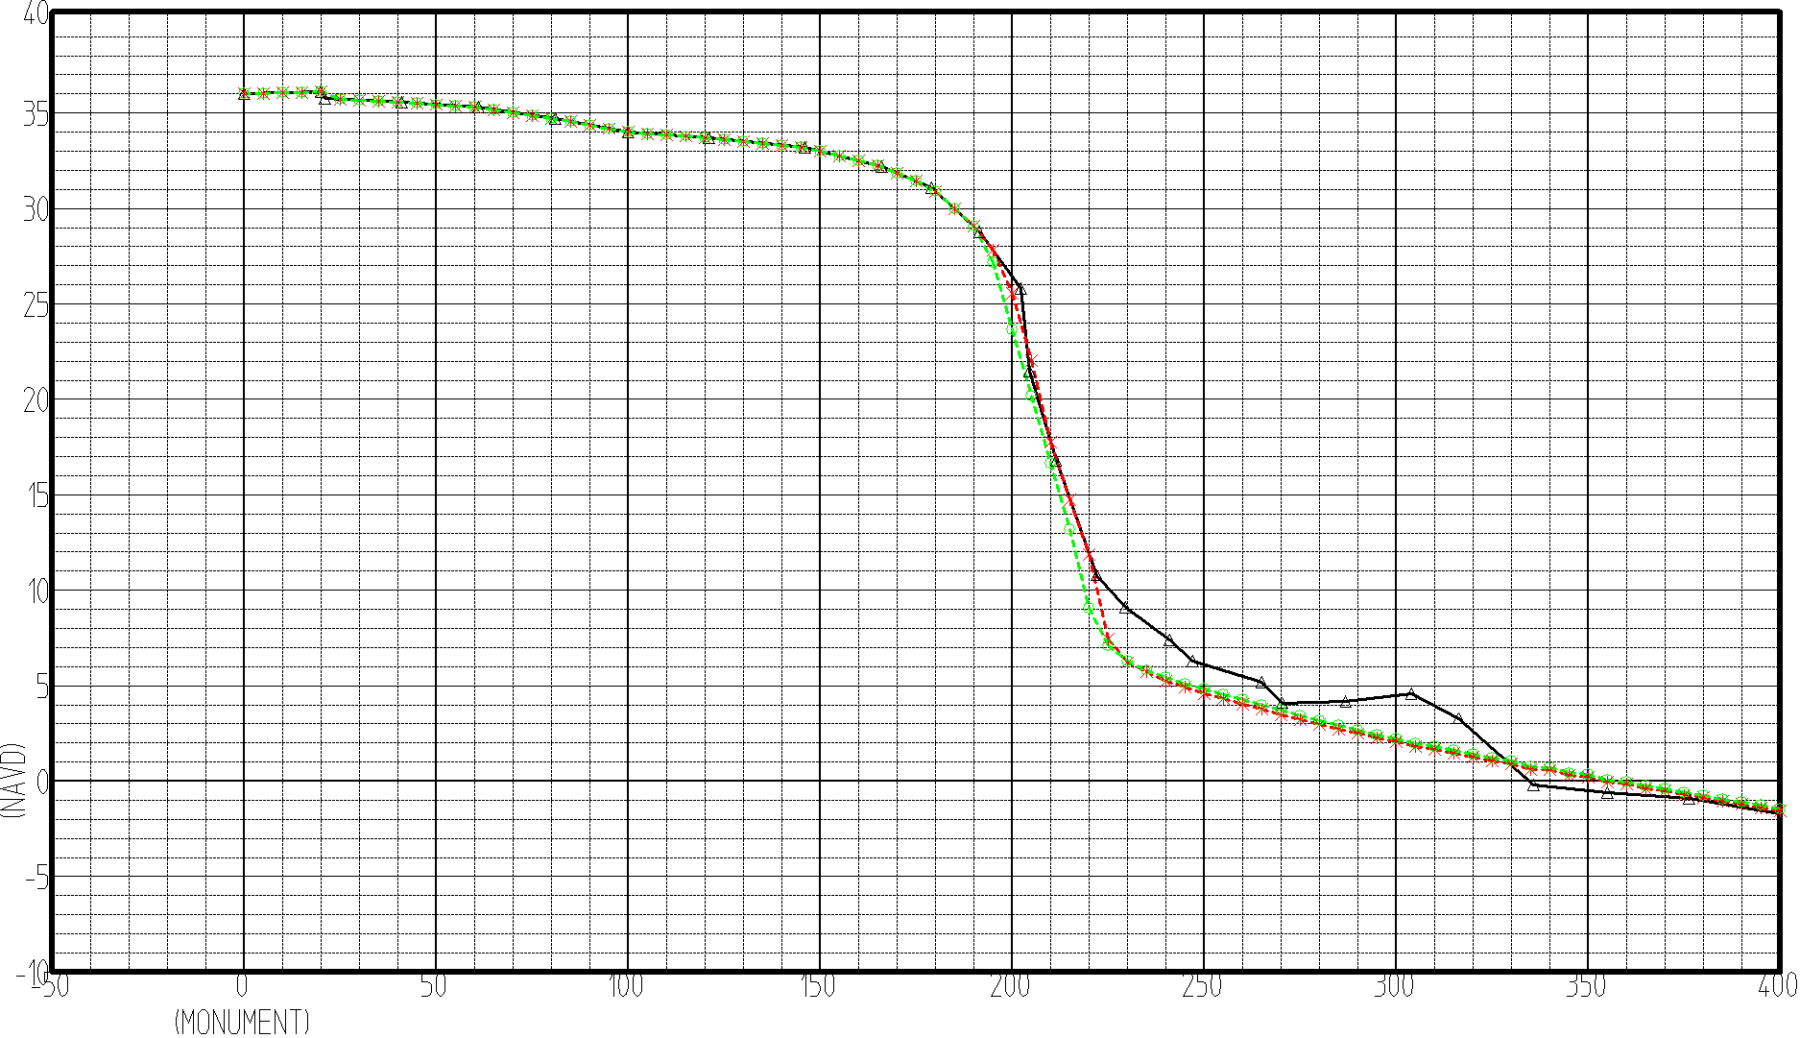
Range: W-108 1/2
 BEARING: 202.00

BEACH PROFILE
 —△—△— WALTON JULY 2007 PRF
 - - * - - SBEACH 15-YR ERODED PRF
 - - o - - SBEACH 25-YR ERODED PRF

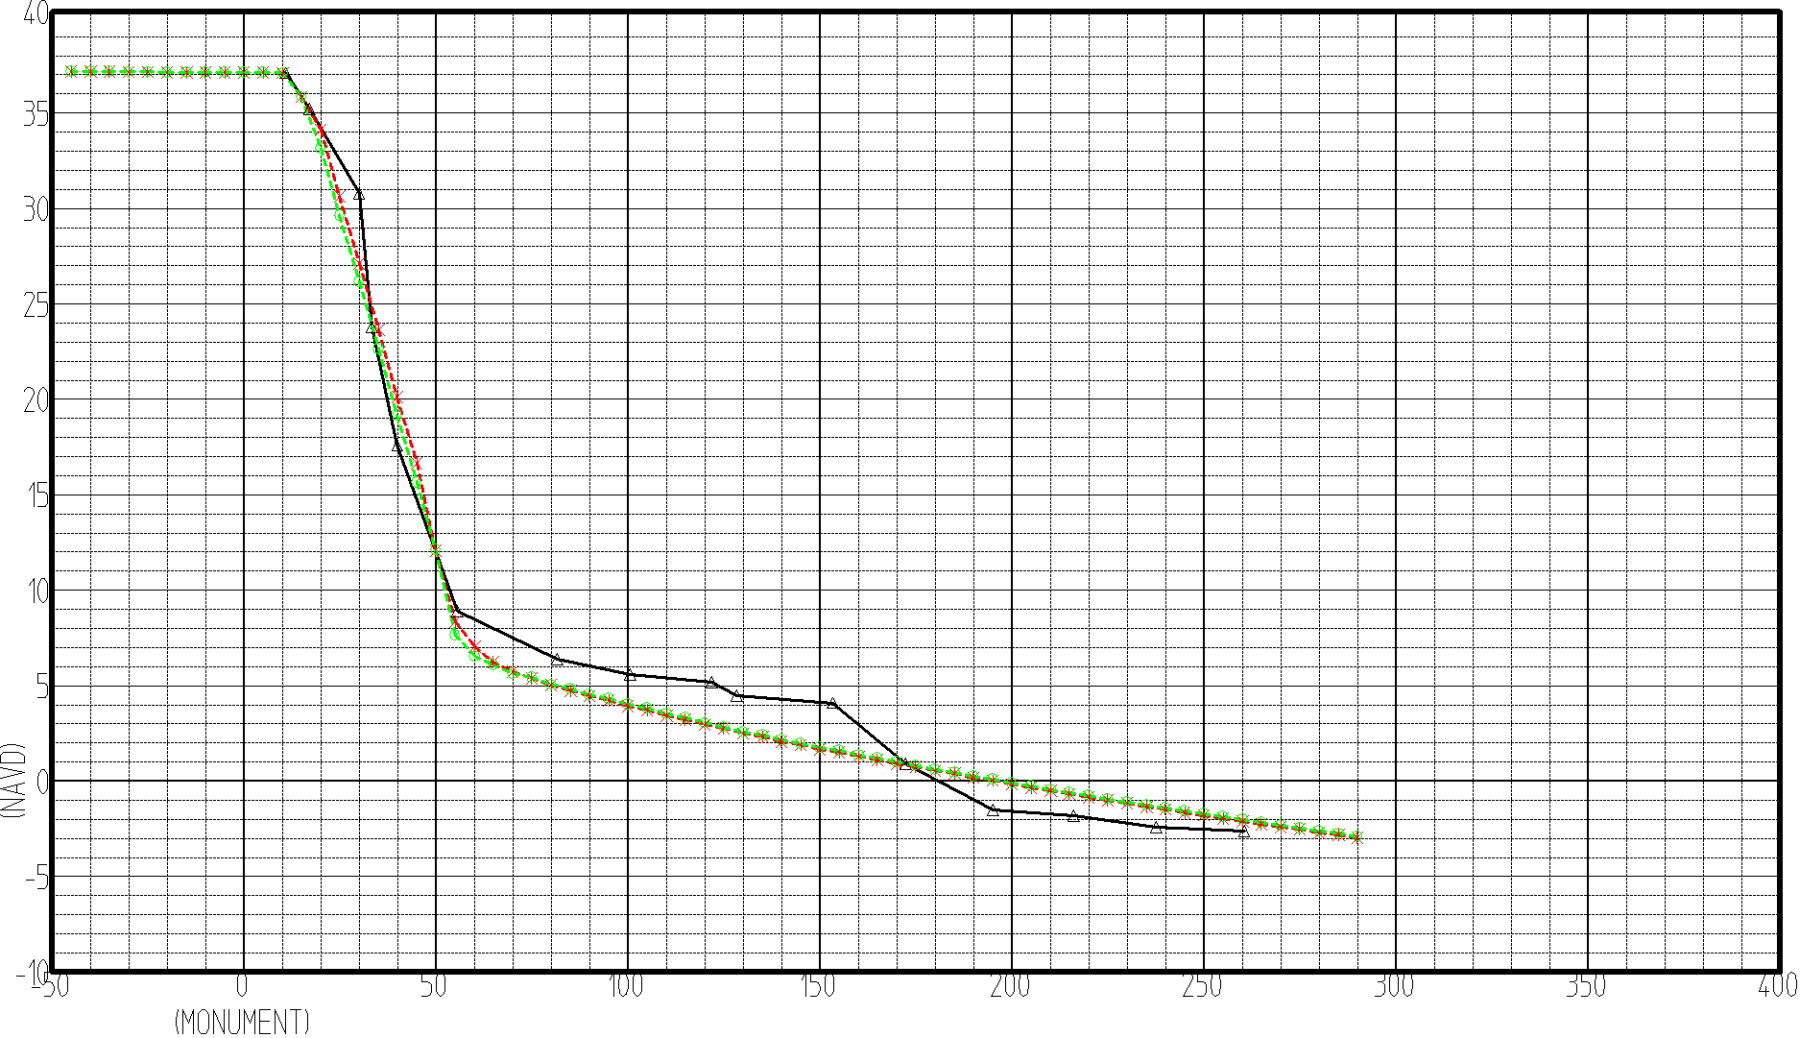
Range: R-109
 BEARING: 202.00
 1/1

BEACH PROFILE
 —△—△— WALTON JULY 2007 PRF
 - - * - - SBEACH 15-YR ERODED PRF
 - - o - - SBEACH 25-YR ERODED PRF

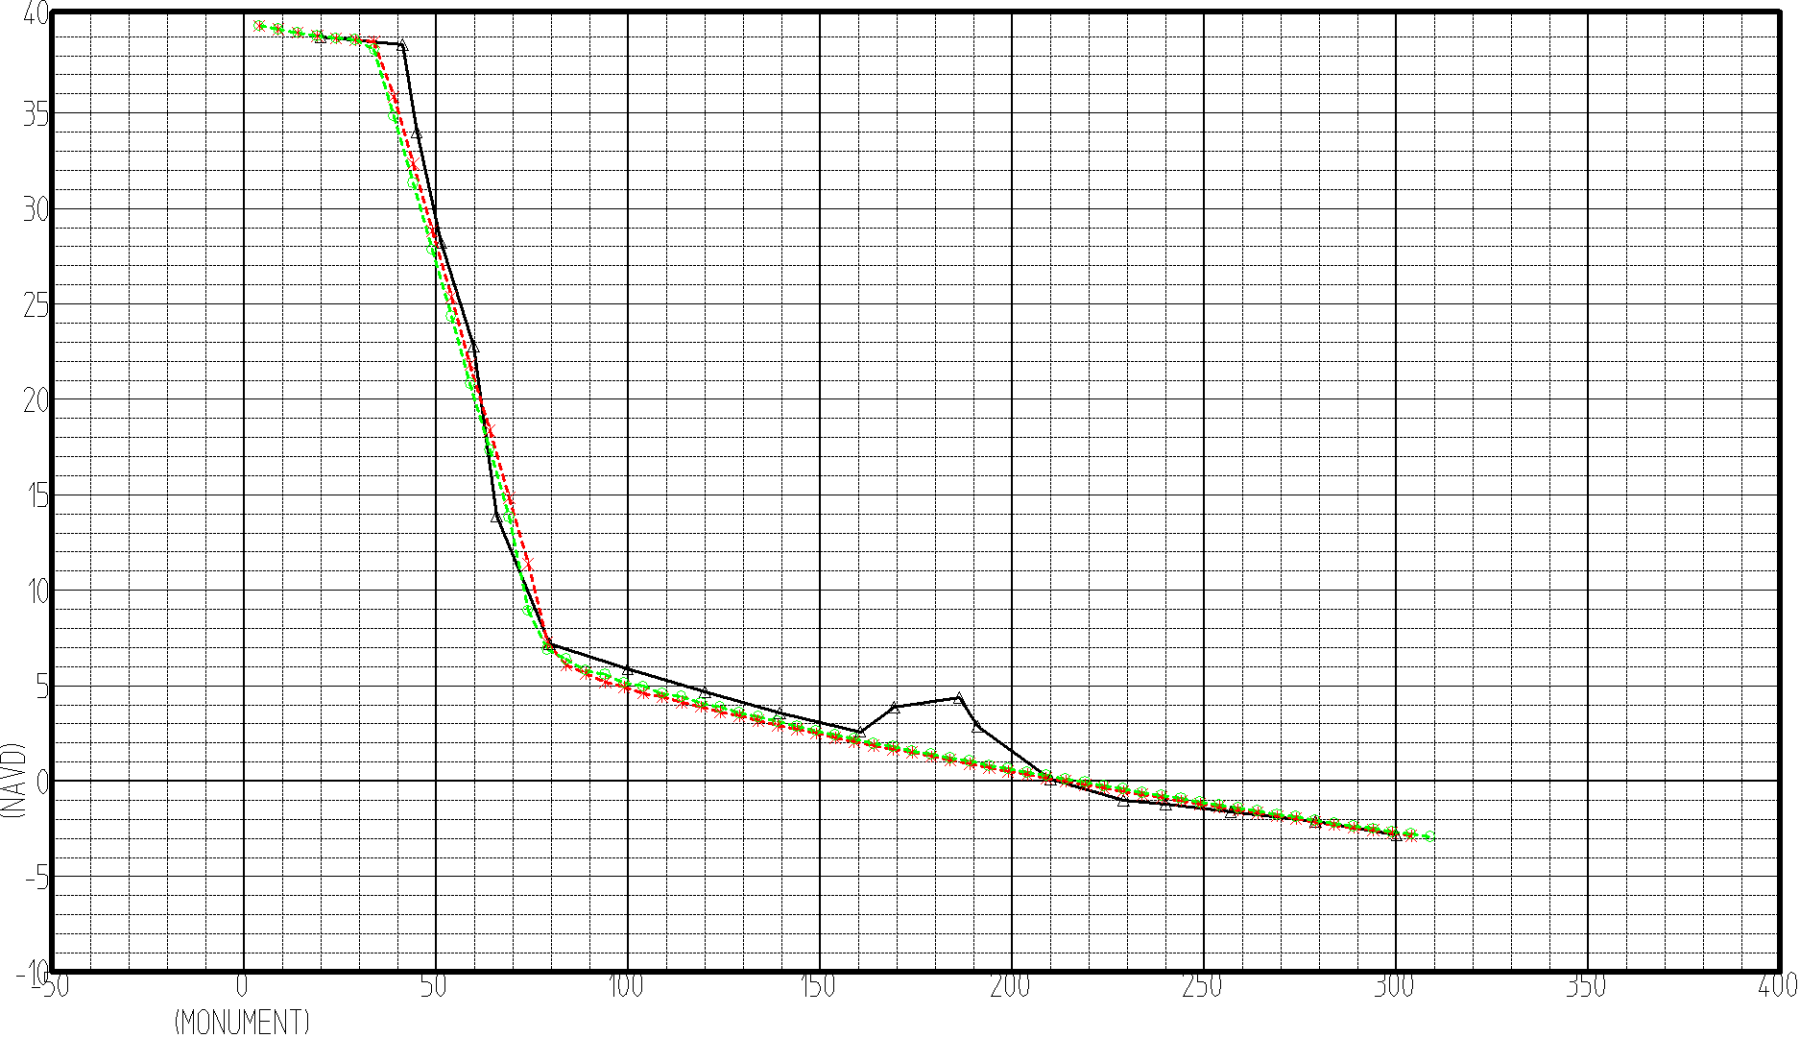
Range: R-110

BEACH PROFILE

—△—△— WALTON JULY 2007 PRF

- - - * - - - SBEACH 15-YR ERODED PRF

- - - o - - - SBEACH 25-YR ERODED PRF

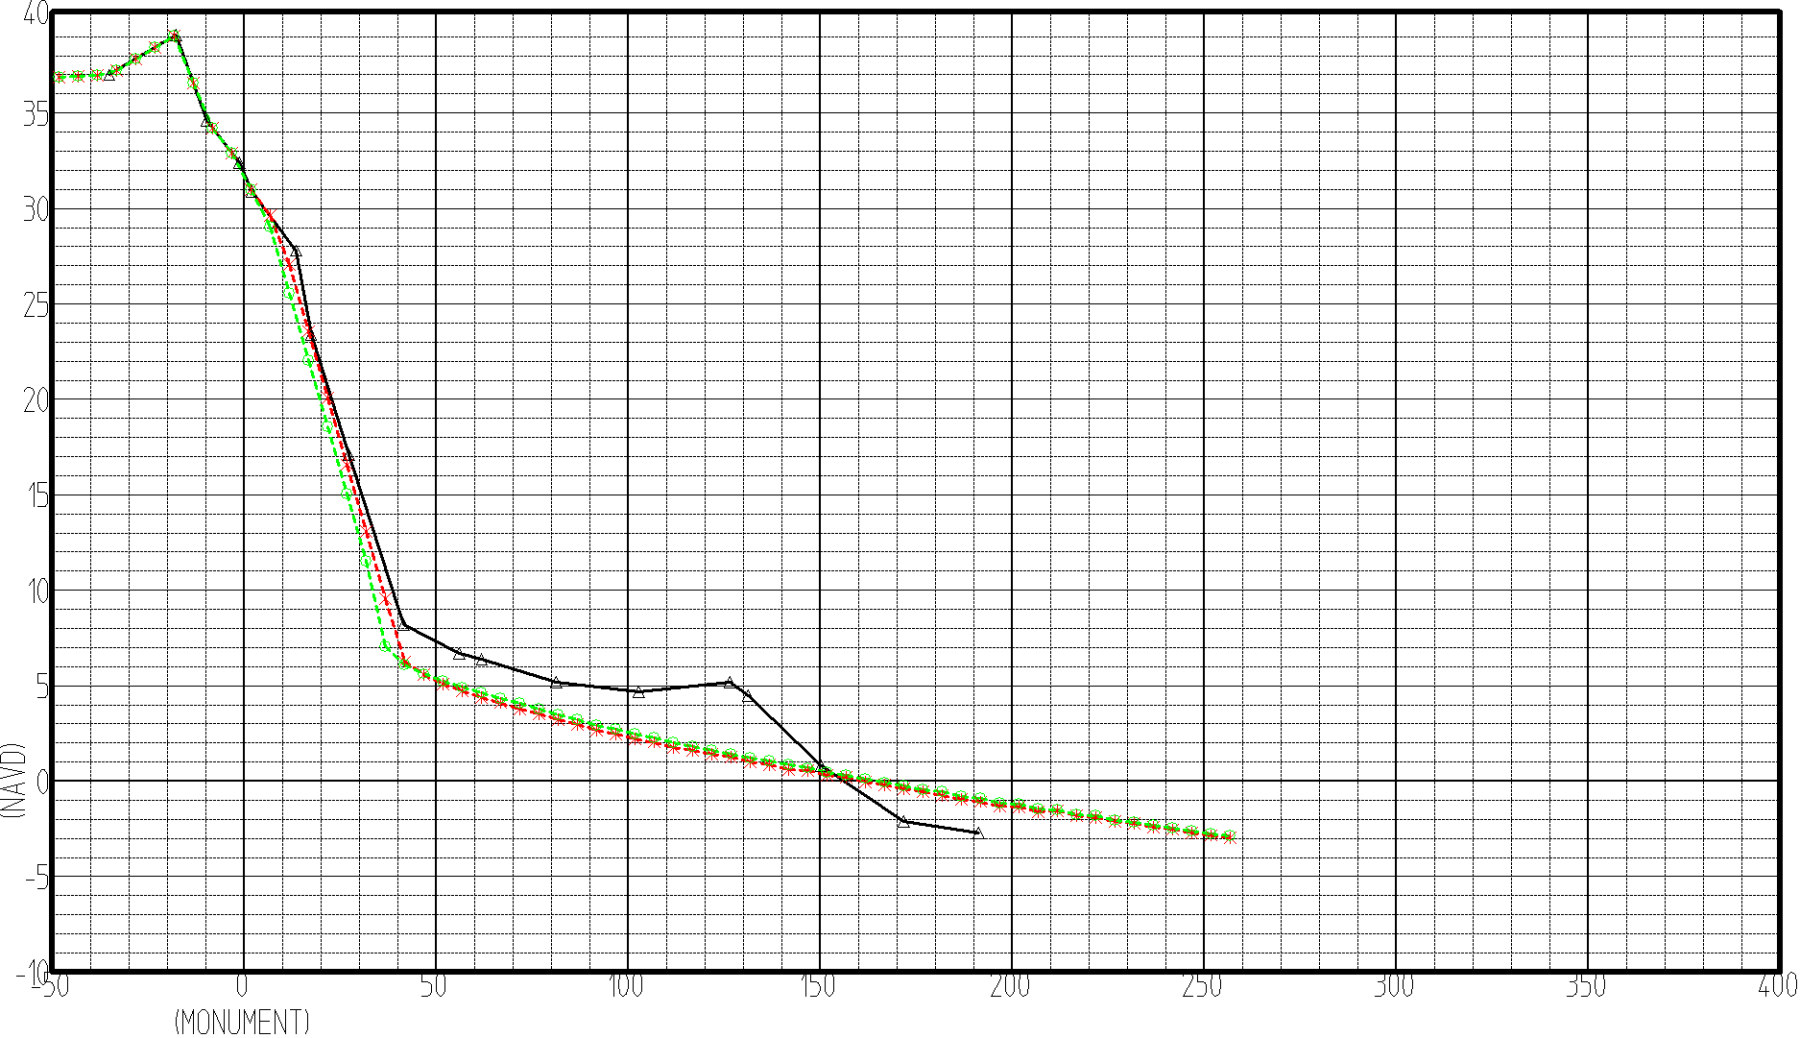
Range: R-111 1/1
 BEARING: 202.00

BEACH PROFILE
 —△—△— WALTON JULY 2007 PRF
 - - * - - SBEACH 15-YR ERODED PRF
 - - o - - SBEACH 25-YR ERODED PRF

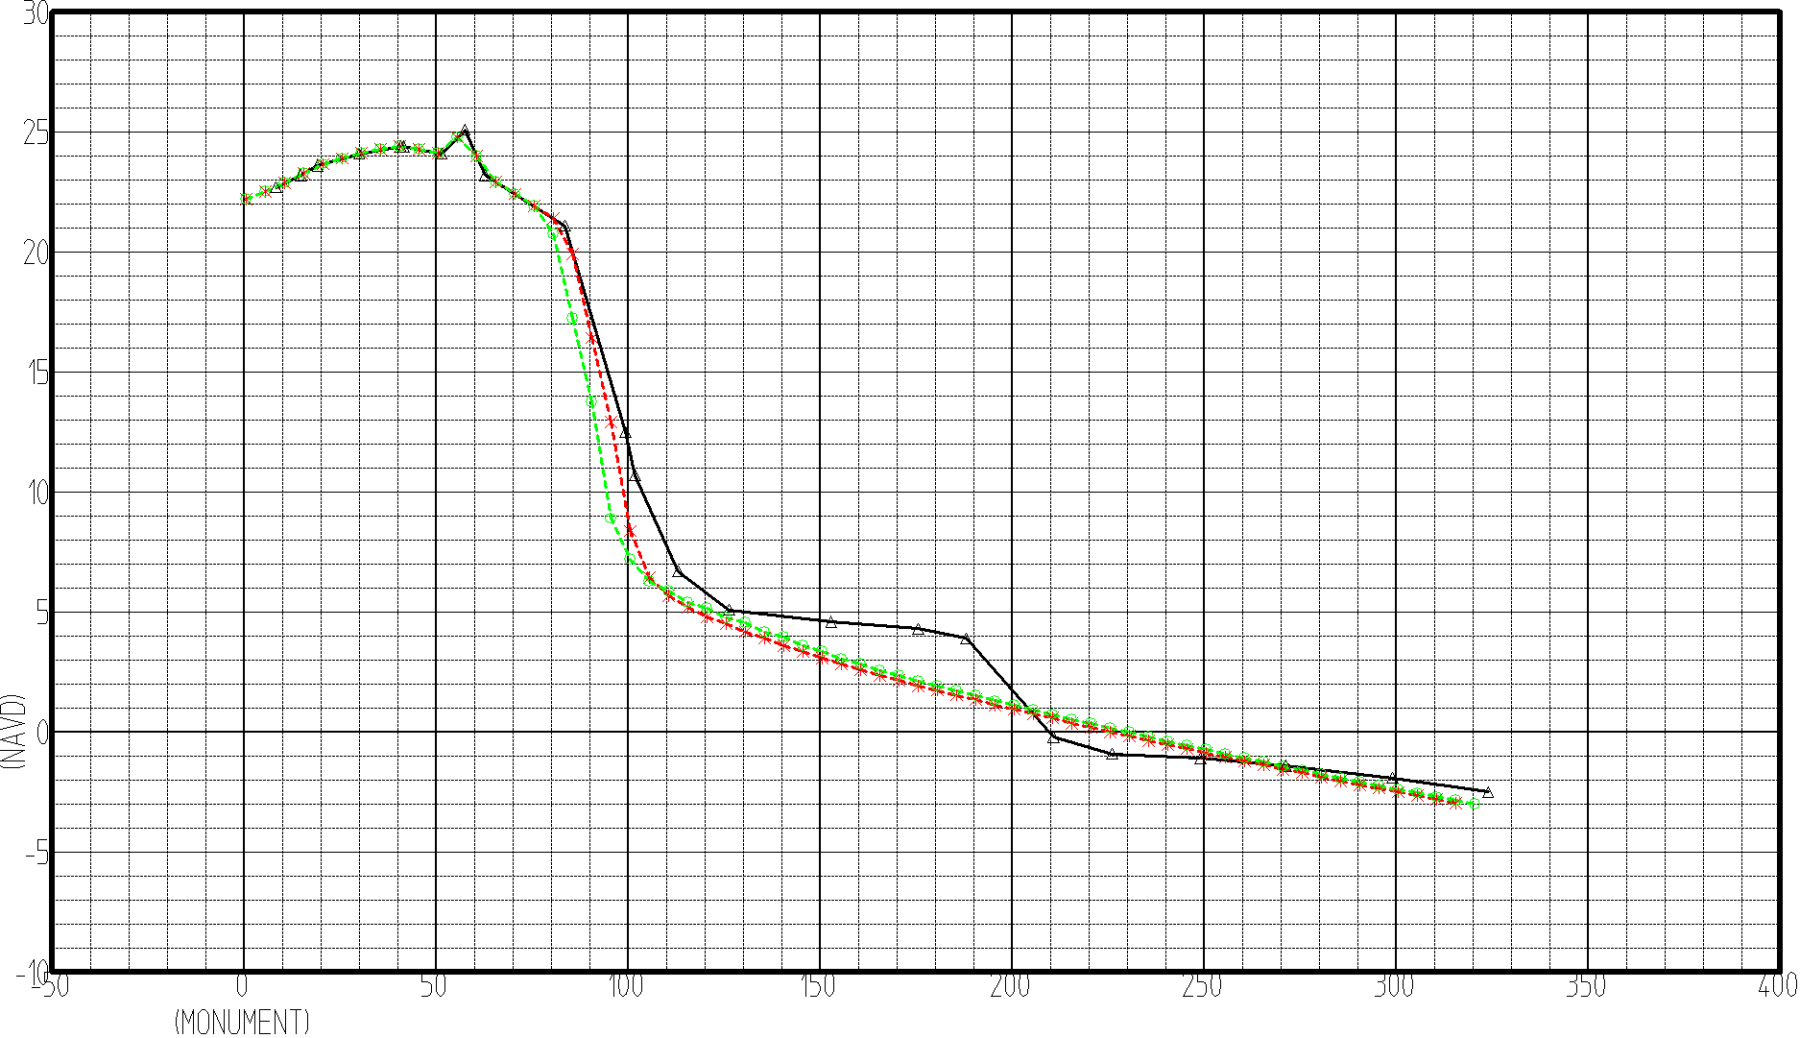
Range: R-112
 BEARING: 202.00
 1/1

BEACH PROFILE
 —△—△— WALTON JULY 2007 PRF
 - - * - - SBEACH 15-YR ERODED PRF
 - - o - - SBEACH 25-YR ERODED PRF

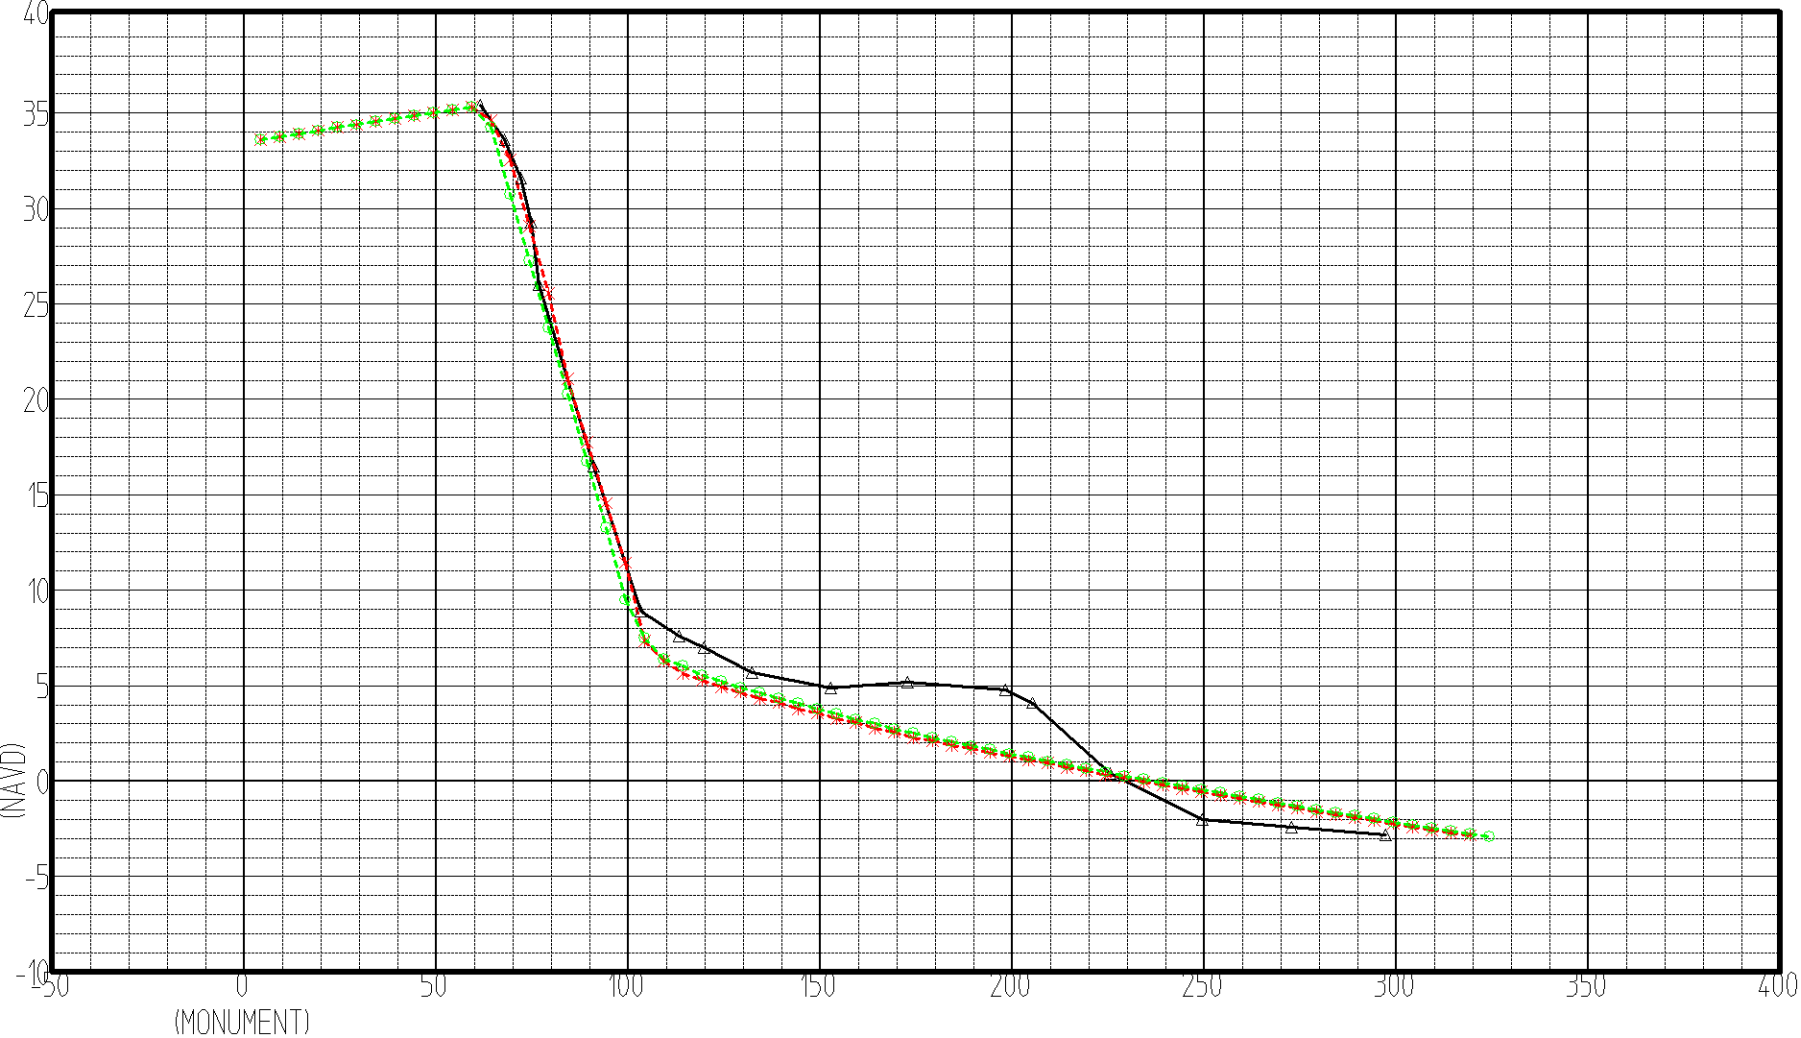
Range: R-113
 BEARING: 202.00
 1/1

BEACH PROFILE
 —△—△— WALTON JULY 2007 PRF
 - - * - - SBEACH 15-YR ERODED PRF
 - - o - - SBEACH 25-YR ERODED PRF

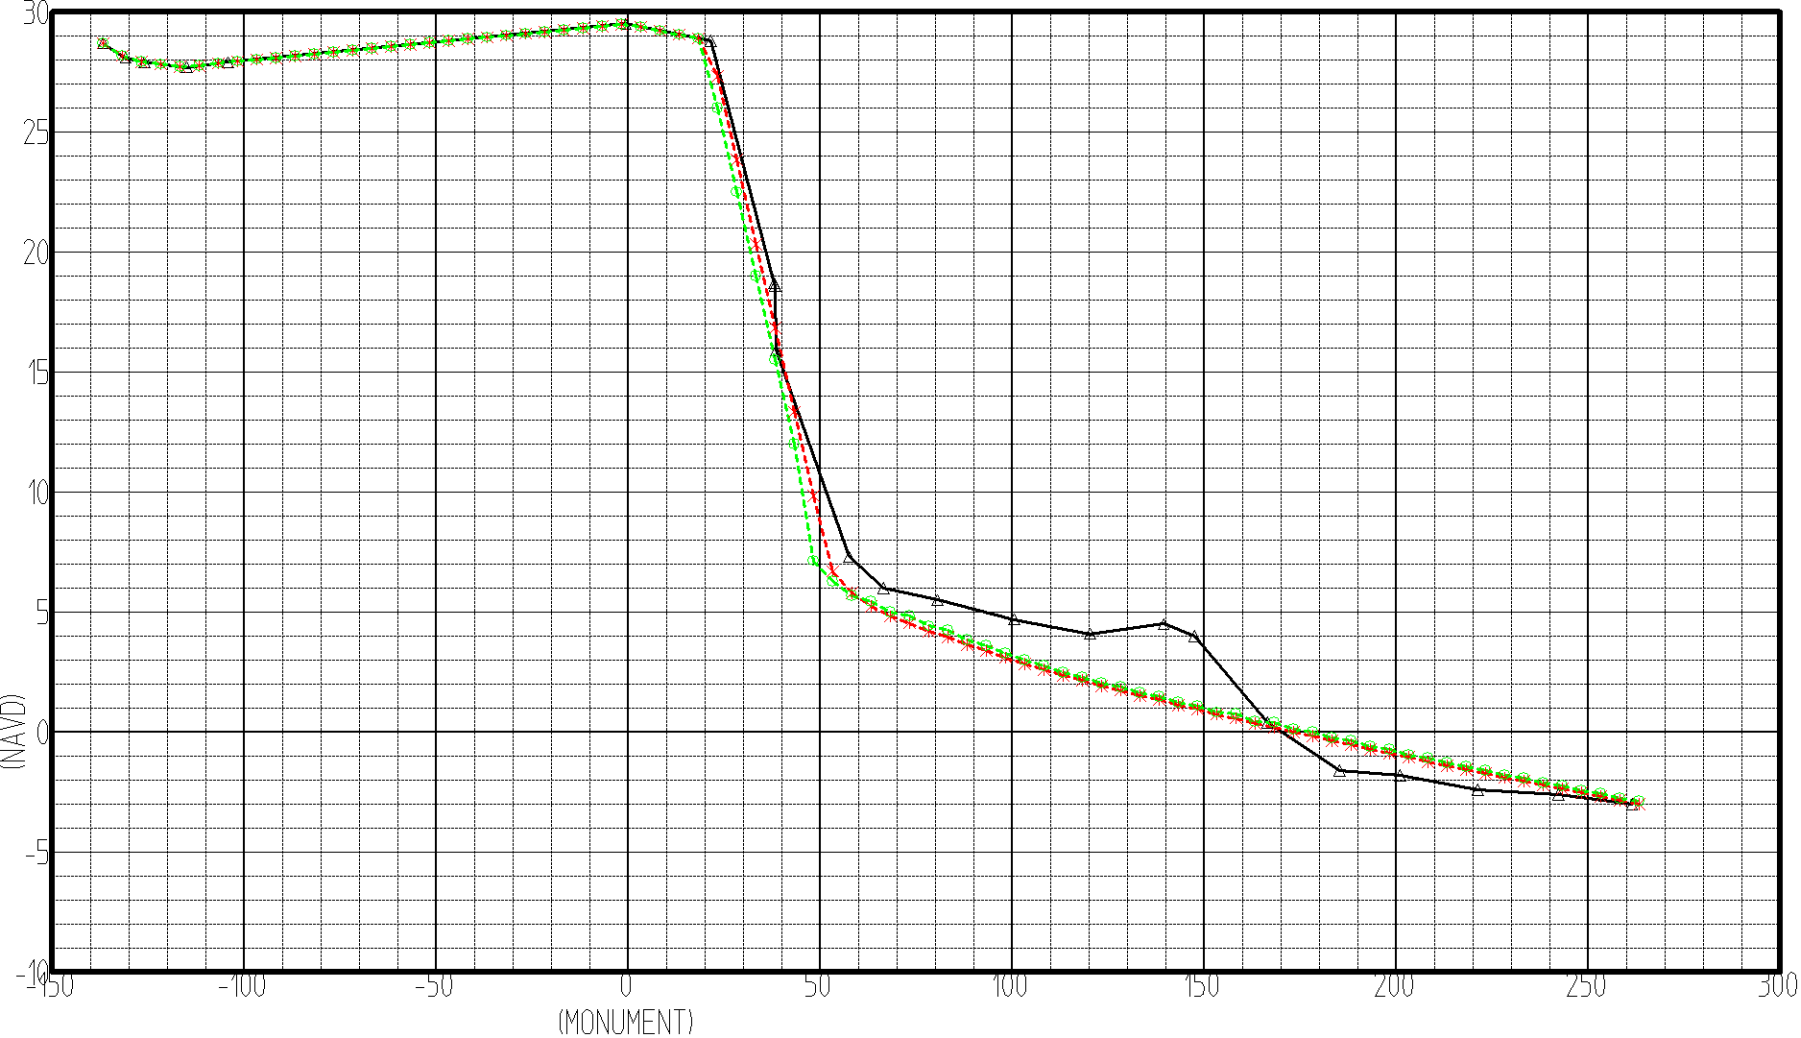
Range: R-114
 BEARING: 202.00
 1/1

BEACH PROFILE
 —△—△— WALTON JULY 2007 PRF
 - - * - - SBEACH 15-YR ERODED PRF
 - - o - - SBEACH 25-YR ERODED PRF

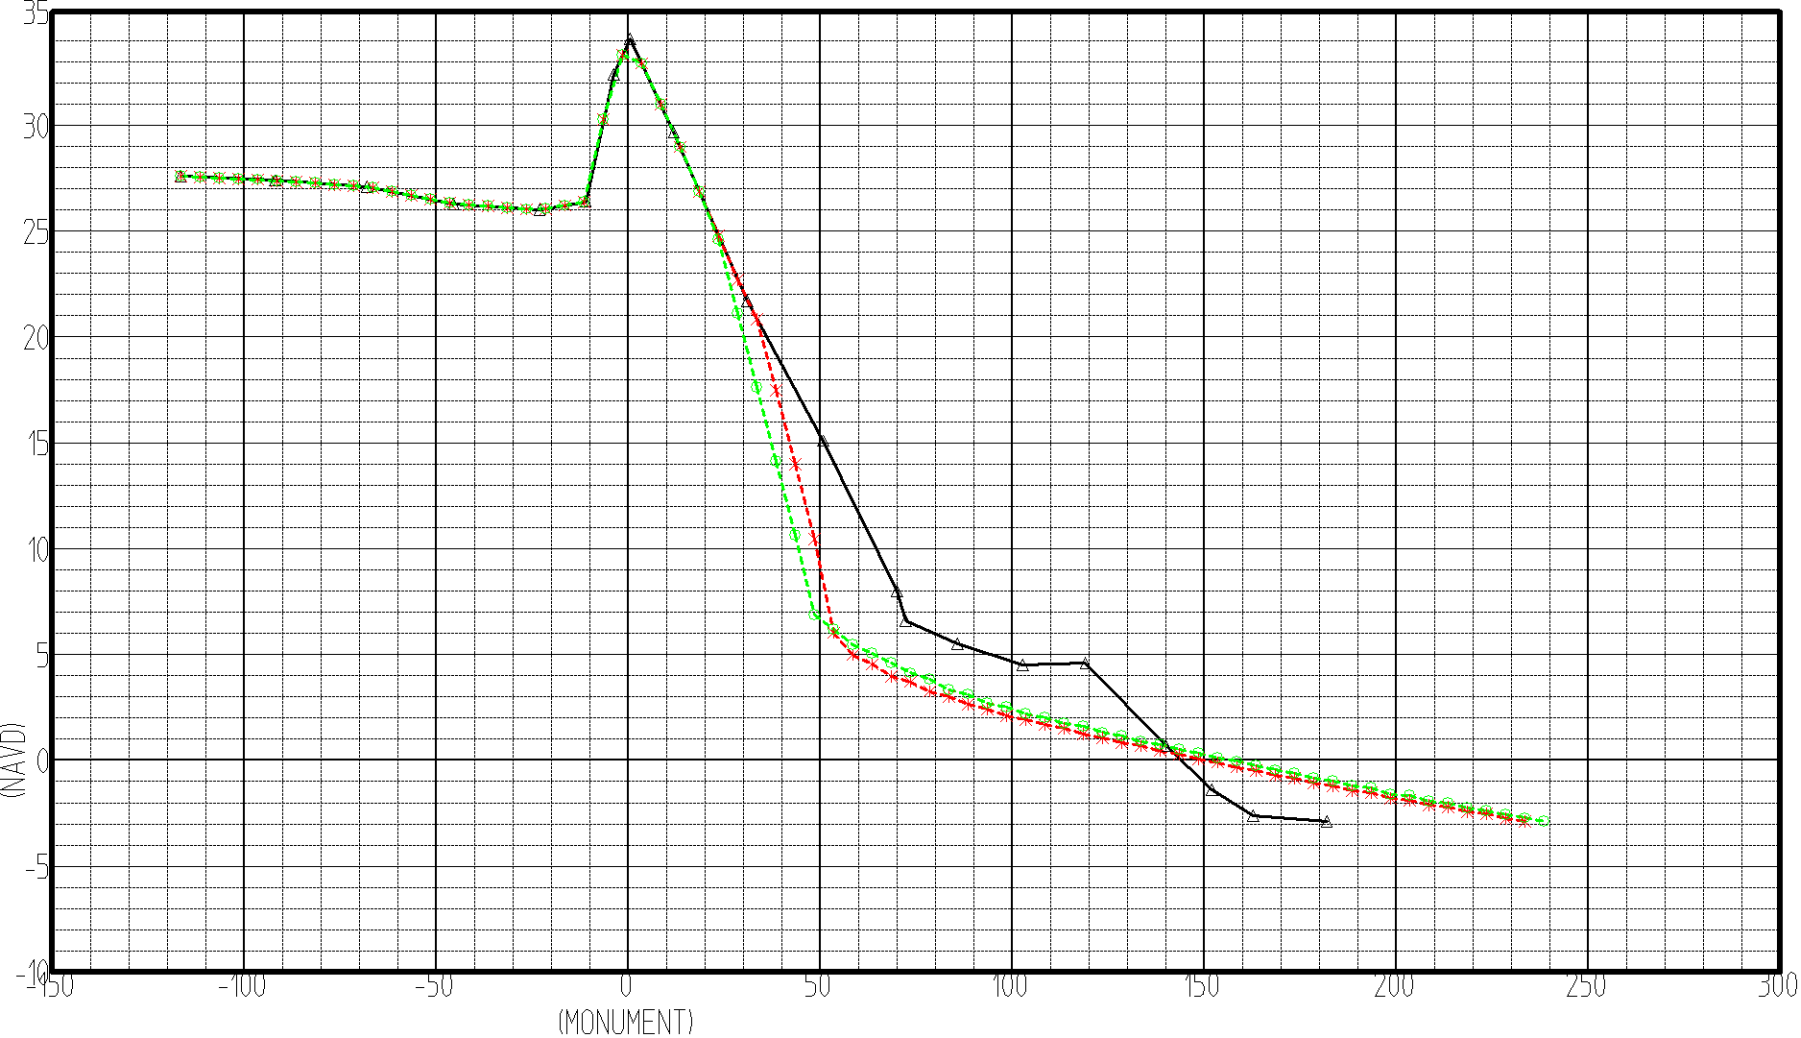
Range: R-115
 BEARING: 202.00
 1/1

BEACH PROFILE
 —△—△— WALTON JULY 2007 PRF
 - - * - - * - - SBEACH 15-YR ERODED PRF
 - - o - - o - - SBEACH 25-YR ERODED PRF

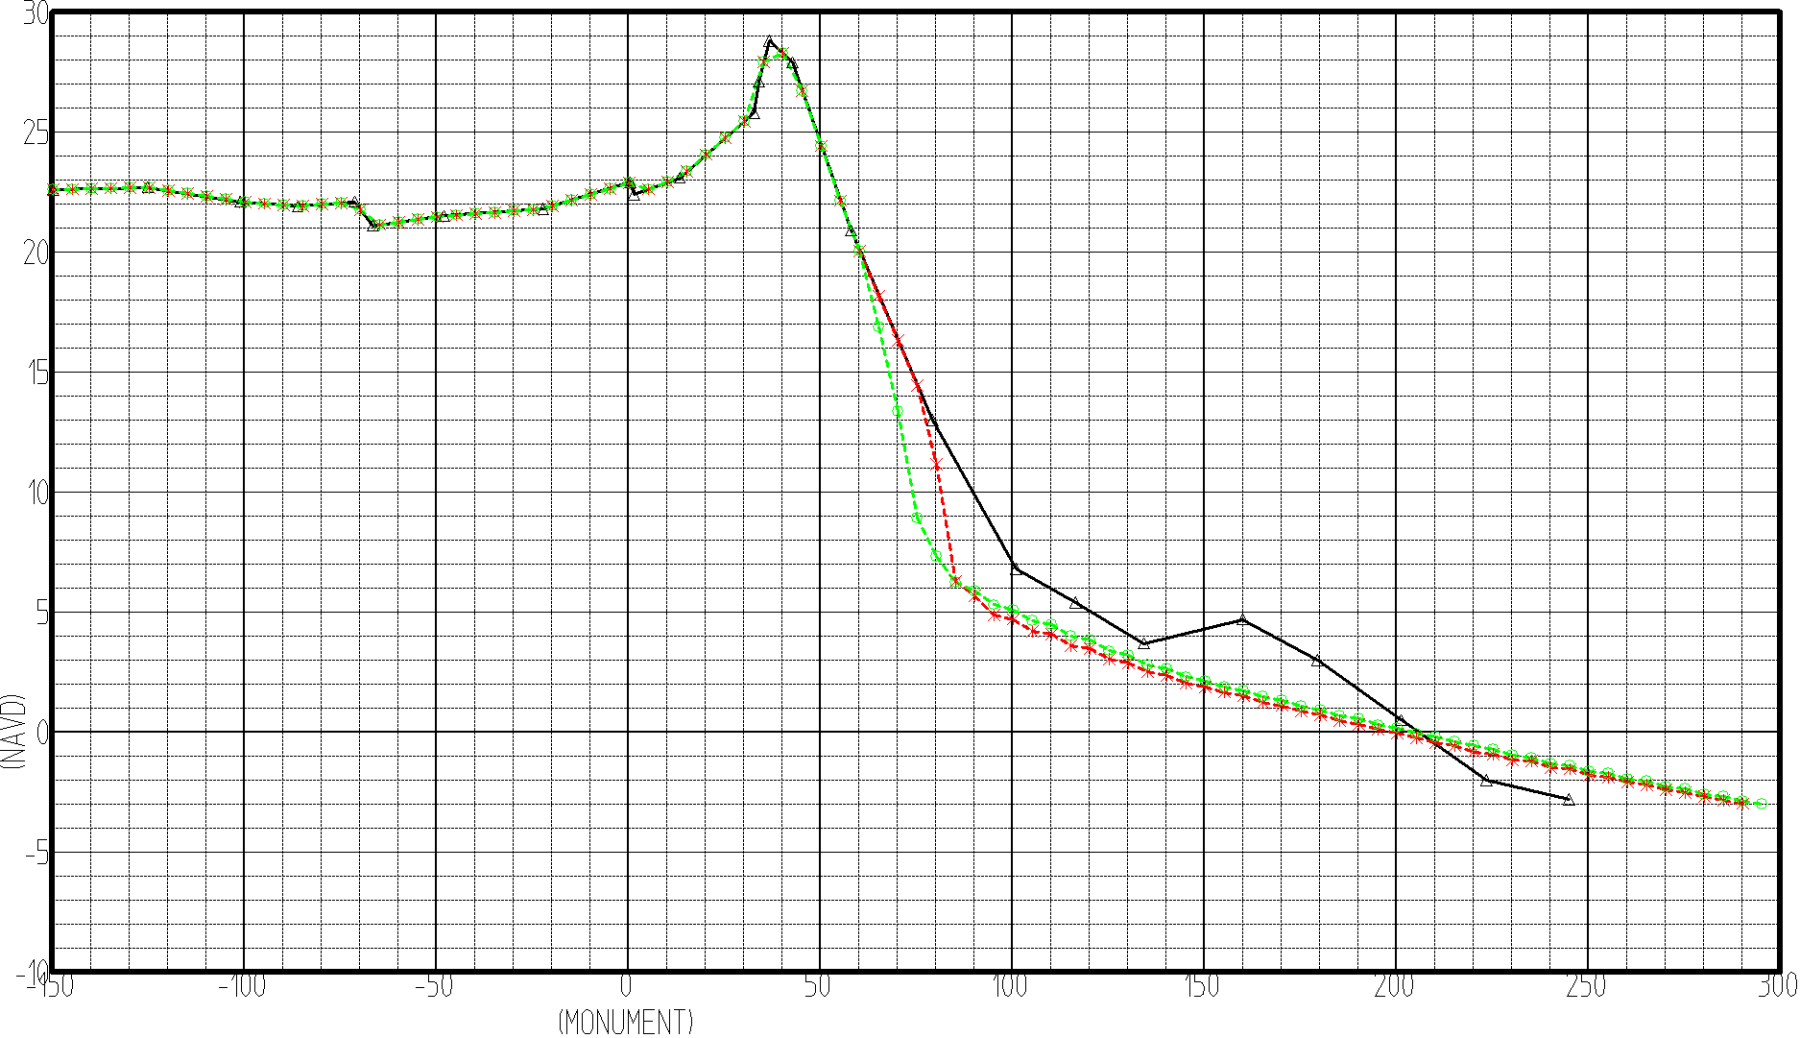
Range: R-116
 BEARING: 202.00
 1/1

BEACH PROFILE
 —△—△— WALTON JULY 2007 PRF
 - - * - - SBEACH 15-YR ERODED PRF
 - - o - - SBEACH 25-YR ERODED PRF
