Appendix II

SBEACH Model Erosion Profile Plots

Walton County

15-year and 25-year Storm Events

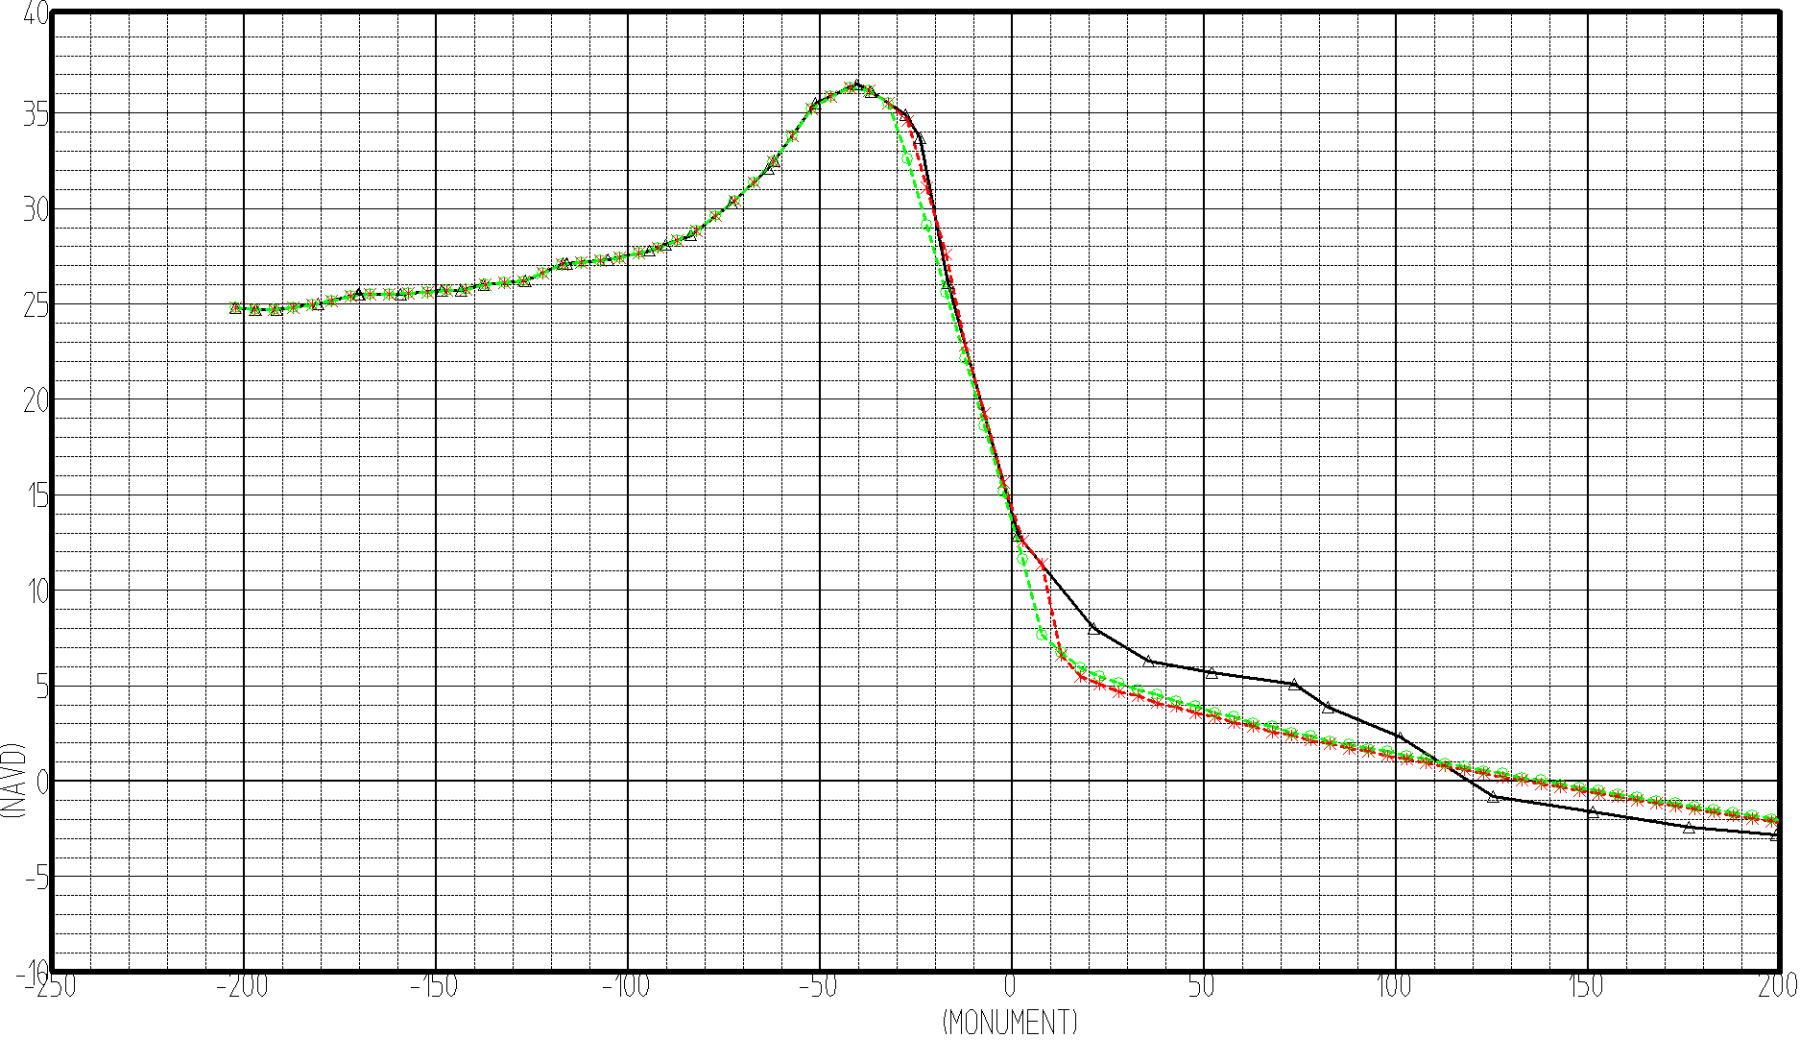
Range: R-117
 BEARING: 202.00
 1/2

BEACH PROFILE
 —△—△— WALTON JULY 2007 PRF
 - - * - - SBEACH 15-YR ERODED PRF
 - - o - - SBEACH 25-YR ERODED PRF

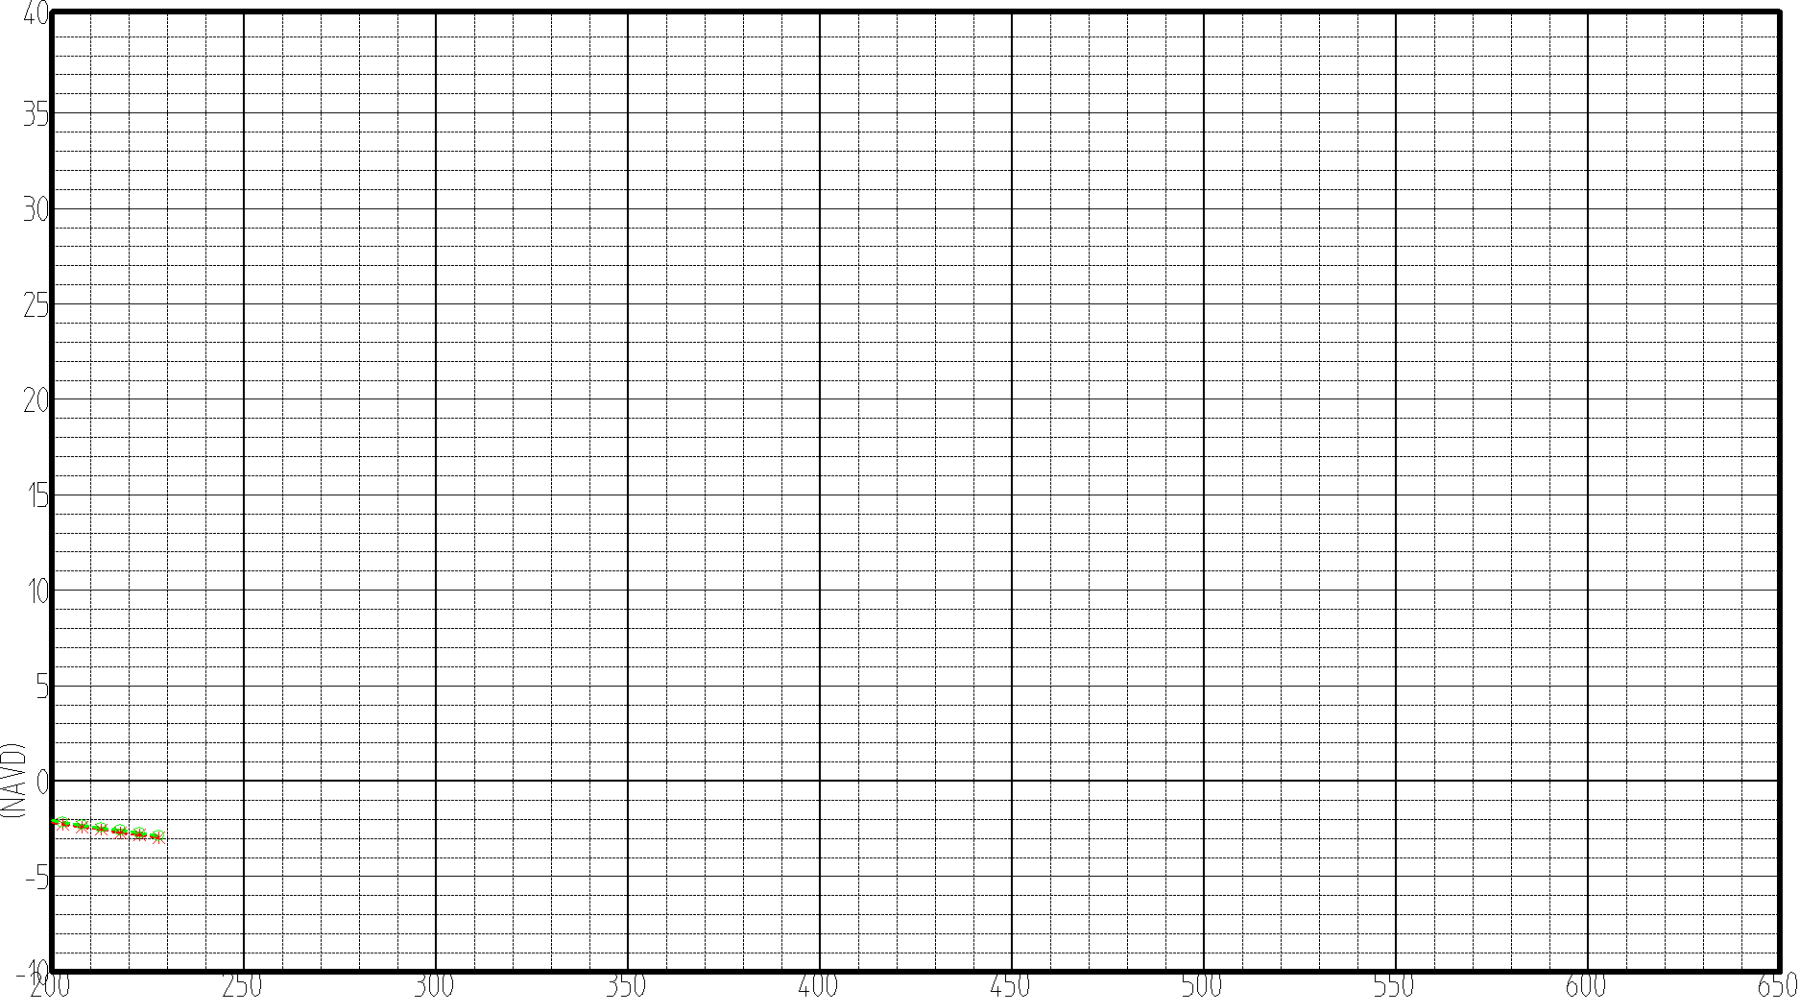
Range: R-117 2/2
 BEARING: 202.00

BEACH PROFILE
 —△—△— WALTON JULY 2007 PRF
 - - - * - - - SBEACH 15-YR ERODED PRF
 - - - o - - - SBEACH 25-YR ERODED PRF

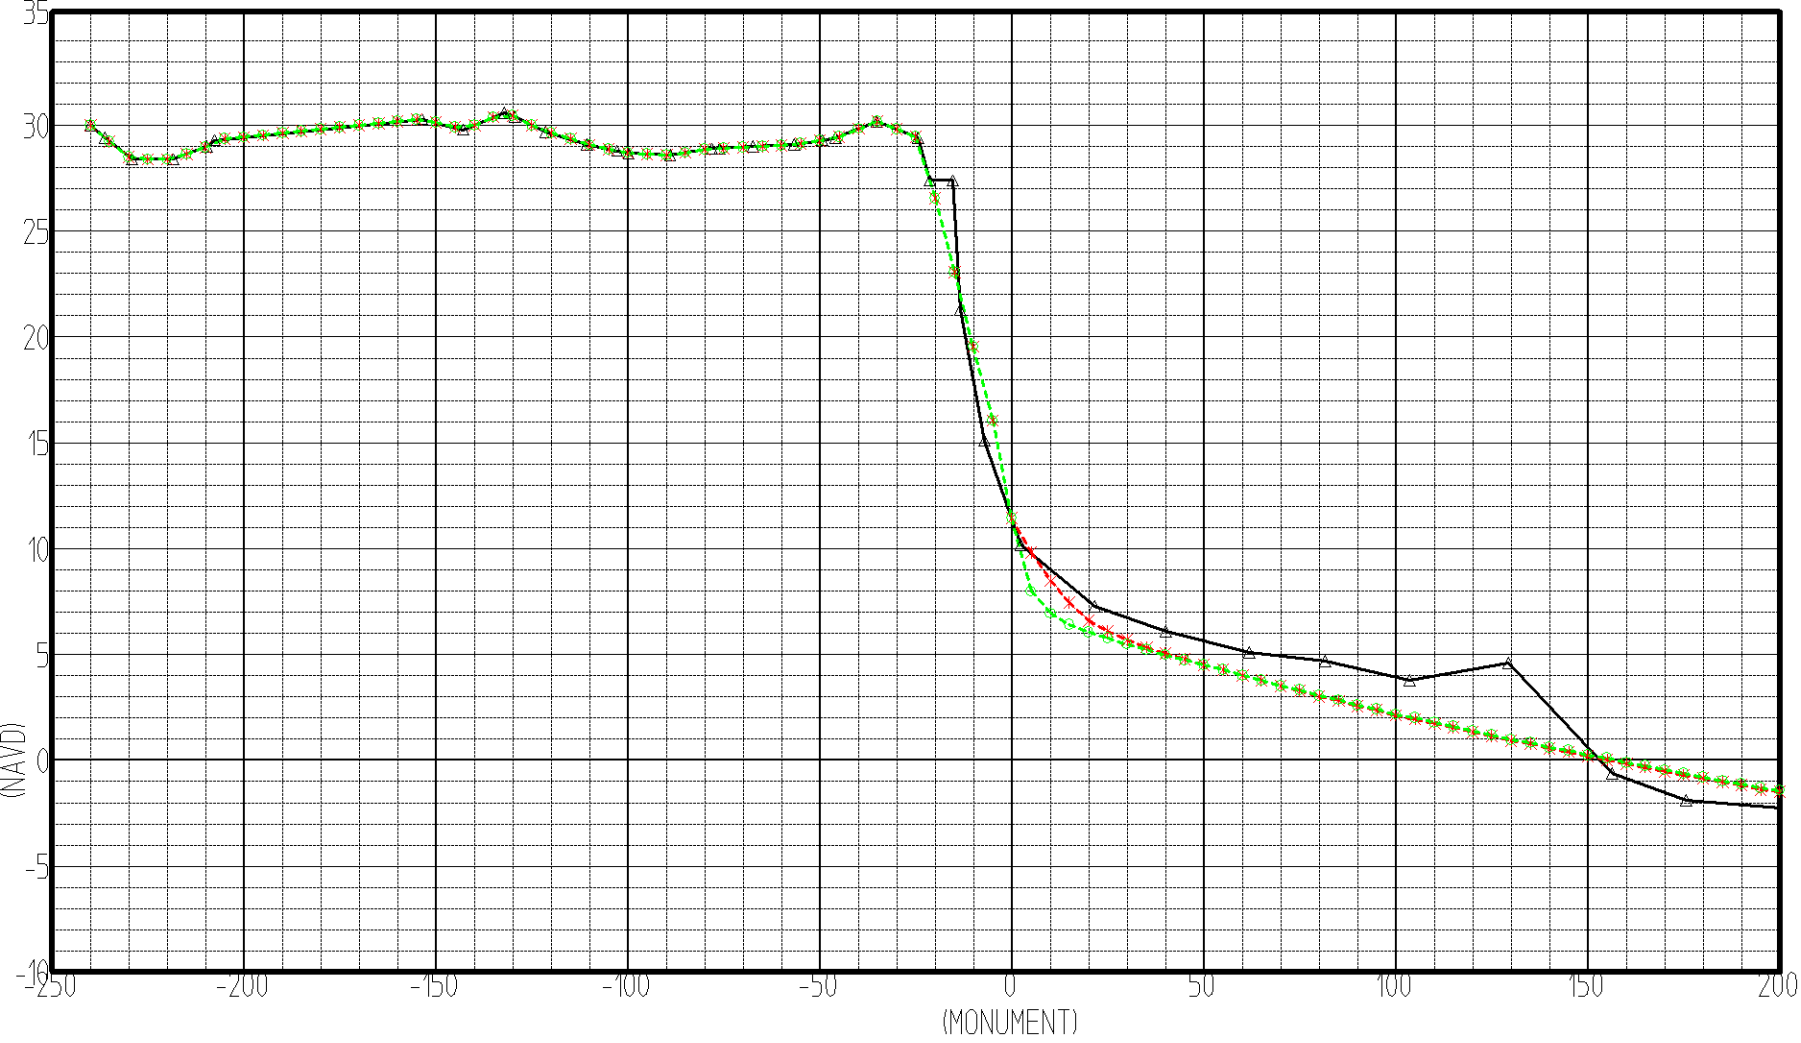
BEACH PROFILE
 —△—△— WALTON JULY 2007 PRF
 - - * - - SBEACH 15-YR ERODED PRF
 - - o - - SBEACH 25-YR ERODED PRF

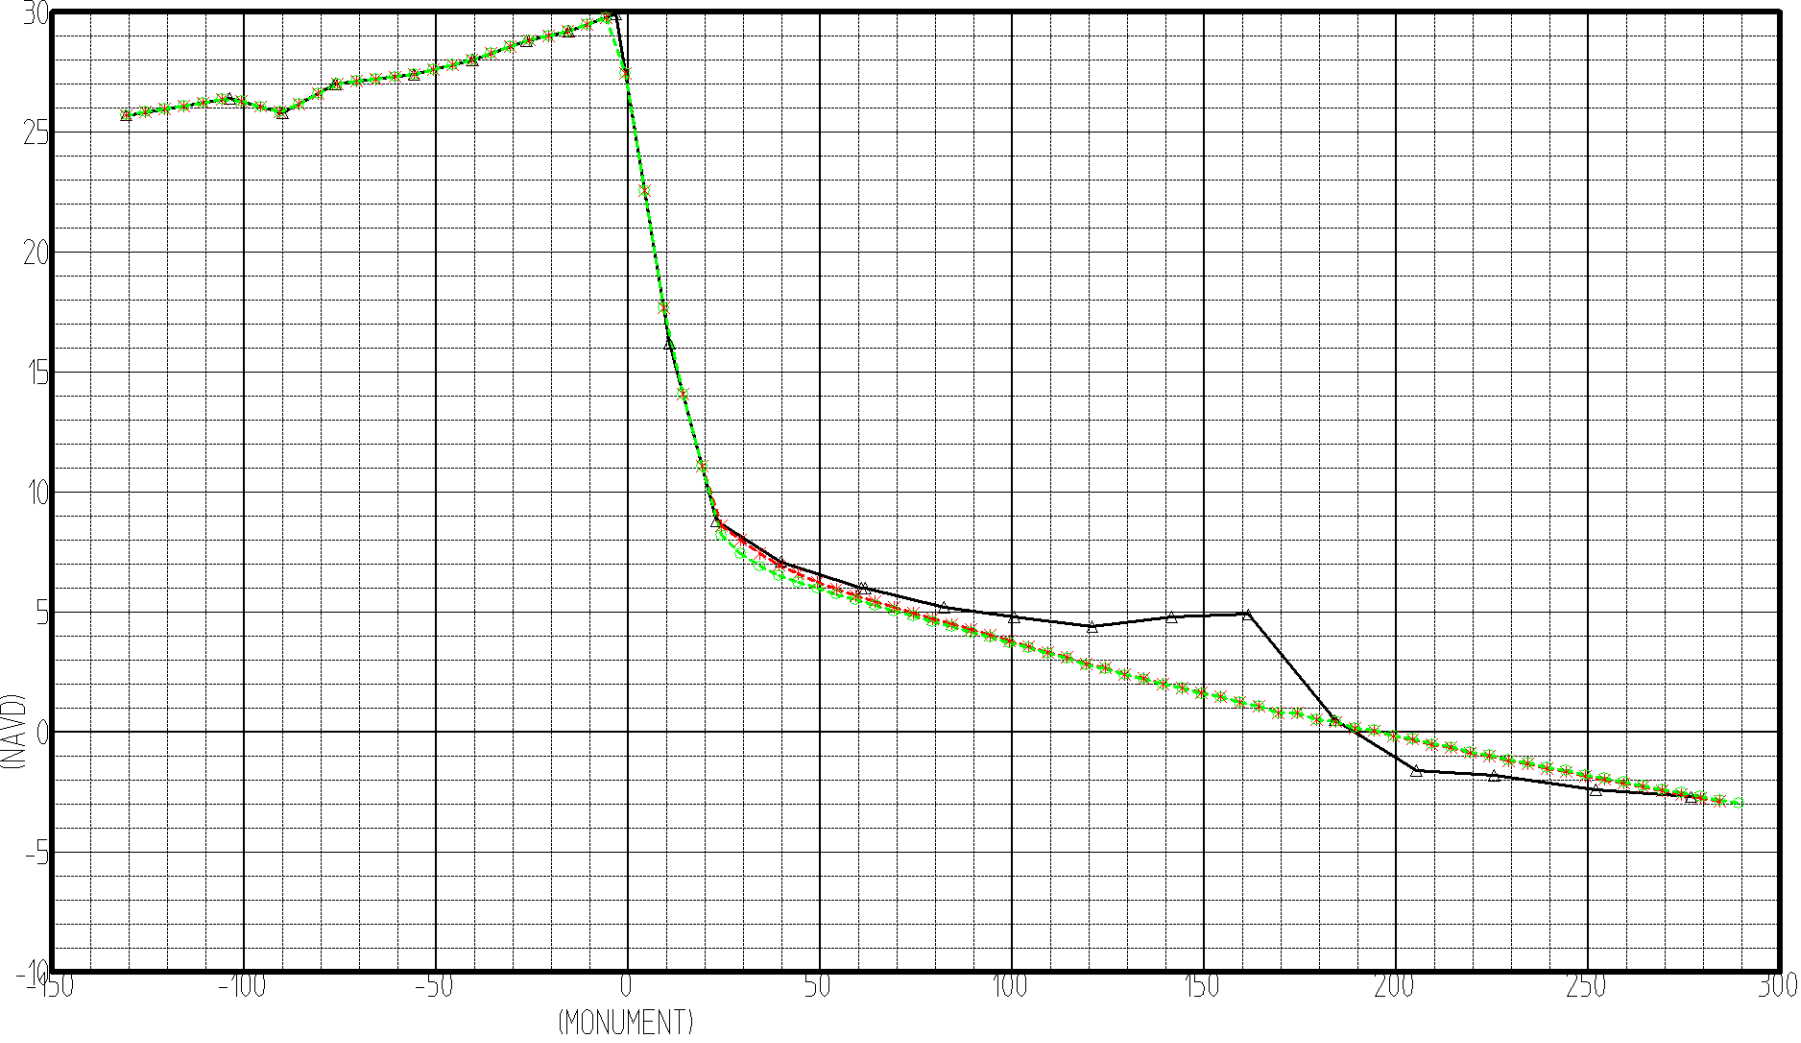
Range: R-119
 BEARING: 202.00
 1/1

BEACH PROFILE
 —△—△— WALTON JULY 2007 PRF
 - - * - - SBEACH 15-YR ERODED PRF
 - - o - - SBEACH 25-YR ERODED PRF

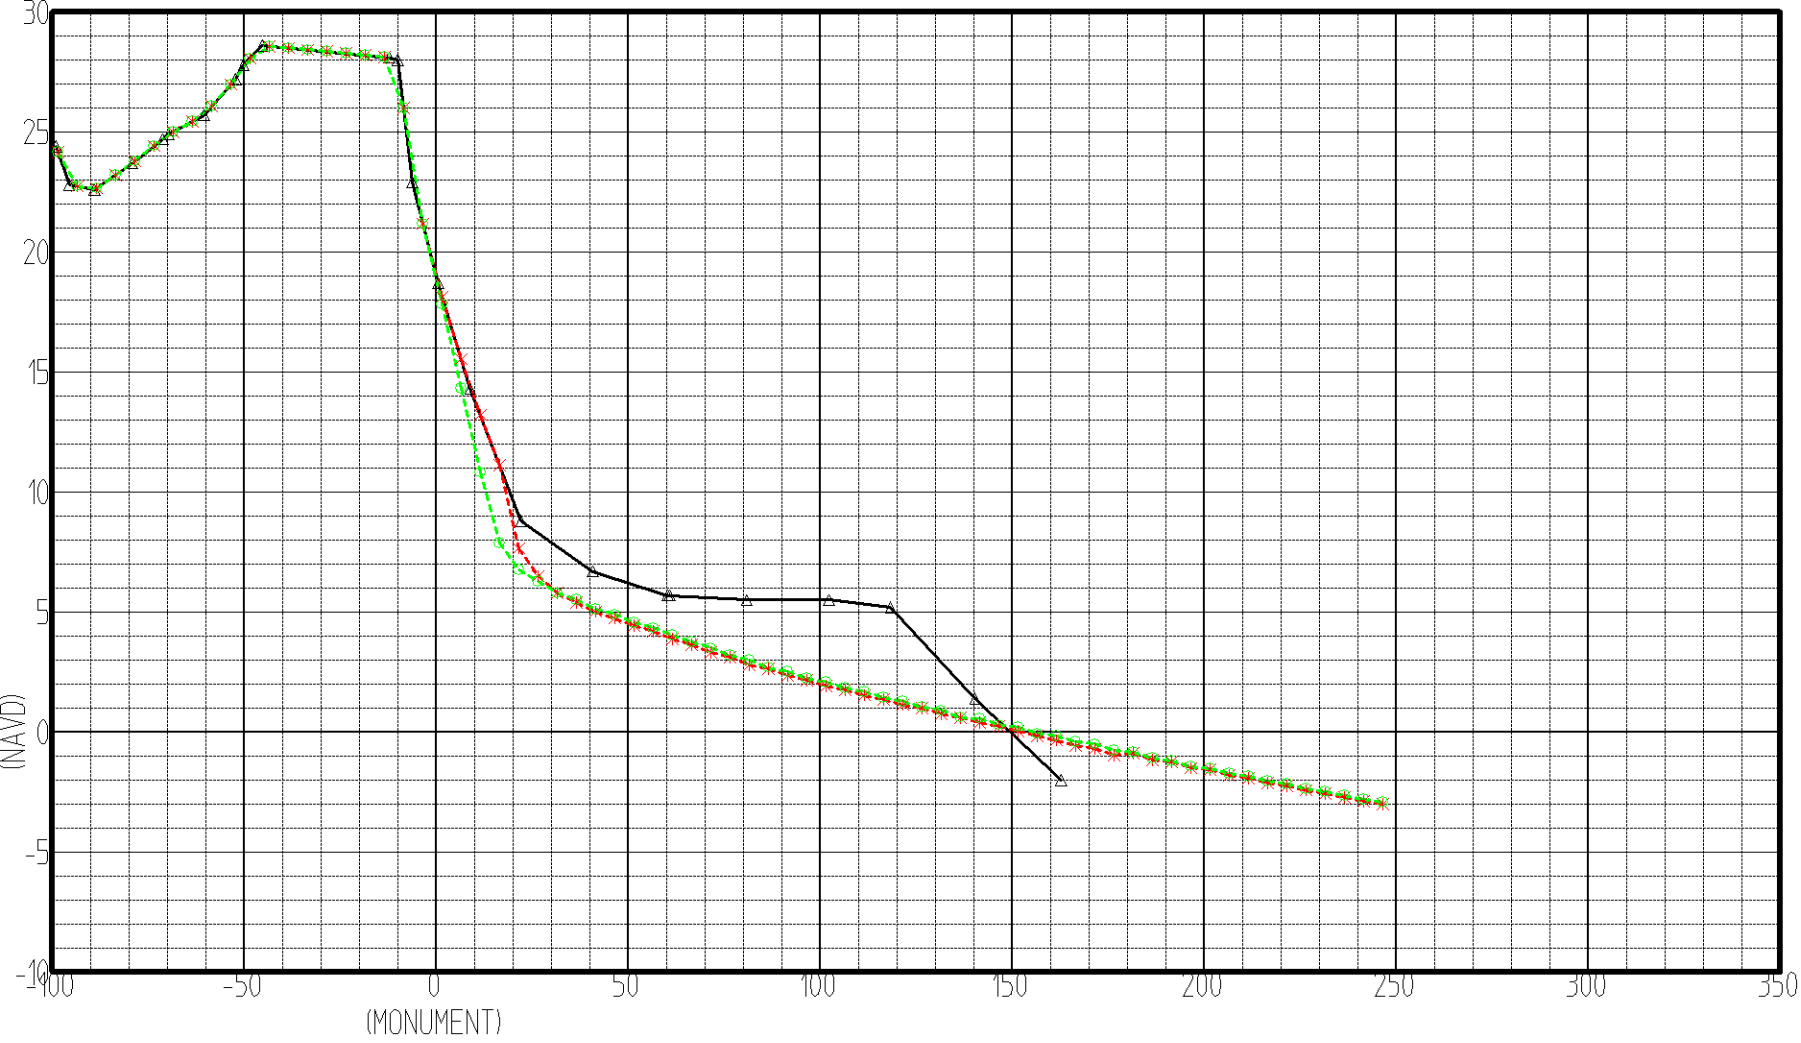
Range: R-120
 BEARING: 202.00
 1/1

BEACH PROFILE
 —△—△— WALTON JULY 2007 PRF
 - - * - - SBEACH 15-YR ERODED PRF
 - - o - - SBEACH 25-YR ERODED PRF

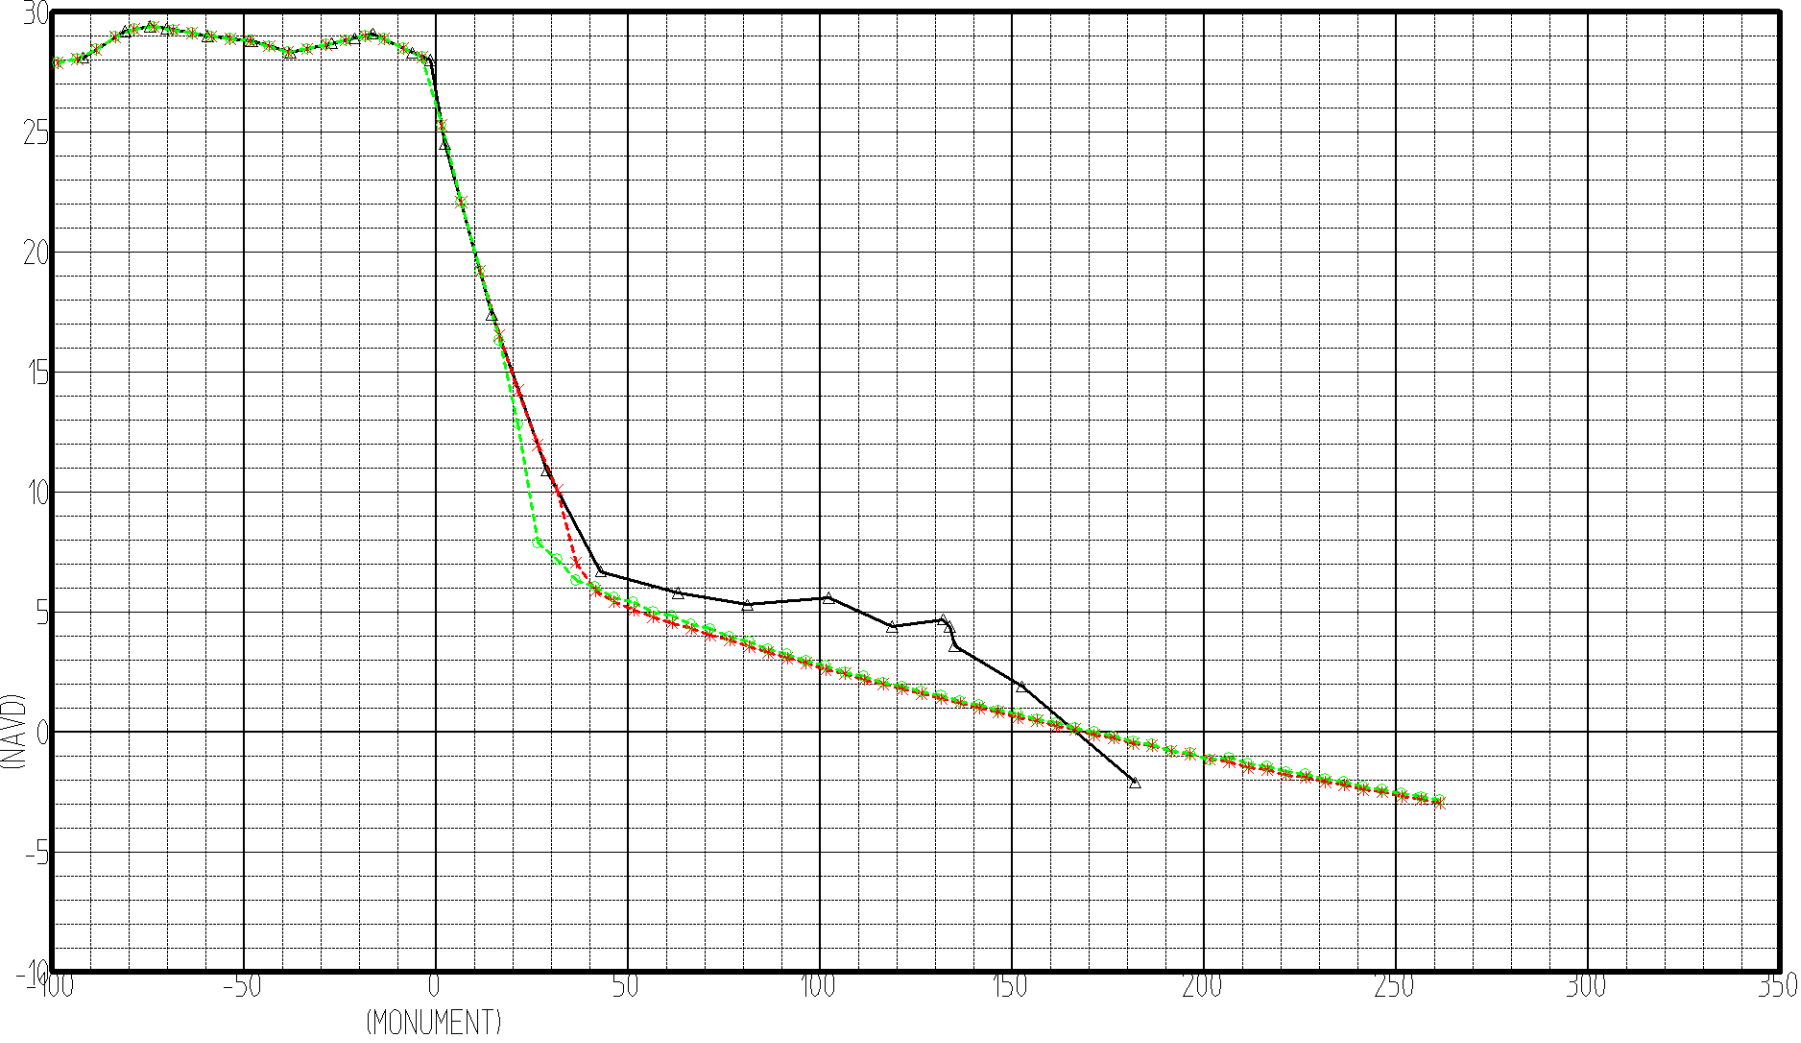
Range: R-121
 BEARING: 202.00
 1/1

BEACH PROFILE
 —△—△— WALTON JULY 2007 PRF
 - - * - - SBEACH 15-YR ERODED PRF
 - - o - - SBEACH 25-YR ERODED PRF

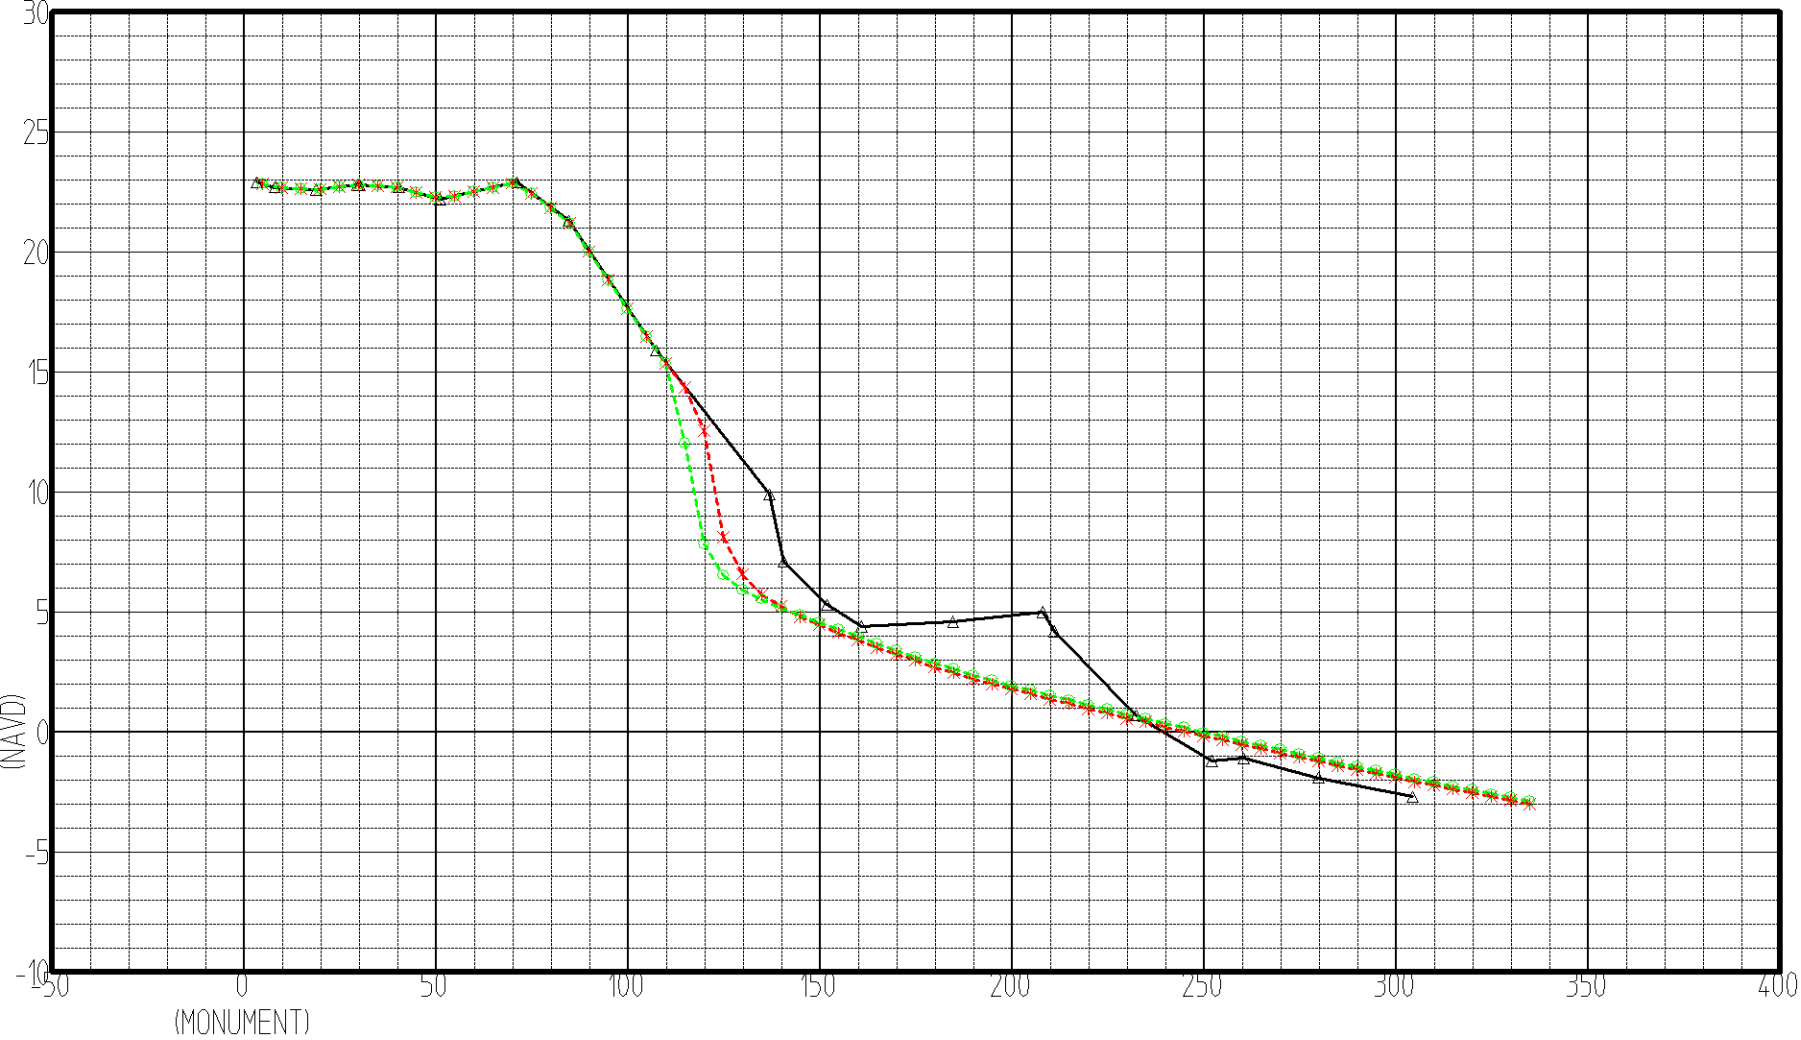
Range: R-122
 BEARING: 202.00
 1/1

BEACH PROFILE
 —△—△— WALTON JULY 2007 PRF
 - - * - - SBEACH 15-YR ERODED PRF
 - - o - - SBEACH 25-YR ERODED PRF

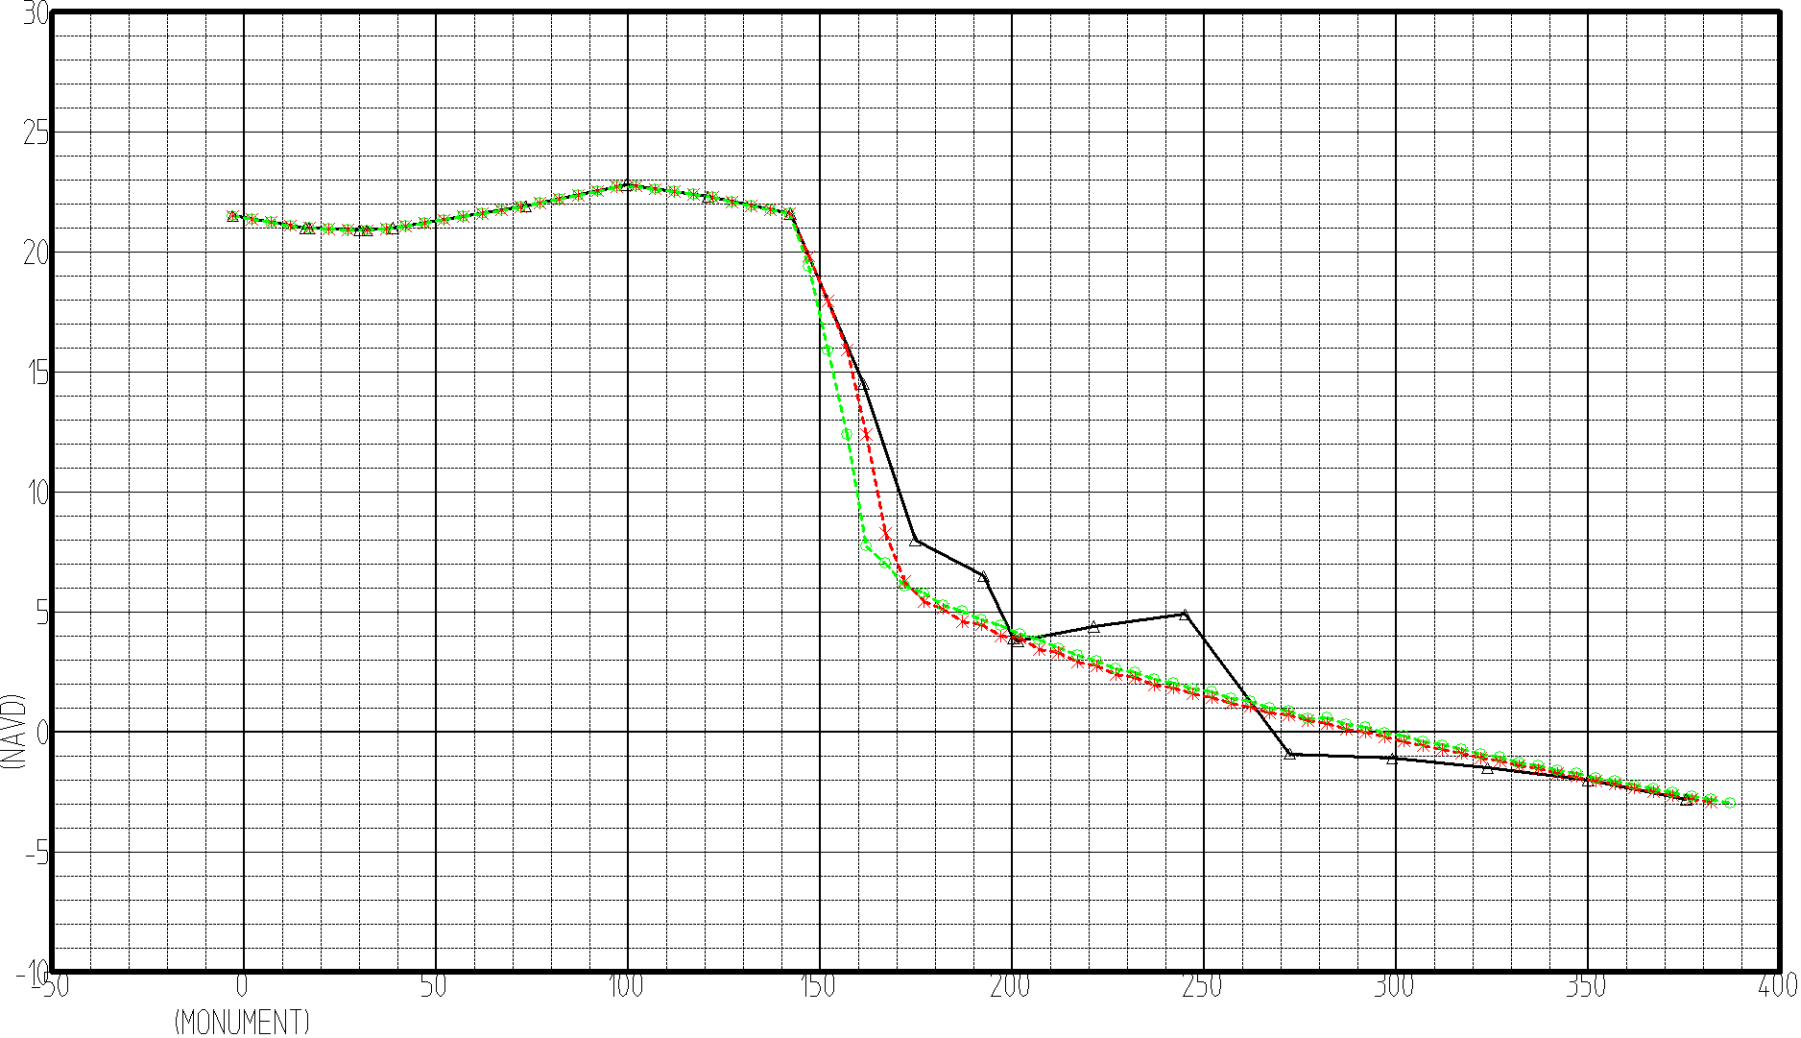
Range: R-123 1/1
 BEARING: 202.00

BEACH PROFILE
 —△—△— WALTON JULY 2007 PRF
 - - * - - SBEACH 15-YR ERODED PRF
 - - o - - SBEACH 25-YR ERODED PRF

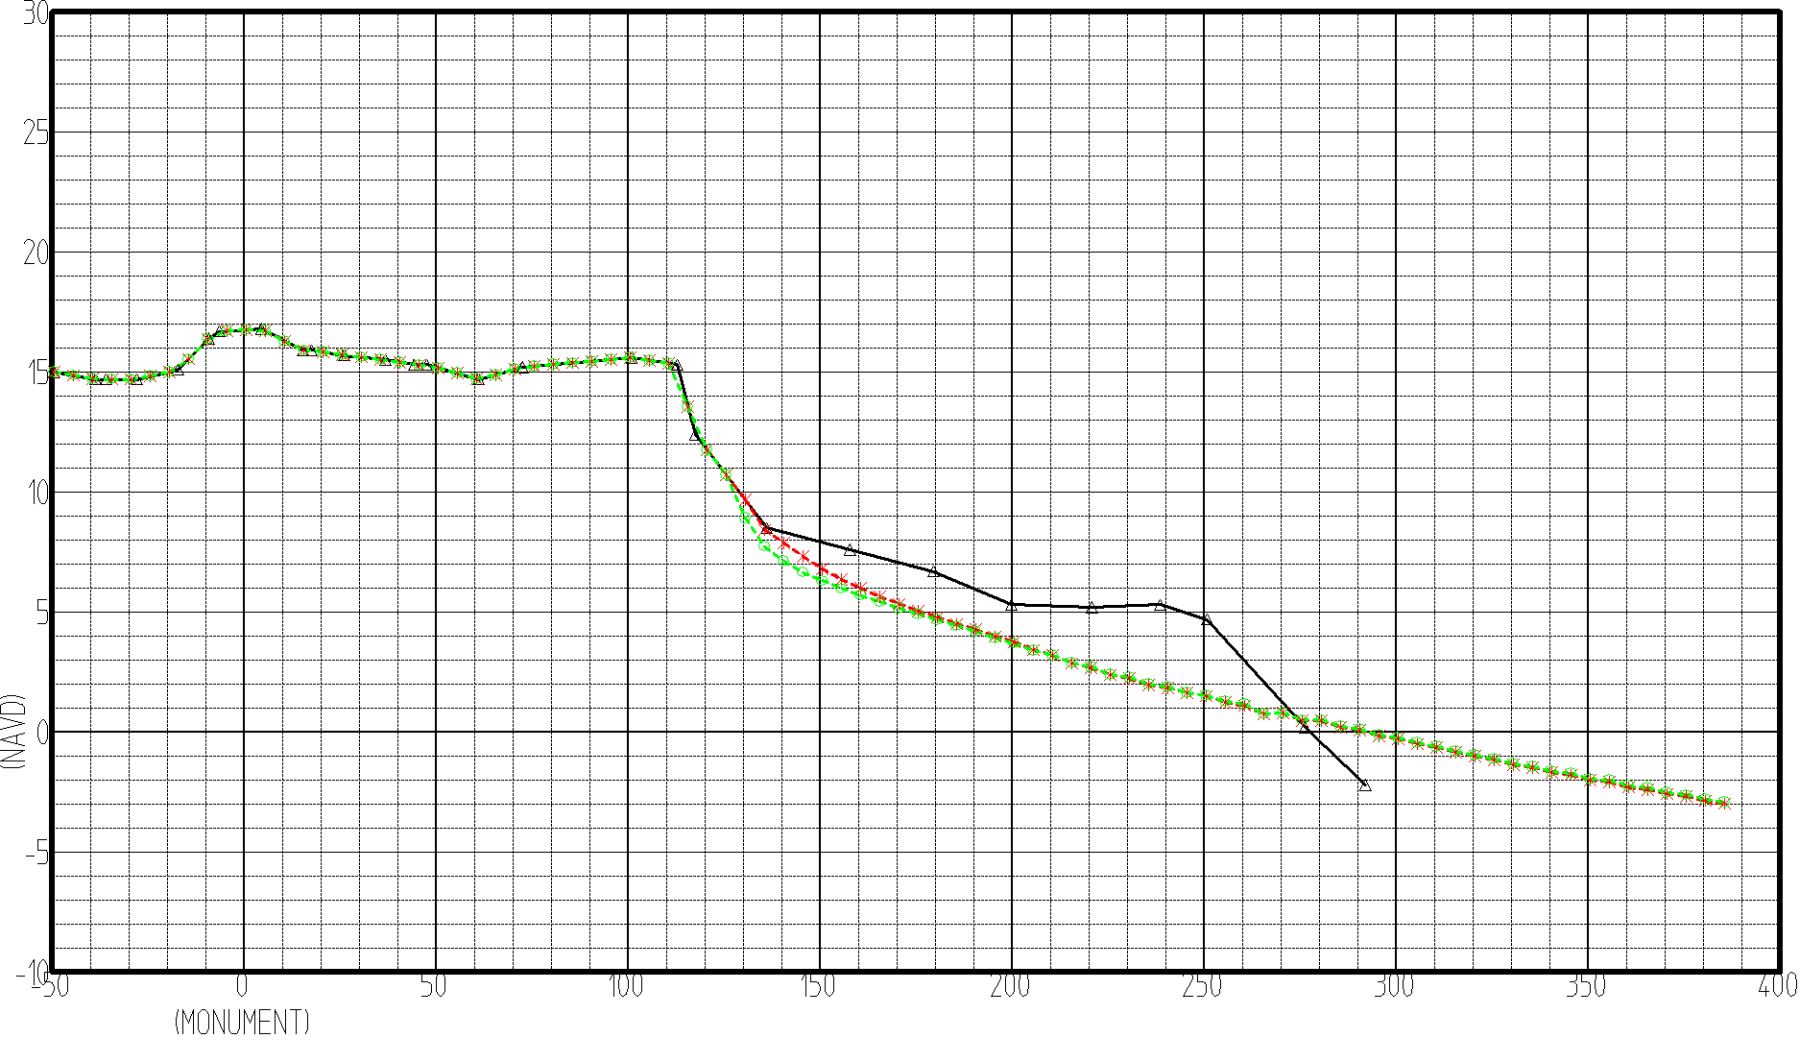
Range: R-124

BEACH PROFILE

—△—△— WALTON JULY 2007 PRF

- - * - - * - - SBEACH 15-YR ERODED PRF

- - o - - o - - SBEACH 25-YR ERODED PRF

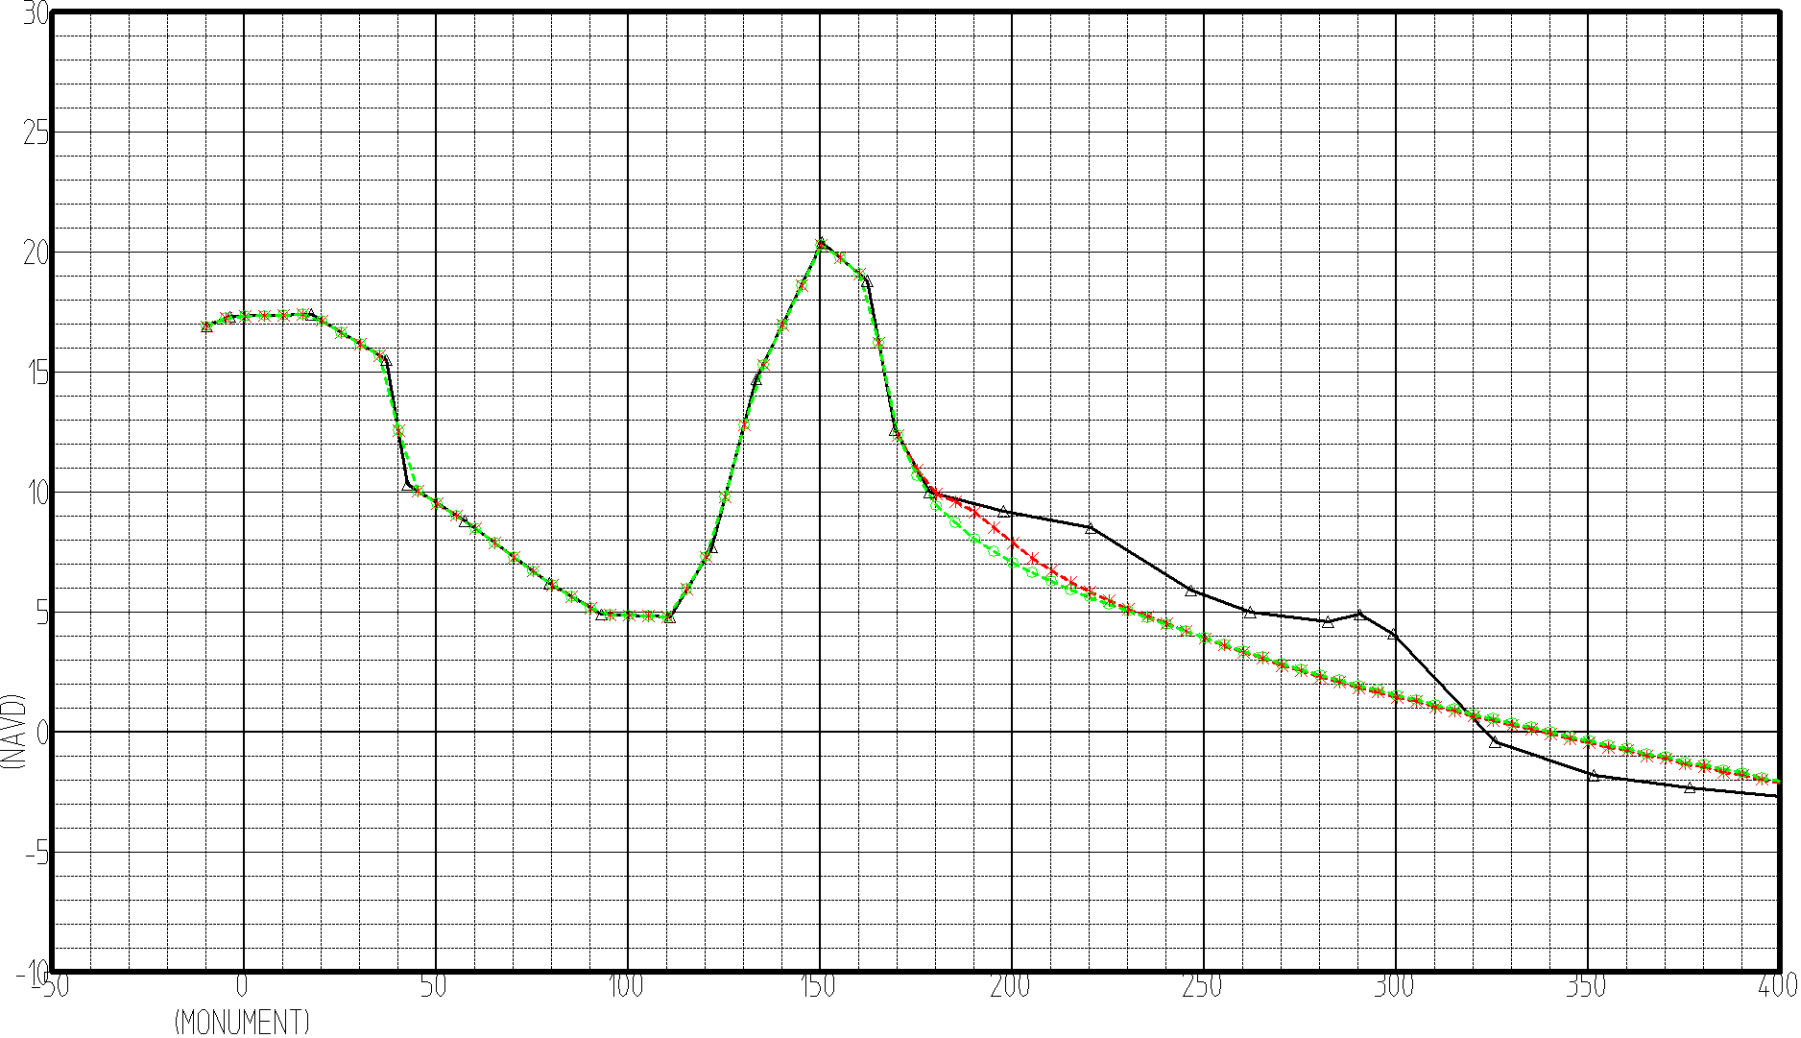
Range: R-125
 BEARING: 202.00
 1/2

BEACH PROFILE
 —△—△— WALTON JULY 2007 PRF
 - - * - - * - - SBEACH 15-YR ERODED PRF
 - - o - - o - - SBEACH 25-YR ERODED PRF

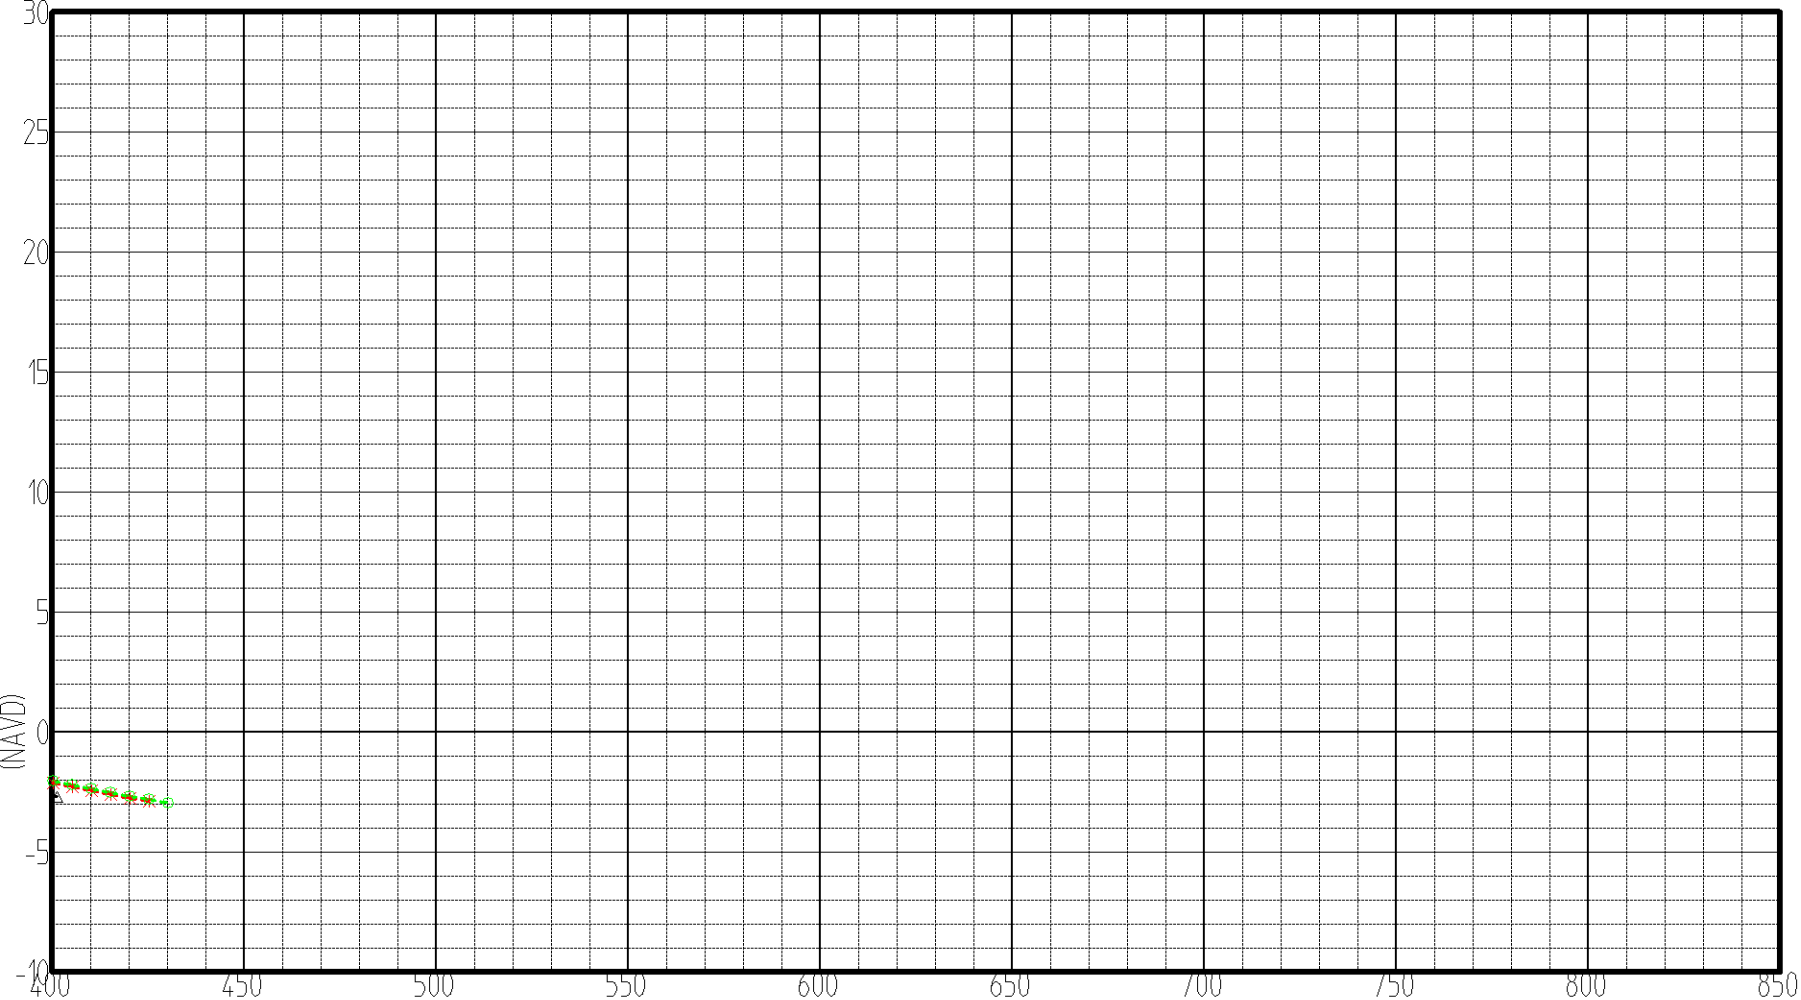
Range: R-125 2/2

BEACH PROFILE

WALTON JULY 2007 PRF

SBEACH 15-YR ERODED PRF

SBEACH 25-YR ERODED PRF

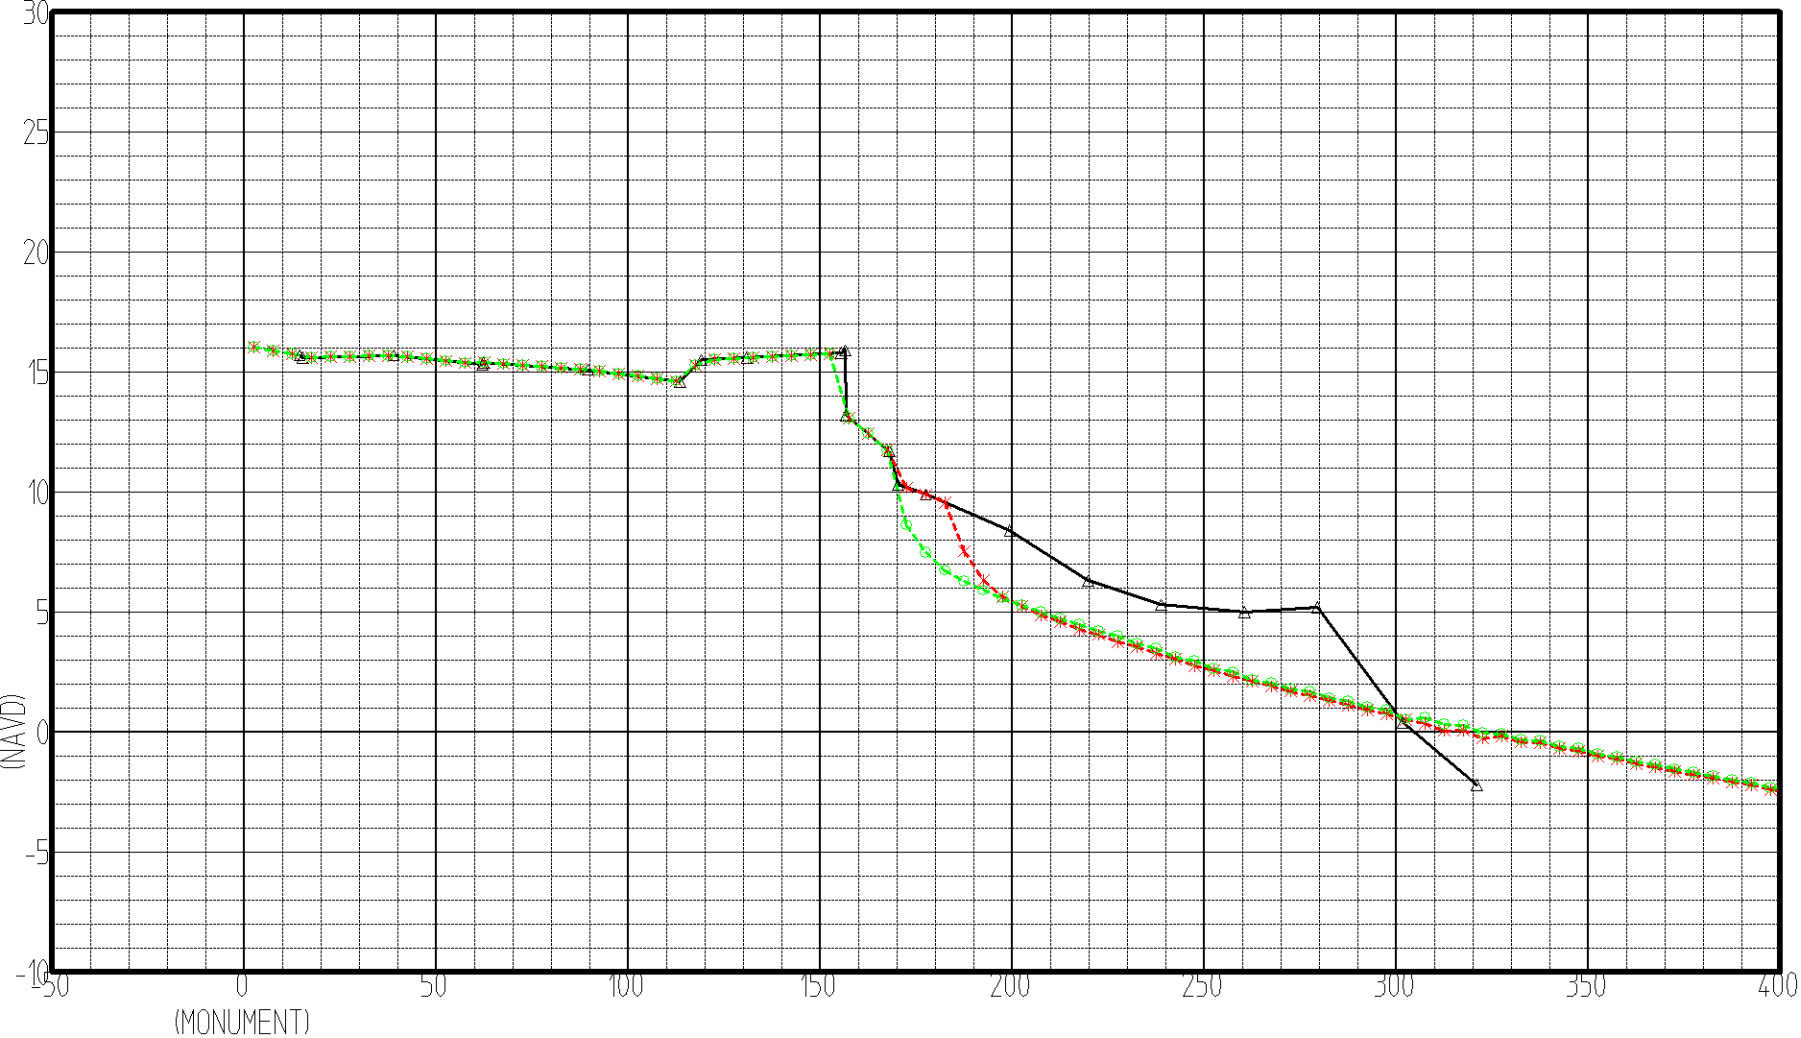
Range: W-126 1/2
 BEARING: 202.00

BEACH PROFILE
 —△—△— WALTON JULY 2007 PRF
 - - * - - SBEACH 15-YR ERODED PRF
 - - o - - SBEACH 25-YR ERODED PRF
