Appendix II

SBEACH Model Erosion Profile Plots

Walton County

15-year and 25-year Storm Events

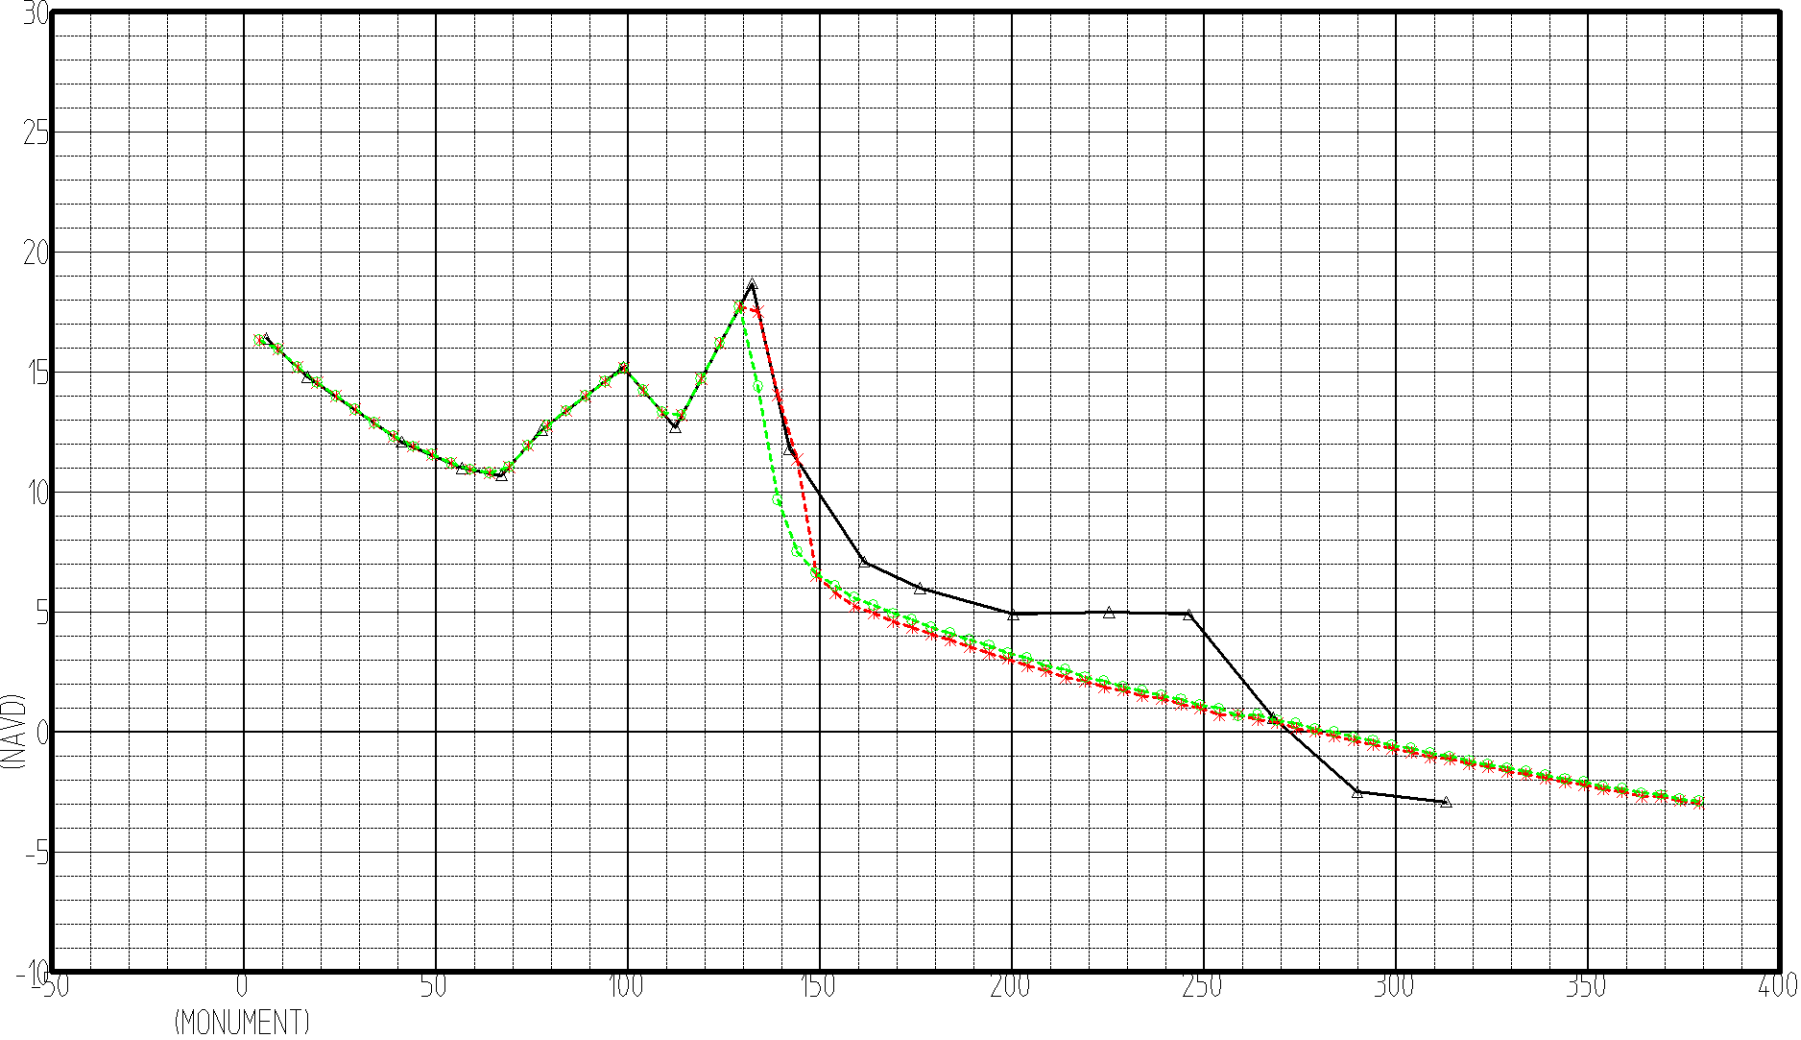
BEACH PROFILE
 —△—△— WALTON JULY 2007 PRF
 - - * - - SBEACH 15-YR ERODED PRF
 - - o - - SBEACH 25-YR ERODED PRF
